**STORMWATER EXISTING CONDITIONS
61 TO 68 WAVERLY STREET
TOWN OF ASHLAND**

**STORMWATER PROPOSED CONDITIONS
61 TO 68 WAVERLY STREET
TOWN OF ASHLAND**

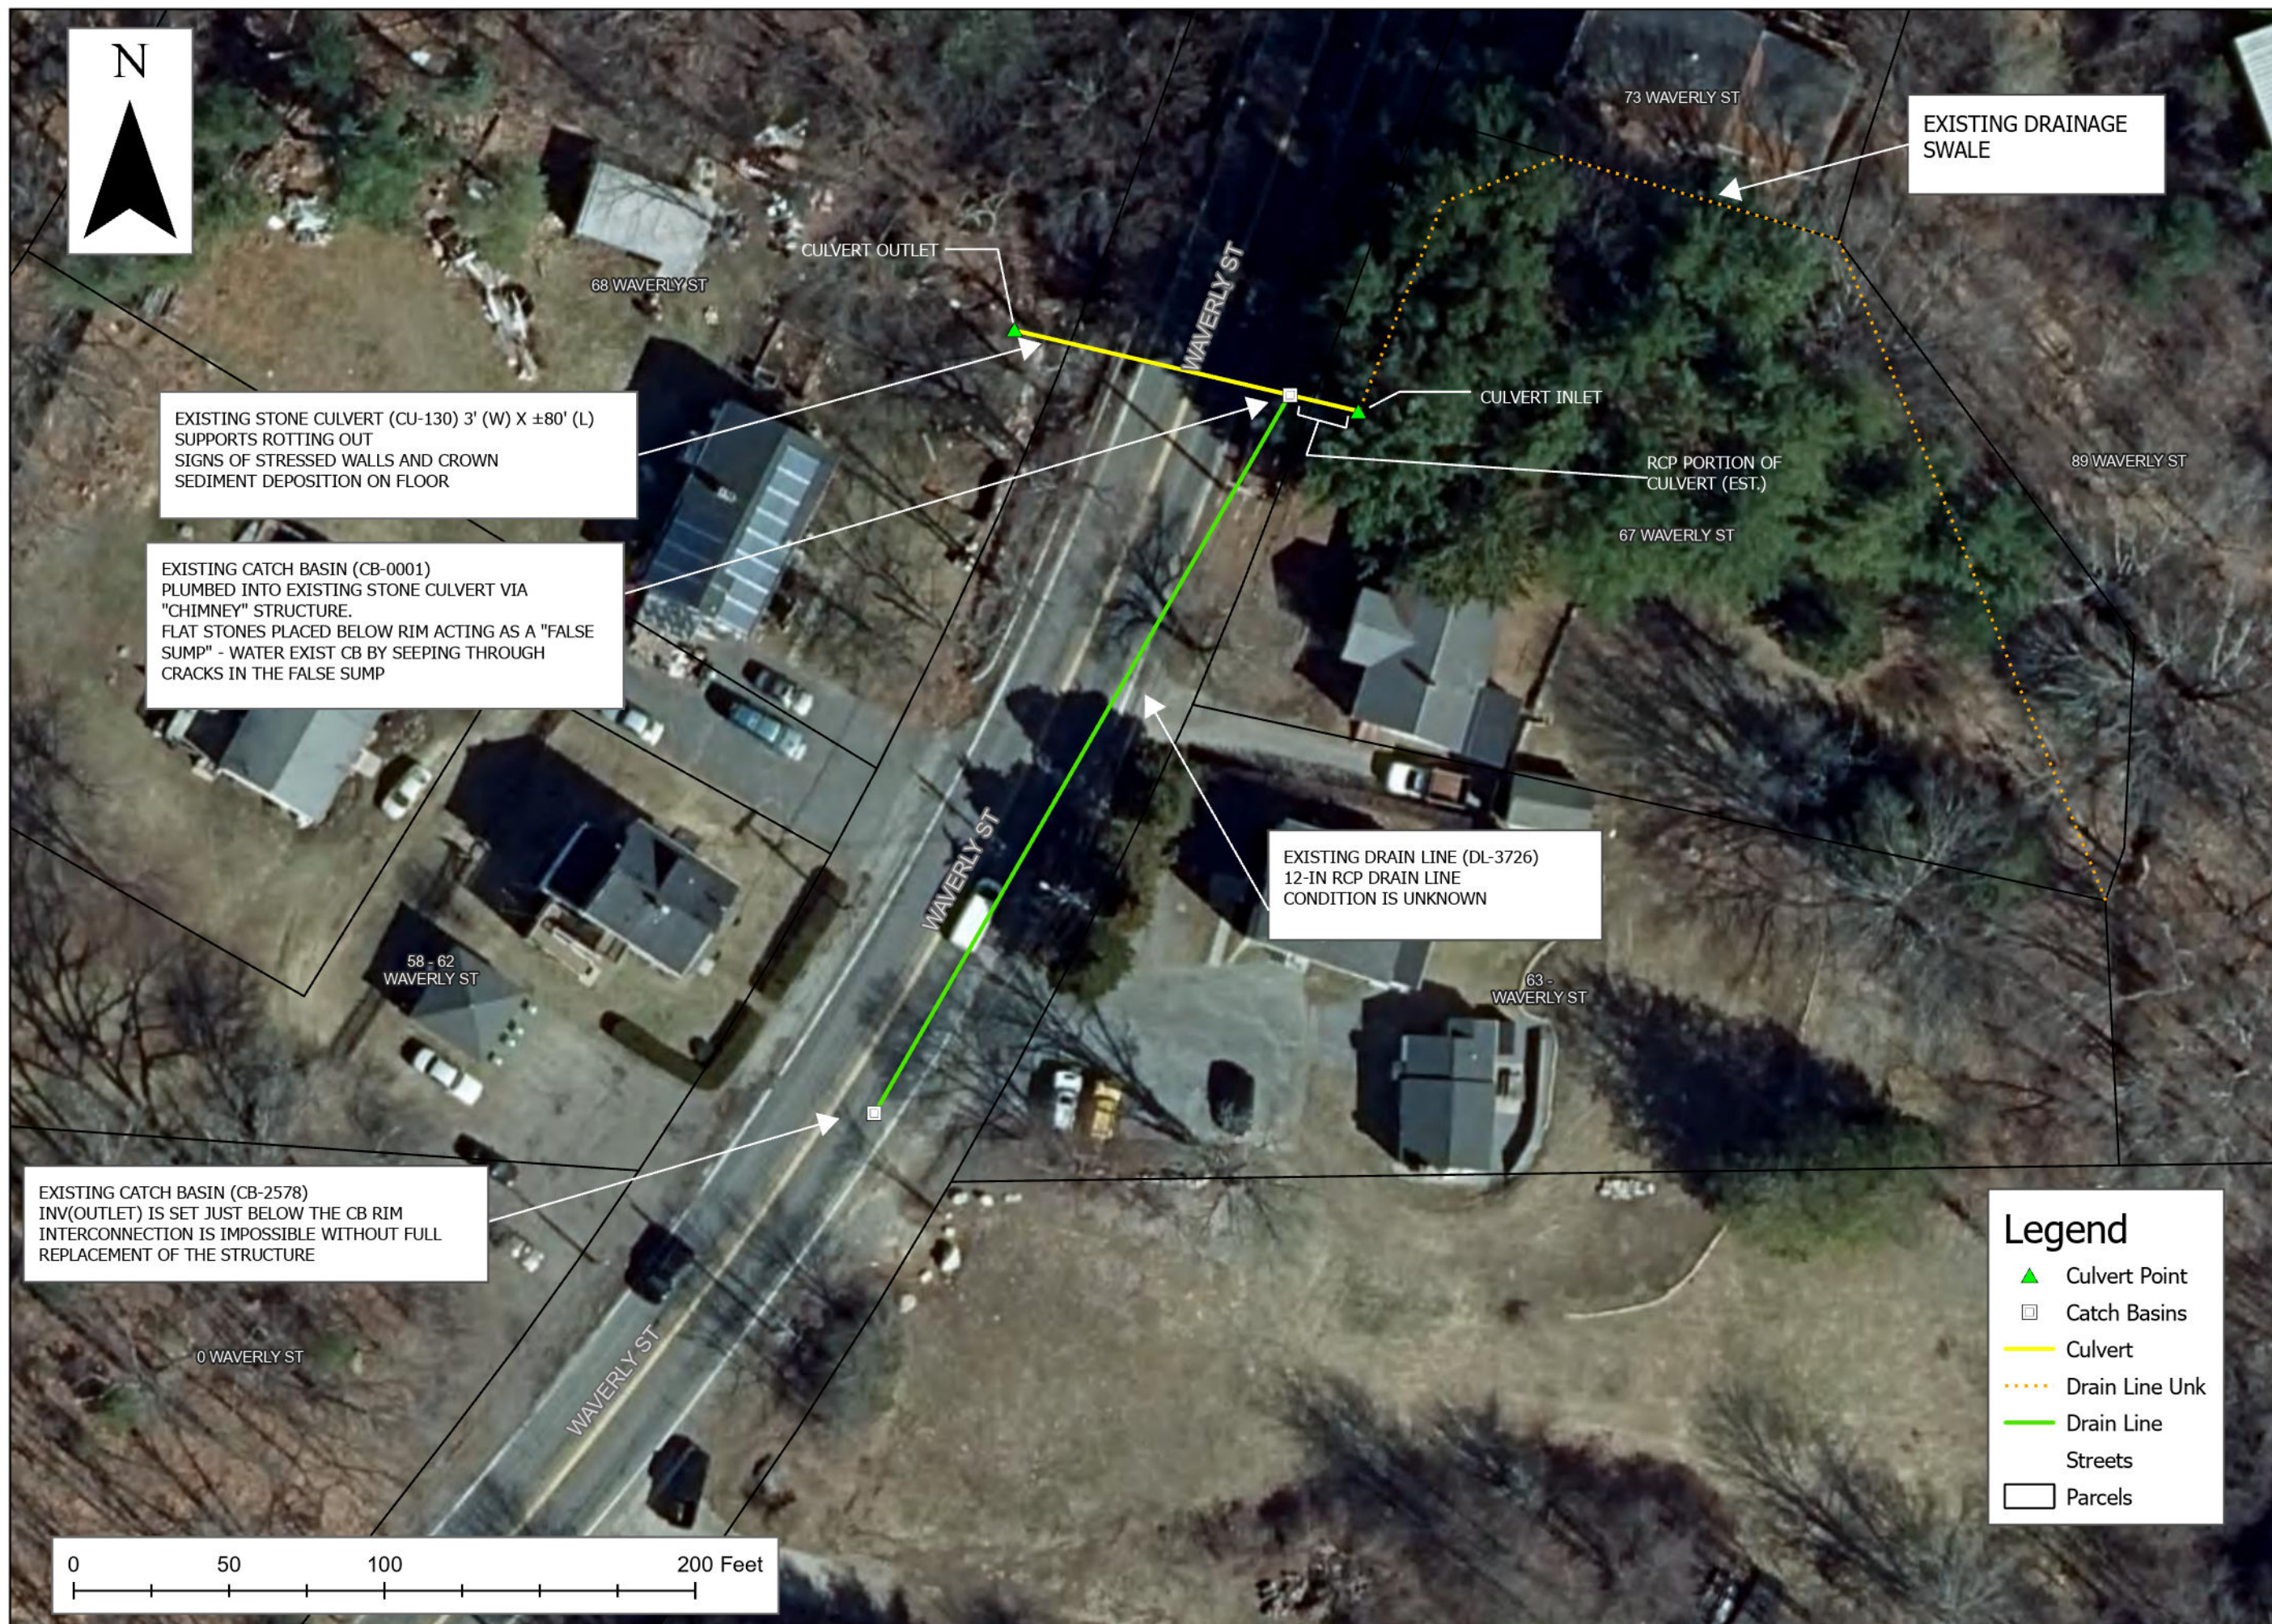
EXISTING STONE CULVERT (CU-130) 3' (W) X ±80' (L) SUPPORTS ROTTING OUT SIGNS OF STRESSED WALLS AND CROWN SEDIMENT DEPOSITION ON FLOOR

EXISTING CATCH BASIN (CB-0001) PLUMBED INTO EXISTING STONE CULVERT VIA "CHIMNEY" STRUCTURE. FLAT STONES PLACED BELOW RIM ACTING AS A "FALSE SUMP" - WATER EXIST CB BY SEEPING THROUGH CRACKS IN THE FALSE SUMP

EXISTING CATCH BASIN (CB-2578) INV(OUTLET) IS SET JUST BELOW THE CB RIM INTERCONNECTION IS IMPOSSIBLE WITHOUT FULL REPLACEMENT OF THE STRUCTURE

EXISTING DRAIN LINE (DL-3726) 12-IN RCP DRAIN LINE CONDITION IS UNKNOWN

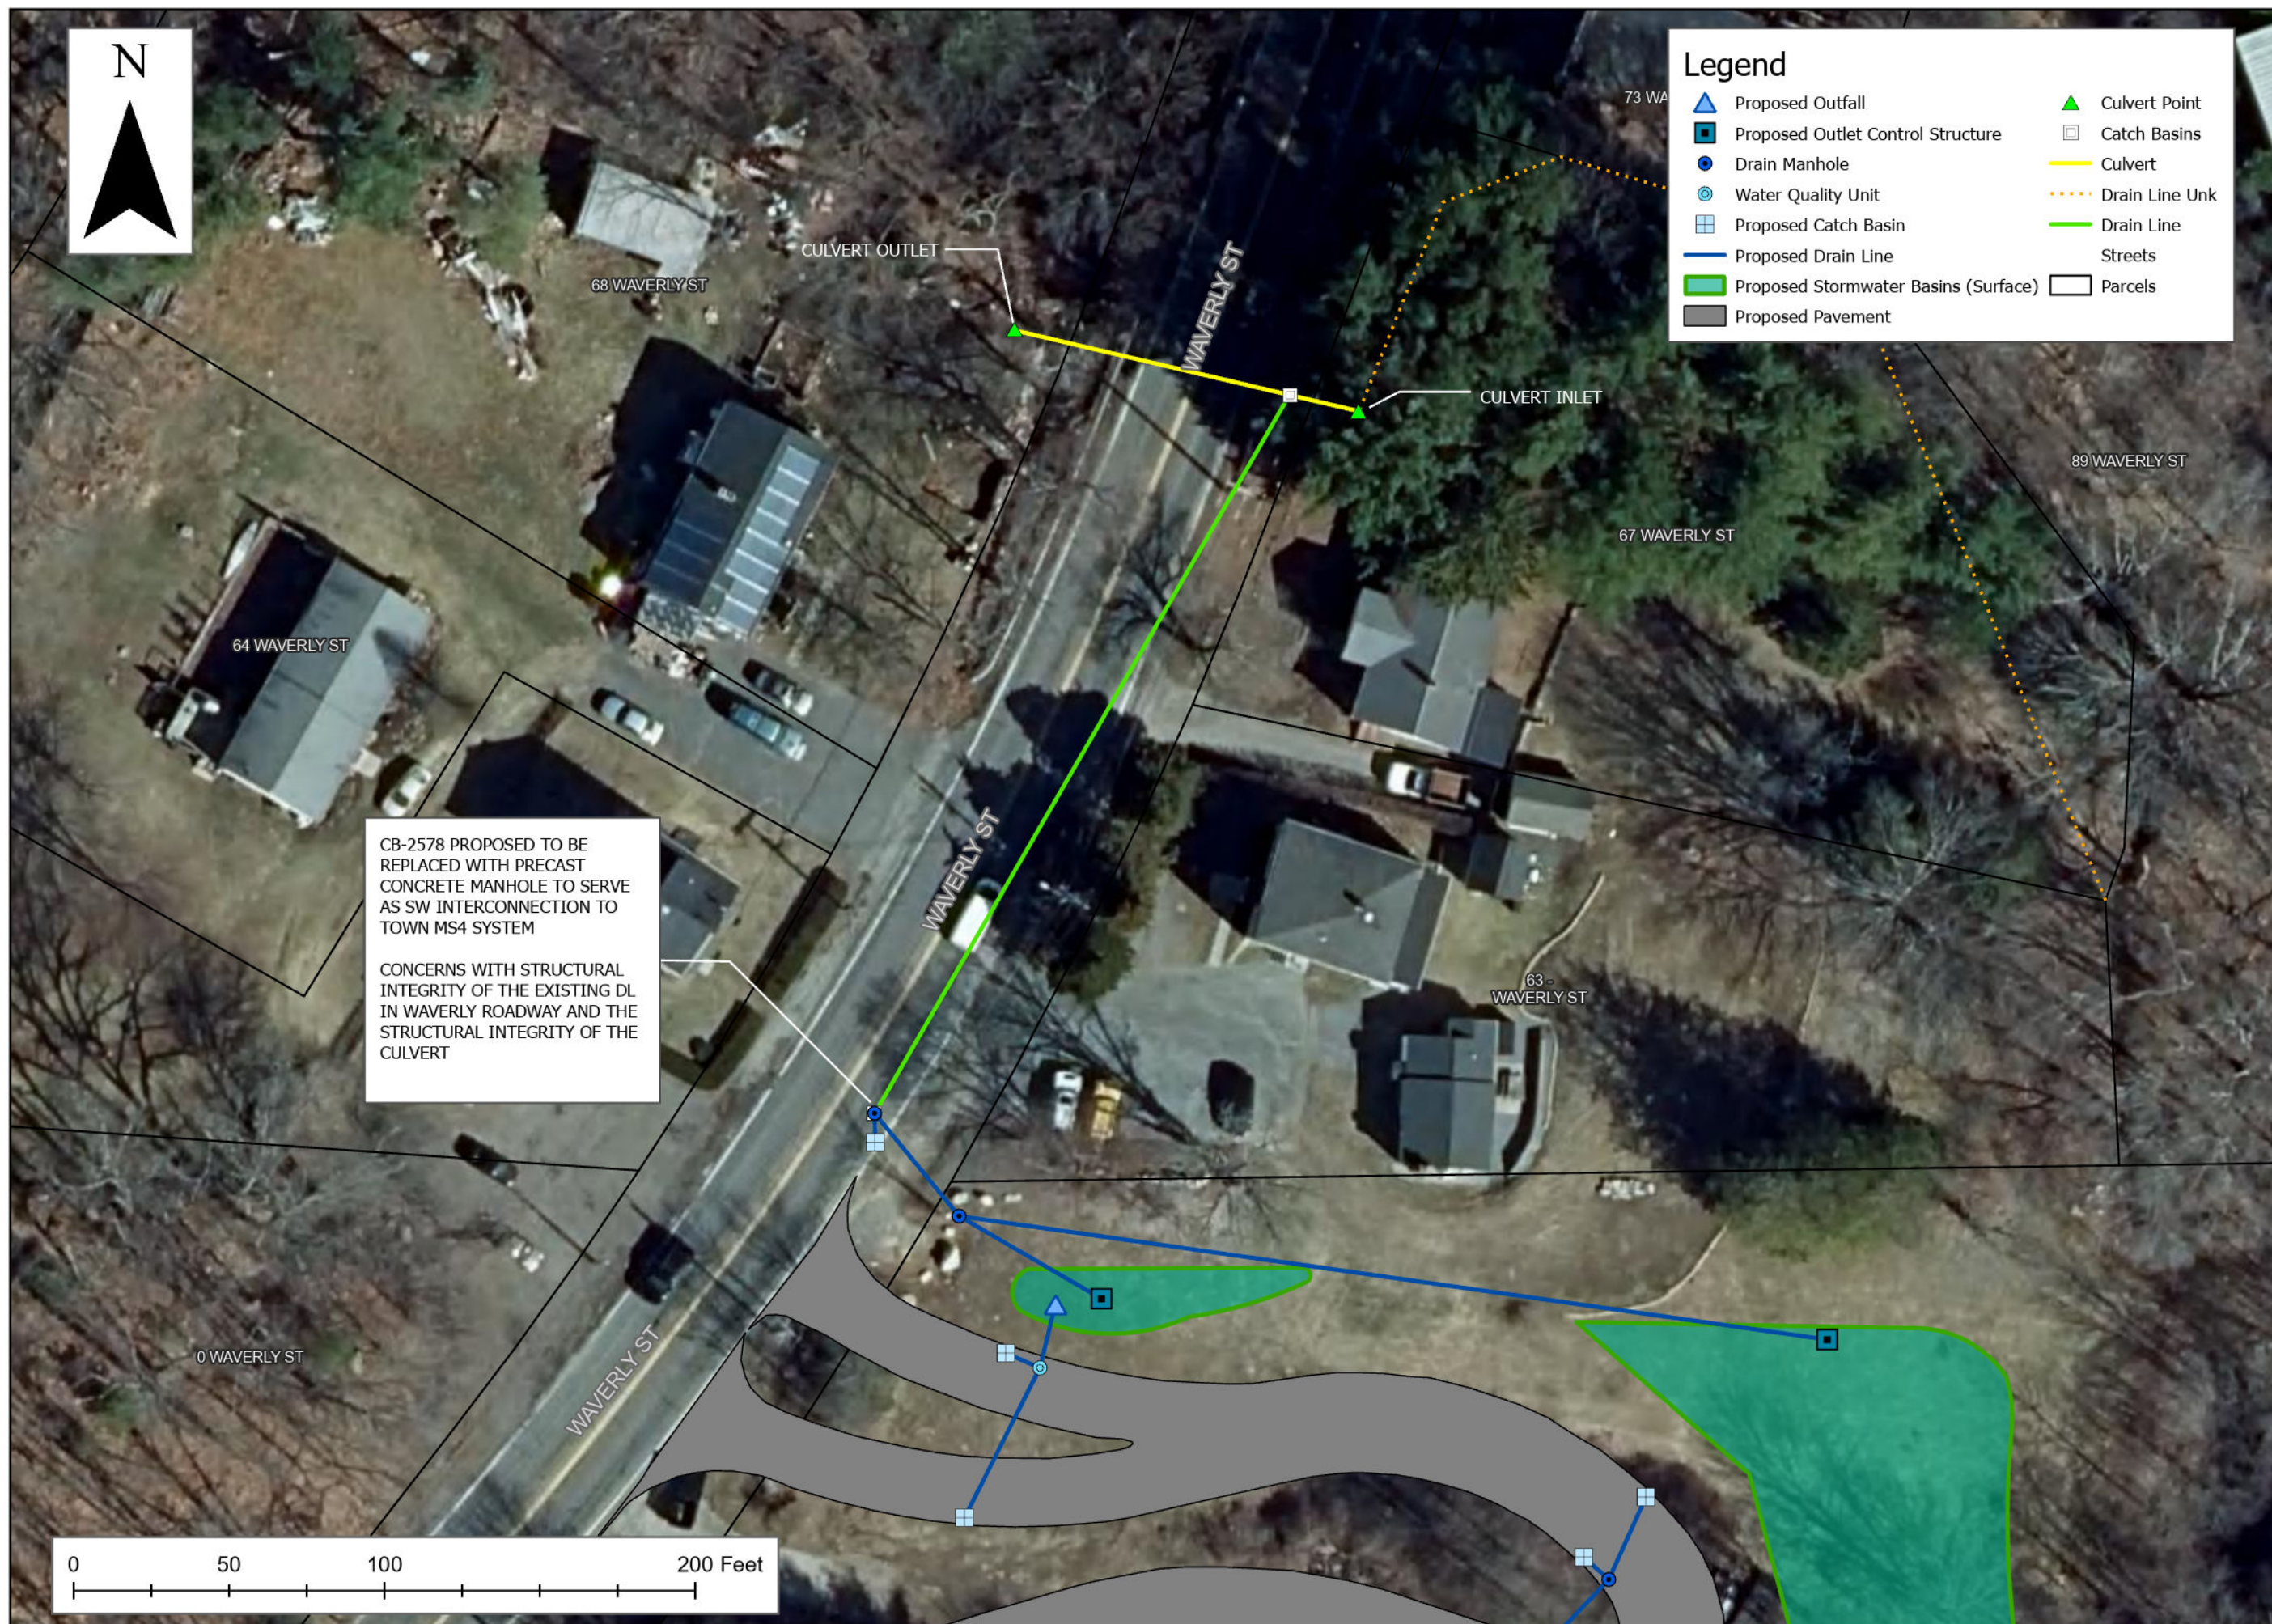
CONCERNS WITH STRUCTURAL INTEGRITY OF THE EXISTING DL IN WAVERLY ROADWAY AND THE STRUCTURAL INTEGRITY OF THE CULVERT

CB-2578 PROPOSED TO BE REPLACED WITH PRECAST CONCRETE MANHOLE TO SERVE AS SW INTERCONNECTION TO TOWN MS4 SYSTEM

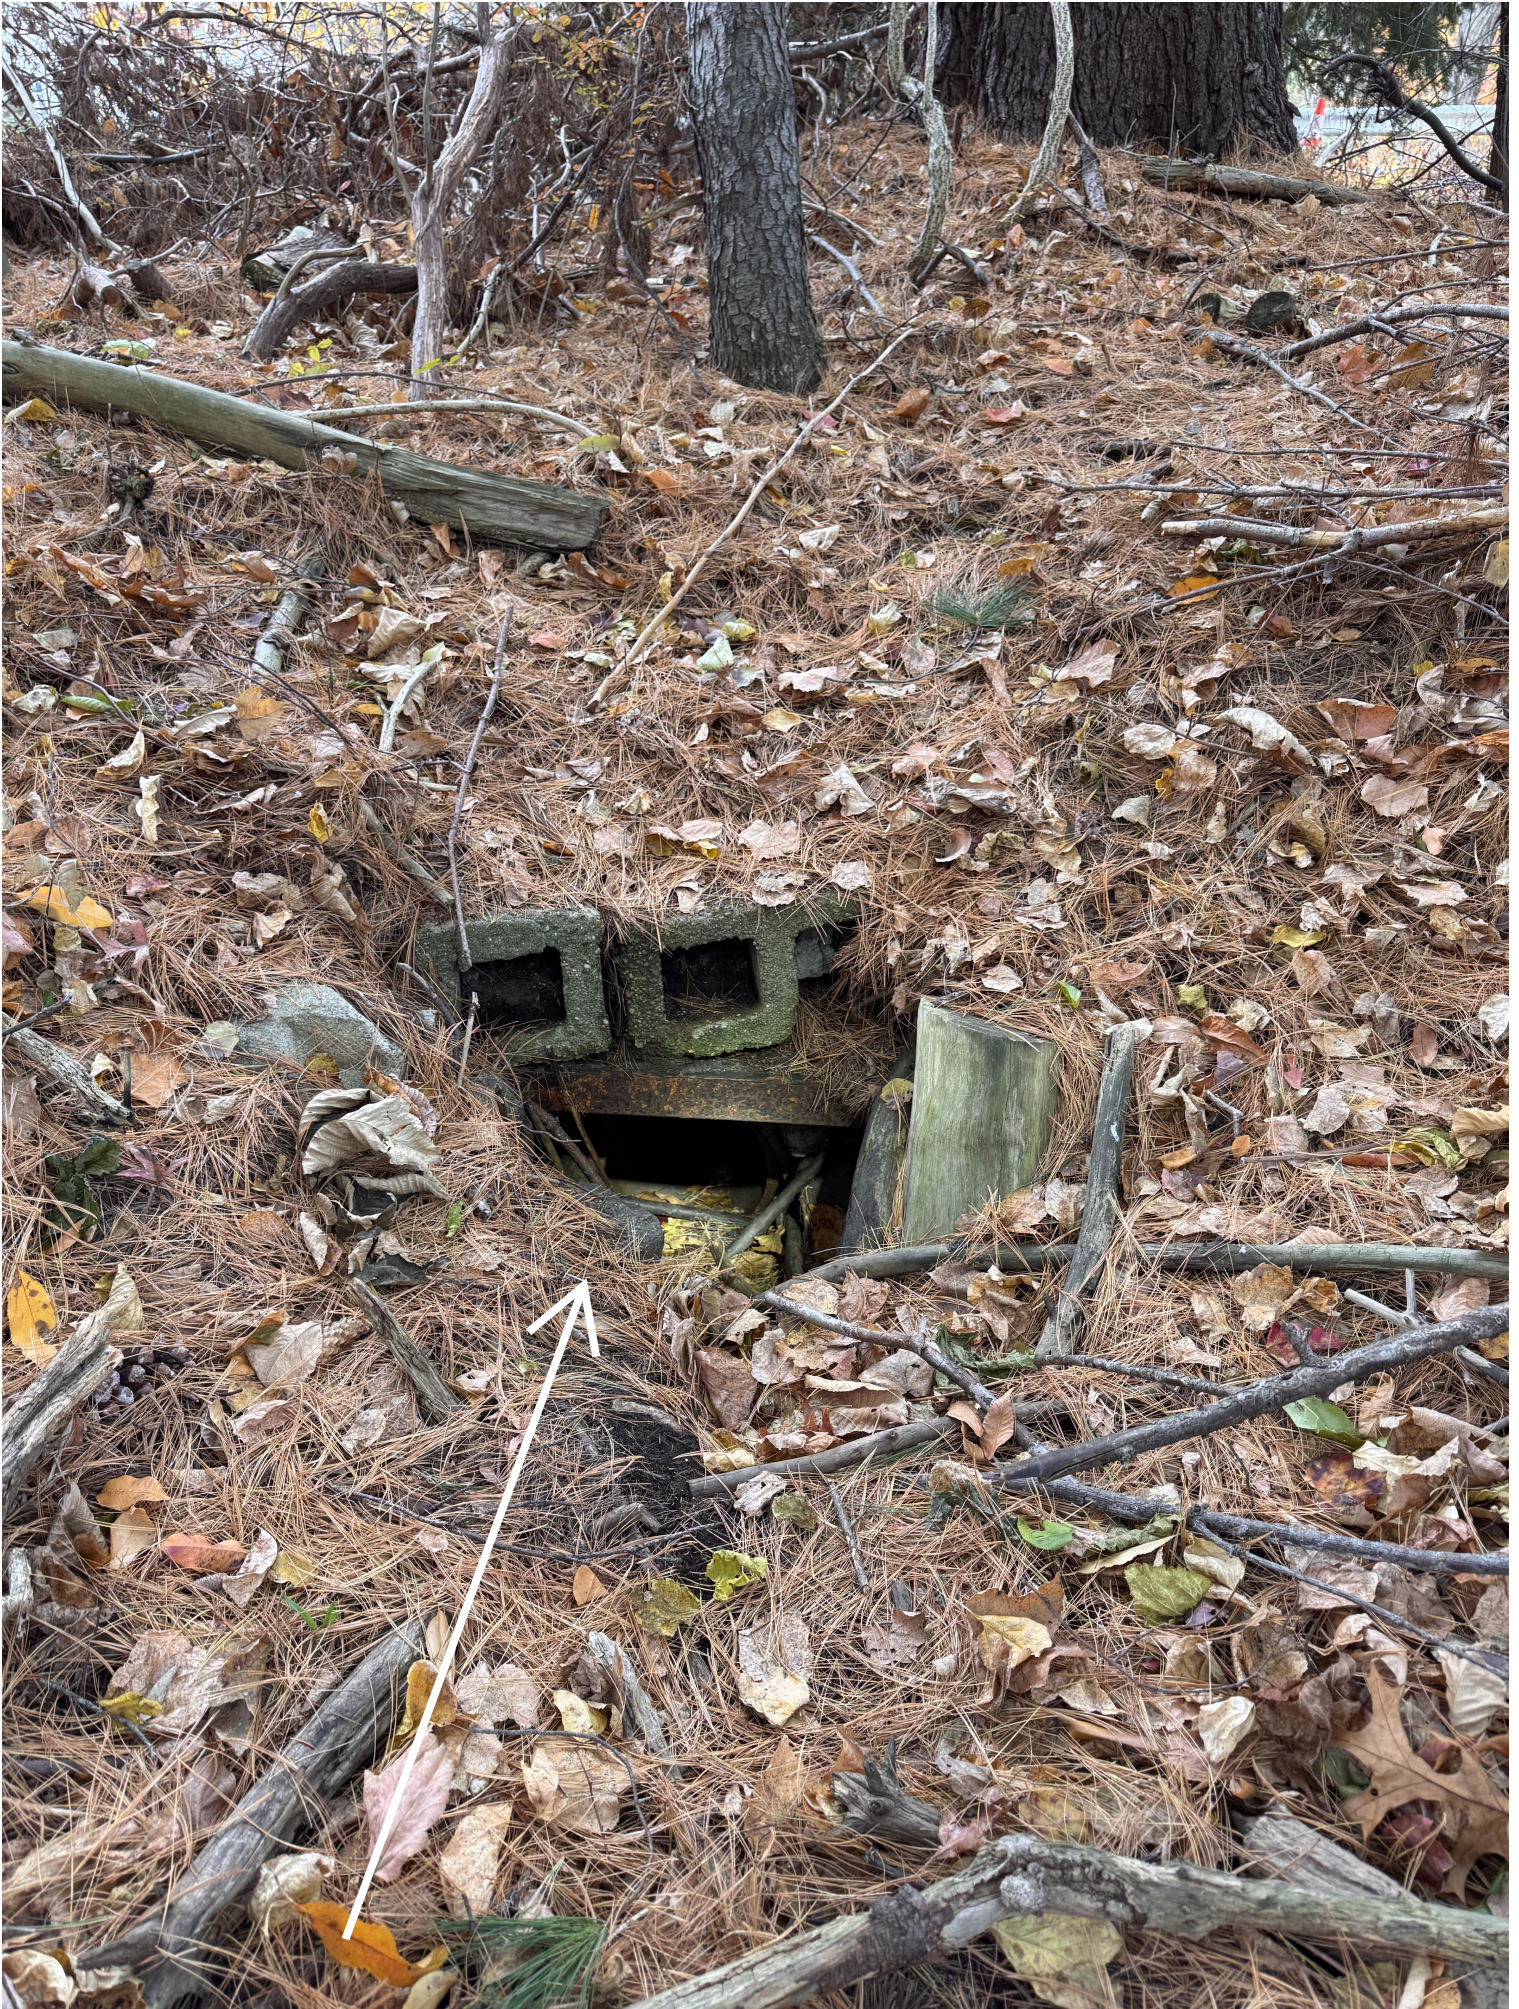
Inlet side of culvert

RCP portion of culvert
daylights at inlet

Signs of stress on RCP; segments have
started to break away from one another,
warping the RCP channel

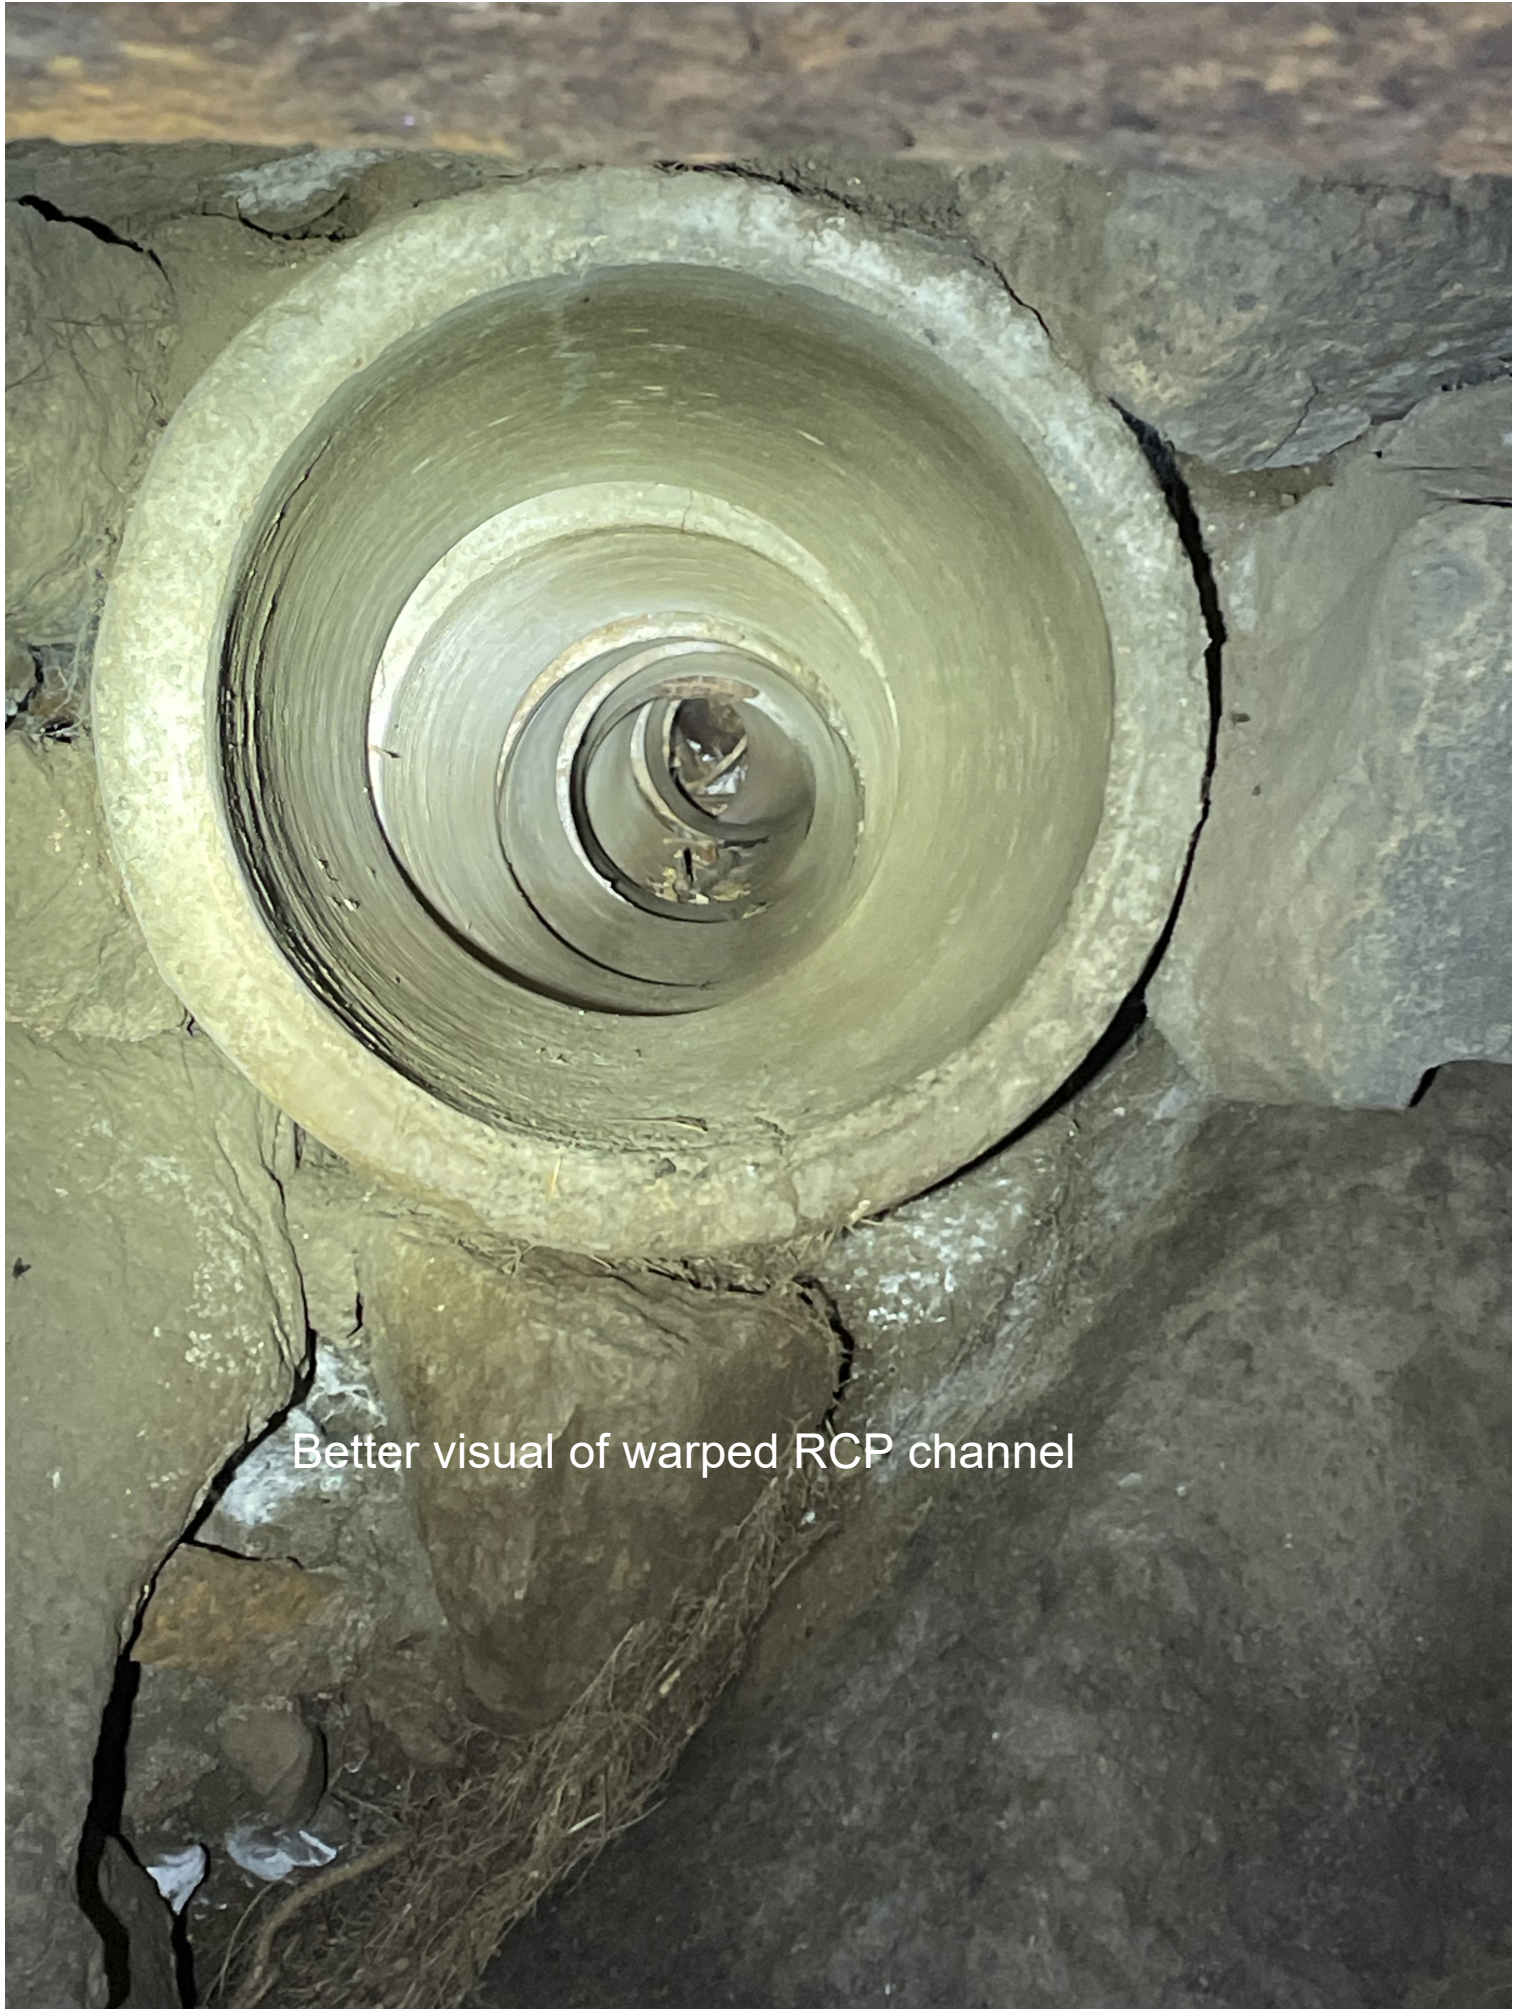
Better visual of warped RCP channel

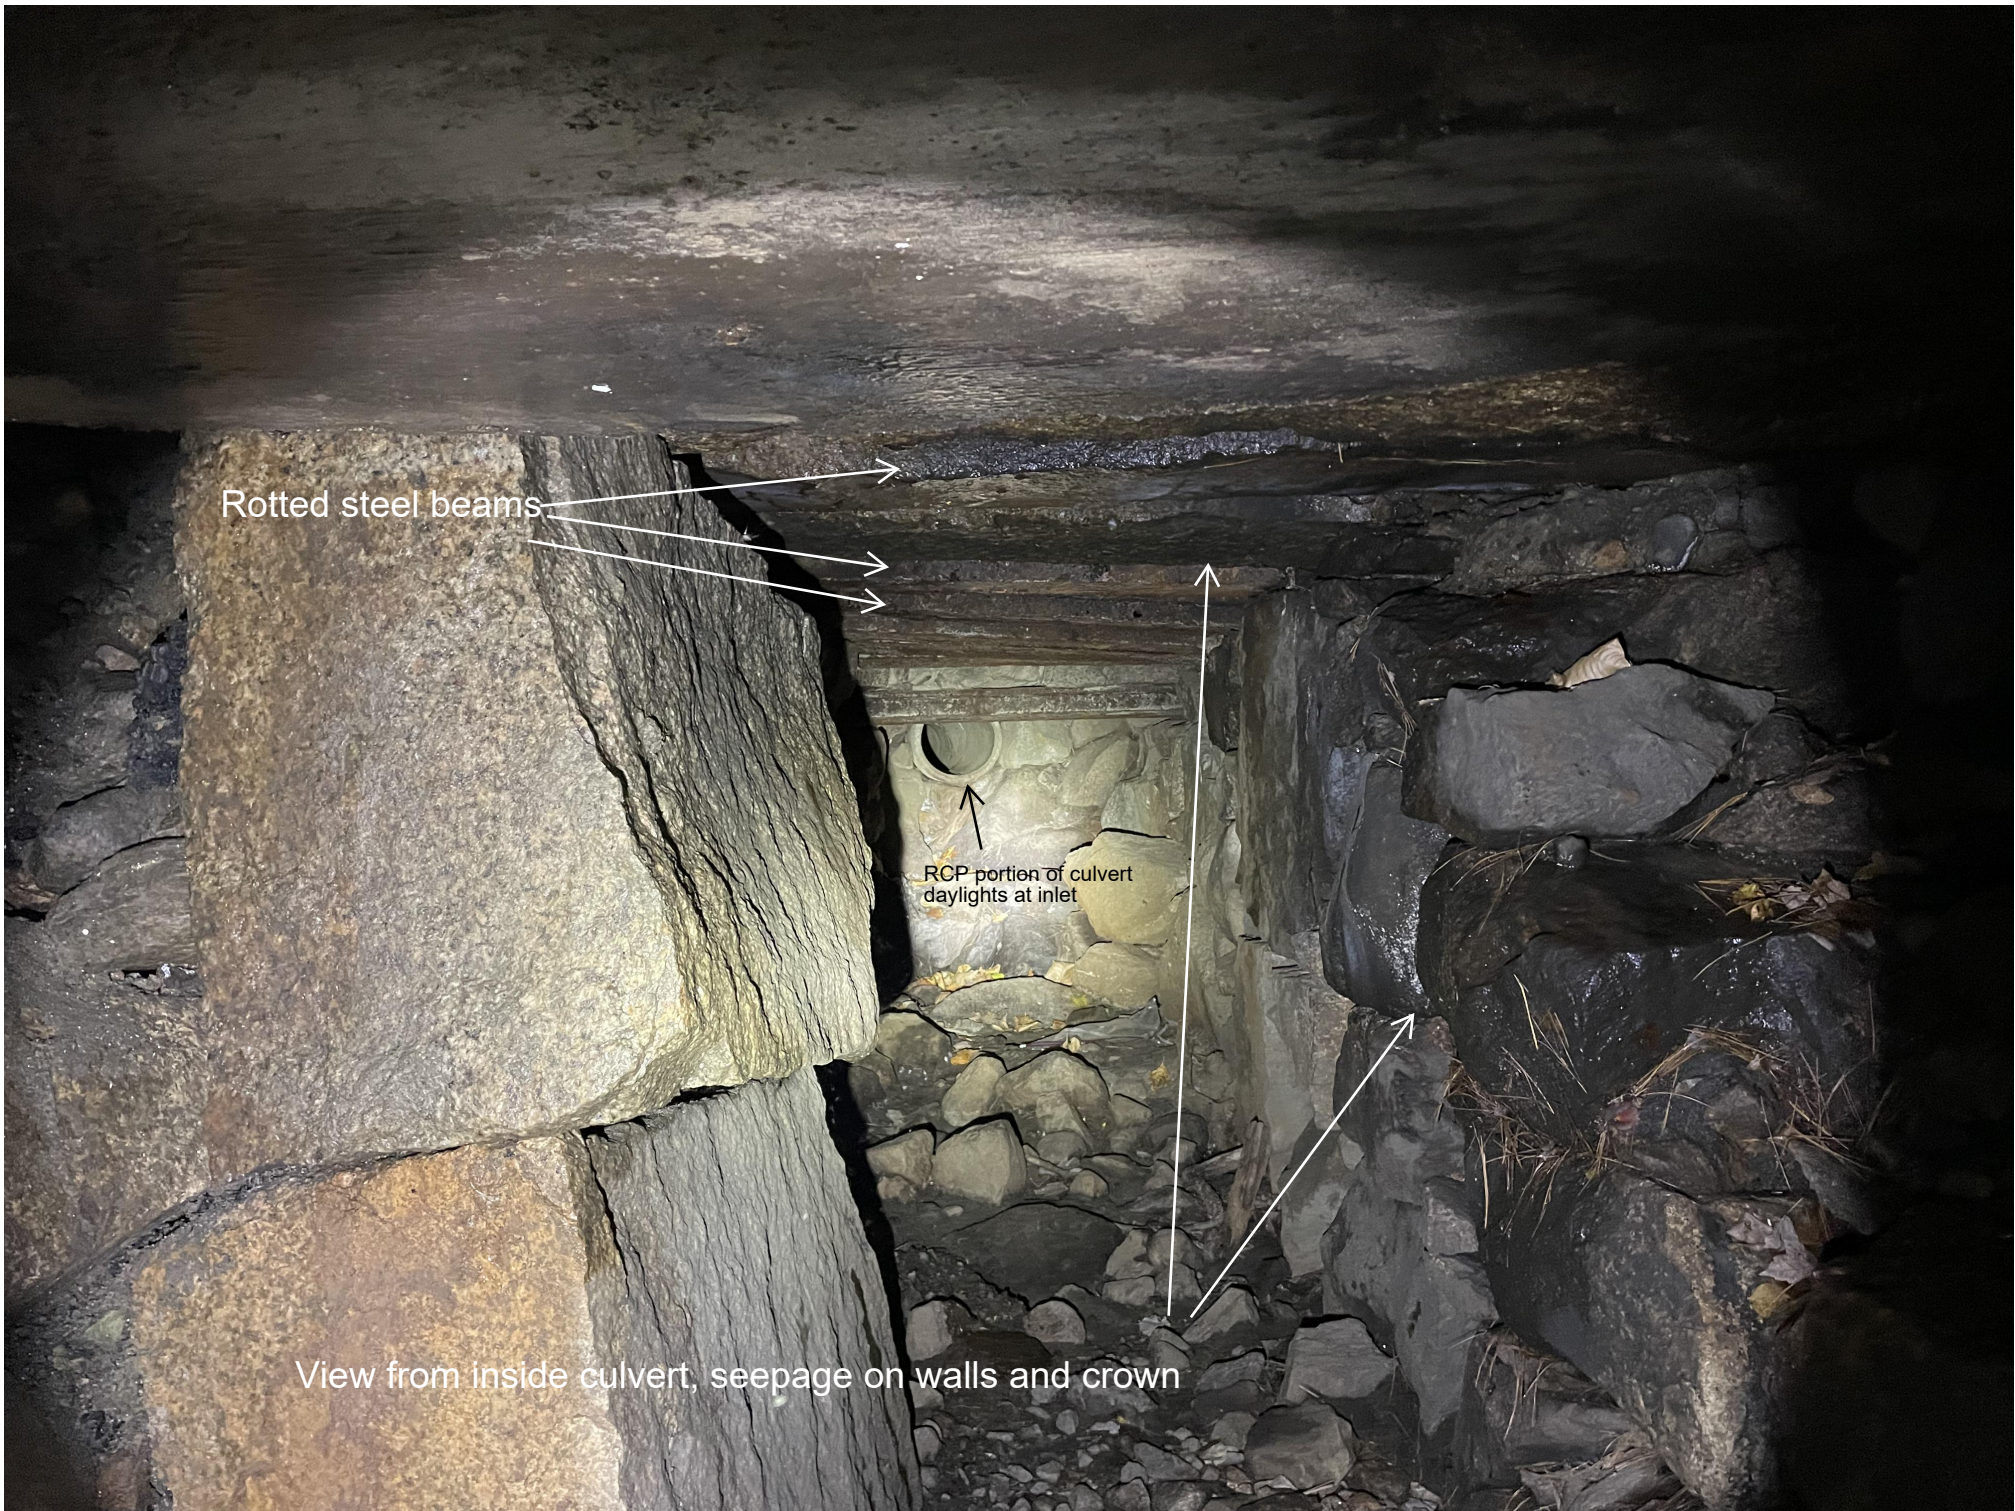
Rotted steel beams

RCP portion of culvert daylight at inlet

View from inside culvert, seepage on walls and crown

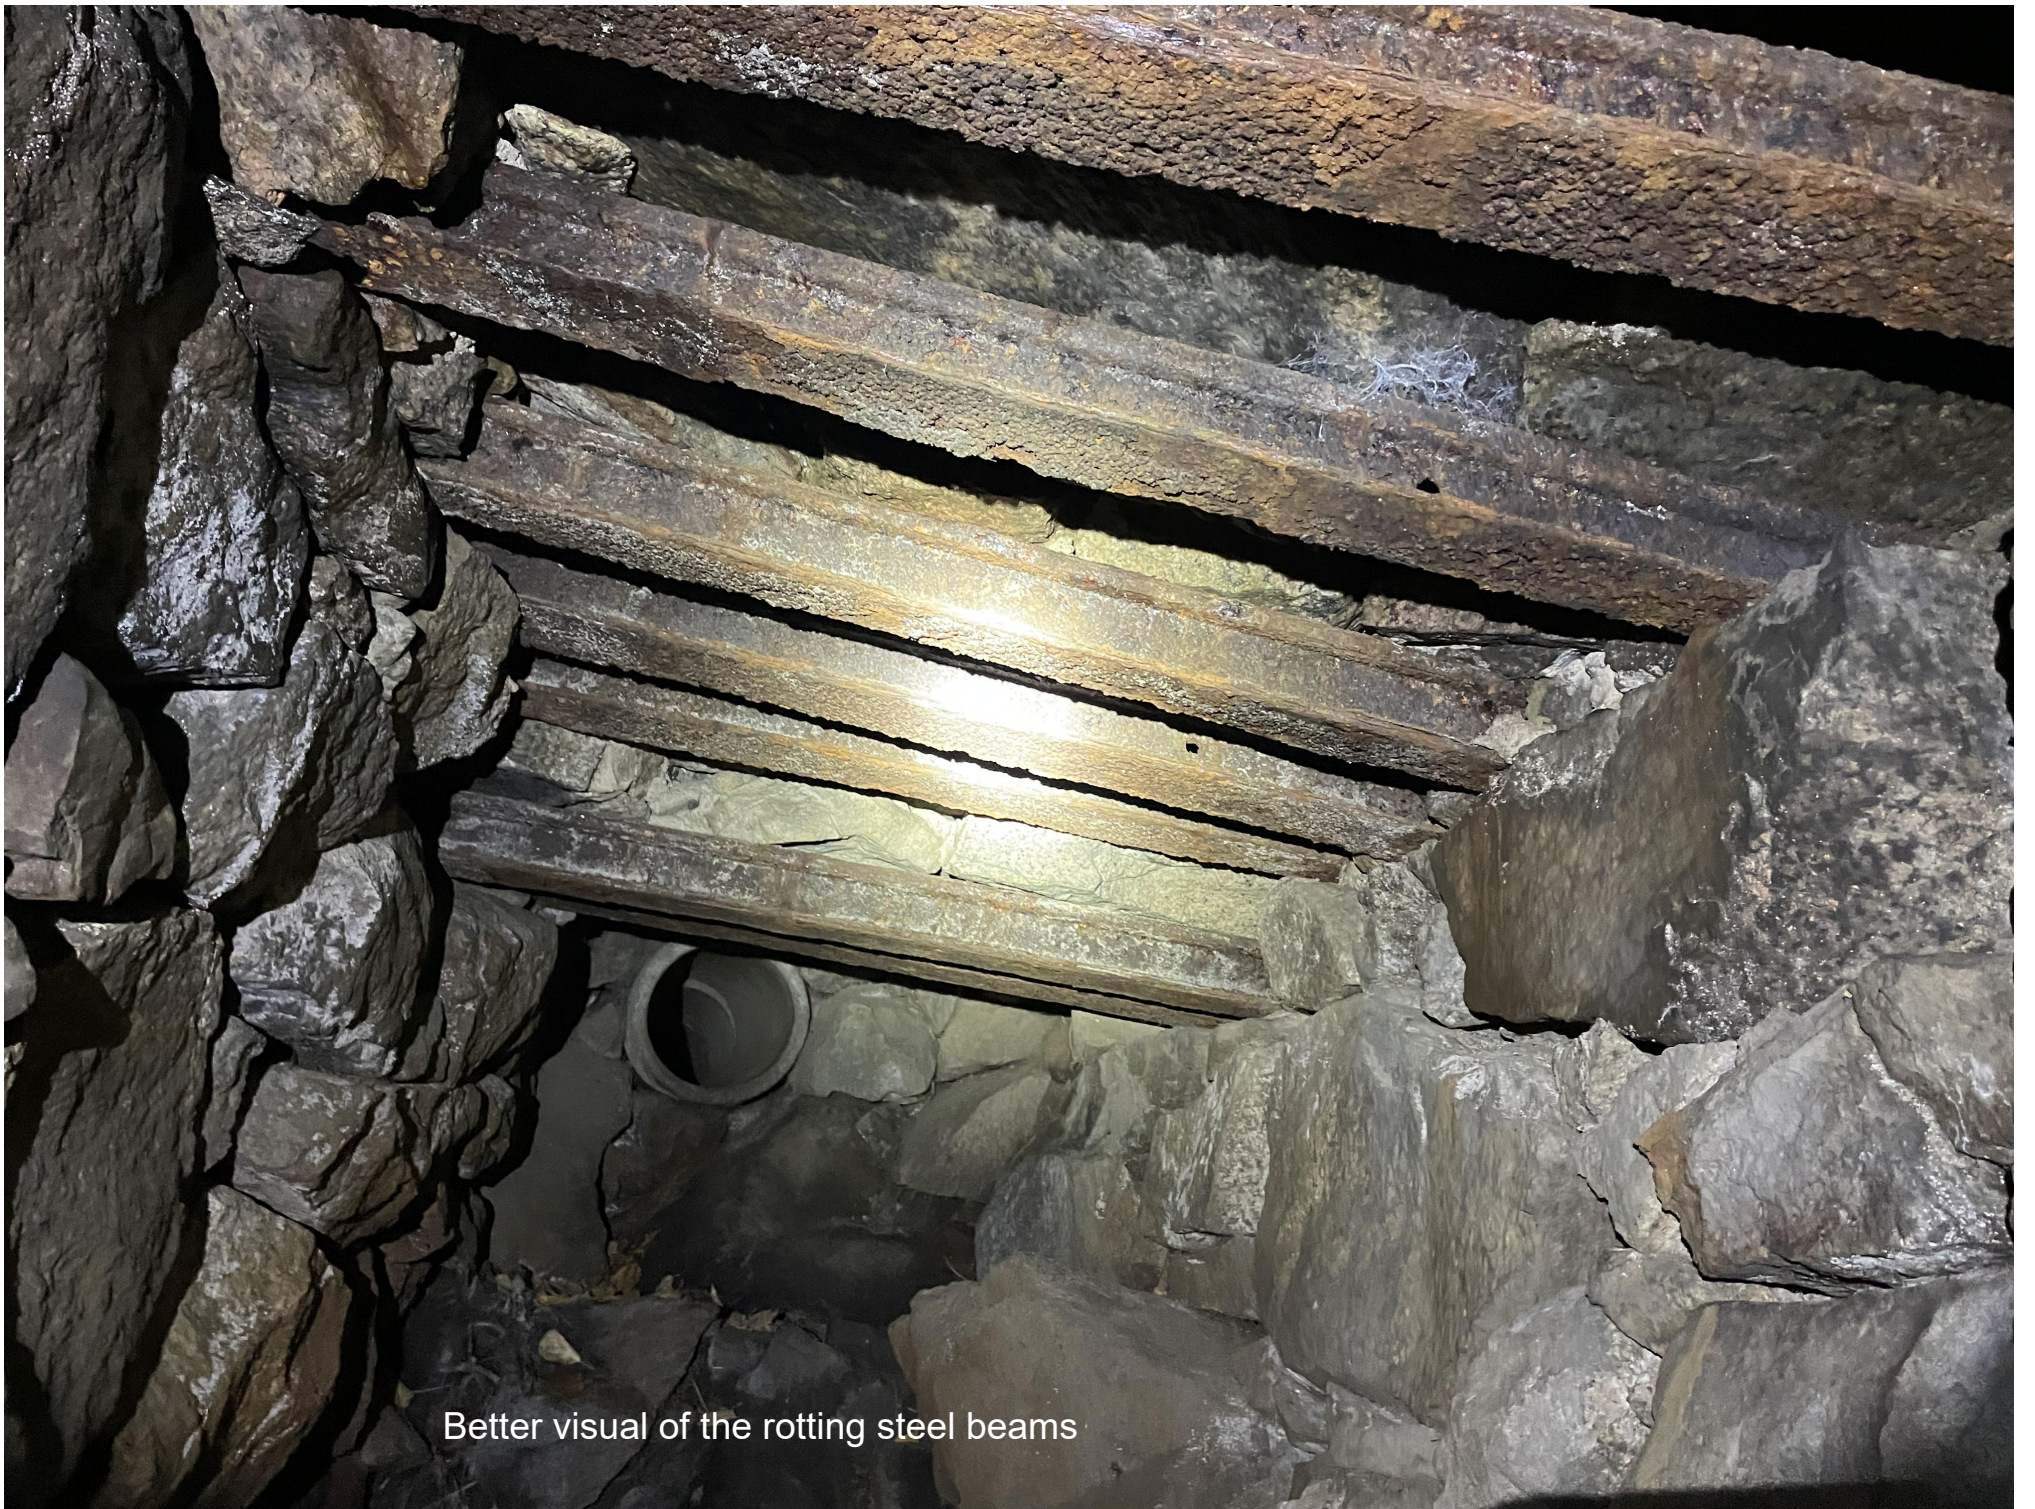
Better visual of the rotting steel beams

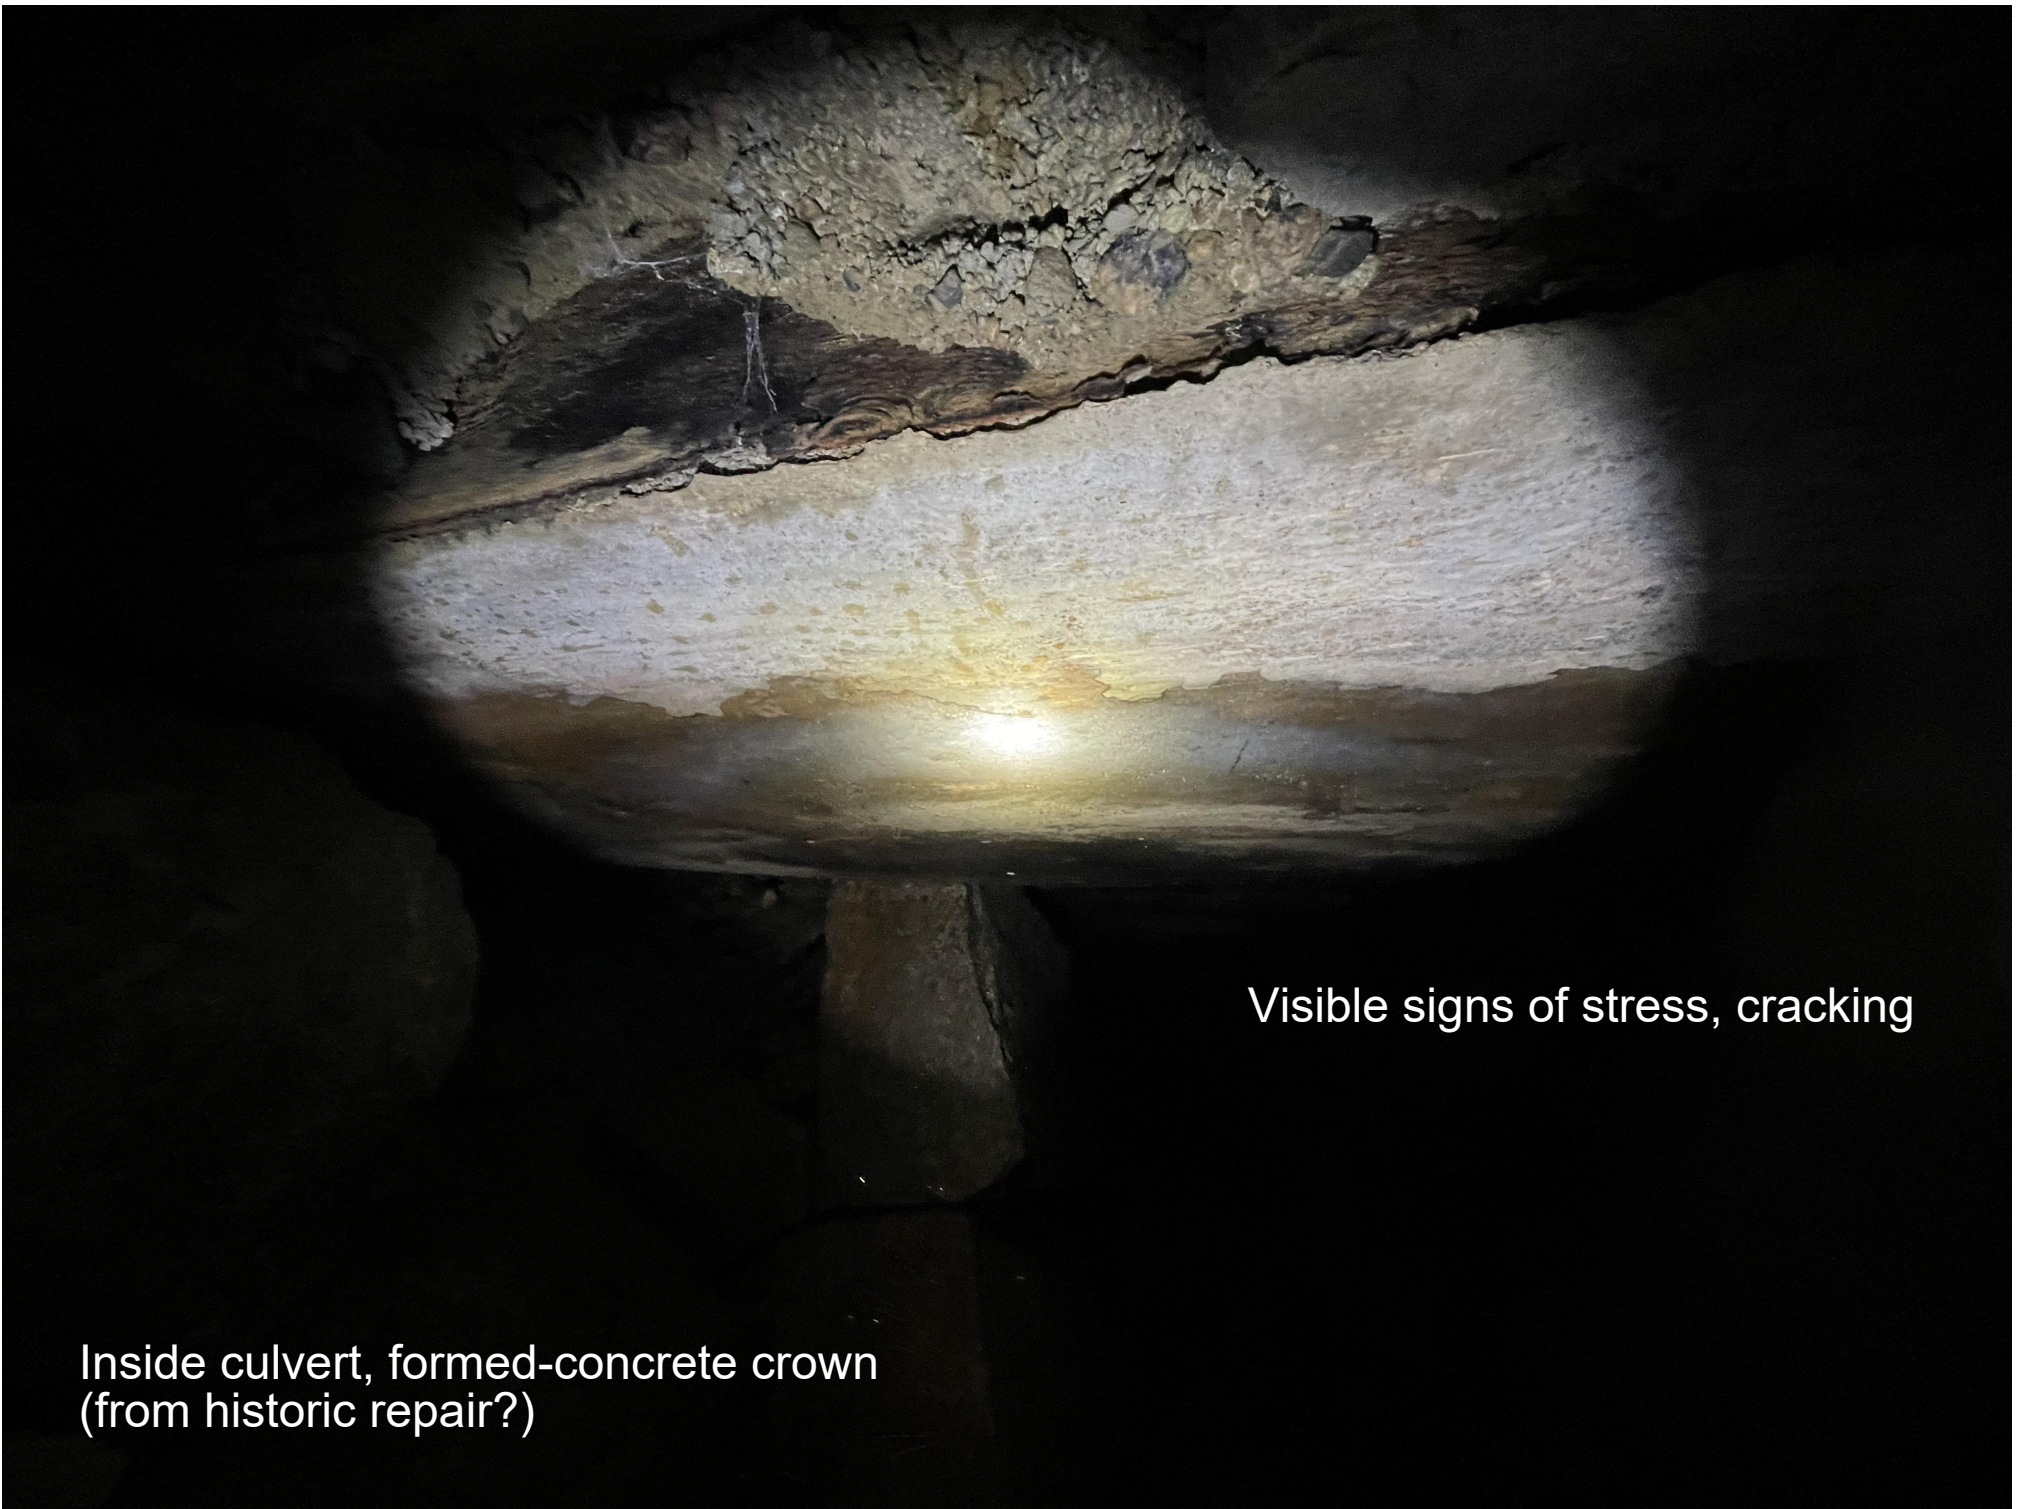
Visible signs of stress, cracking

Inside culvert, formed-concrete crown
(from historic repair?)
