**STORMWATER EXISTING CONDITIONS
61 TO 68 WAVERLY STREET
TOWN OF ASHLAND**

**STORMWATER PROPOSED CONDITIONS
61 TO 68 WAVERLY STREET
TOWN OF ASHLAND**

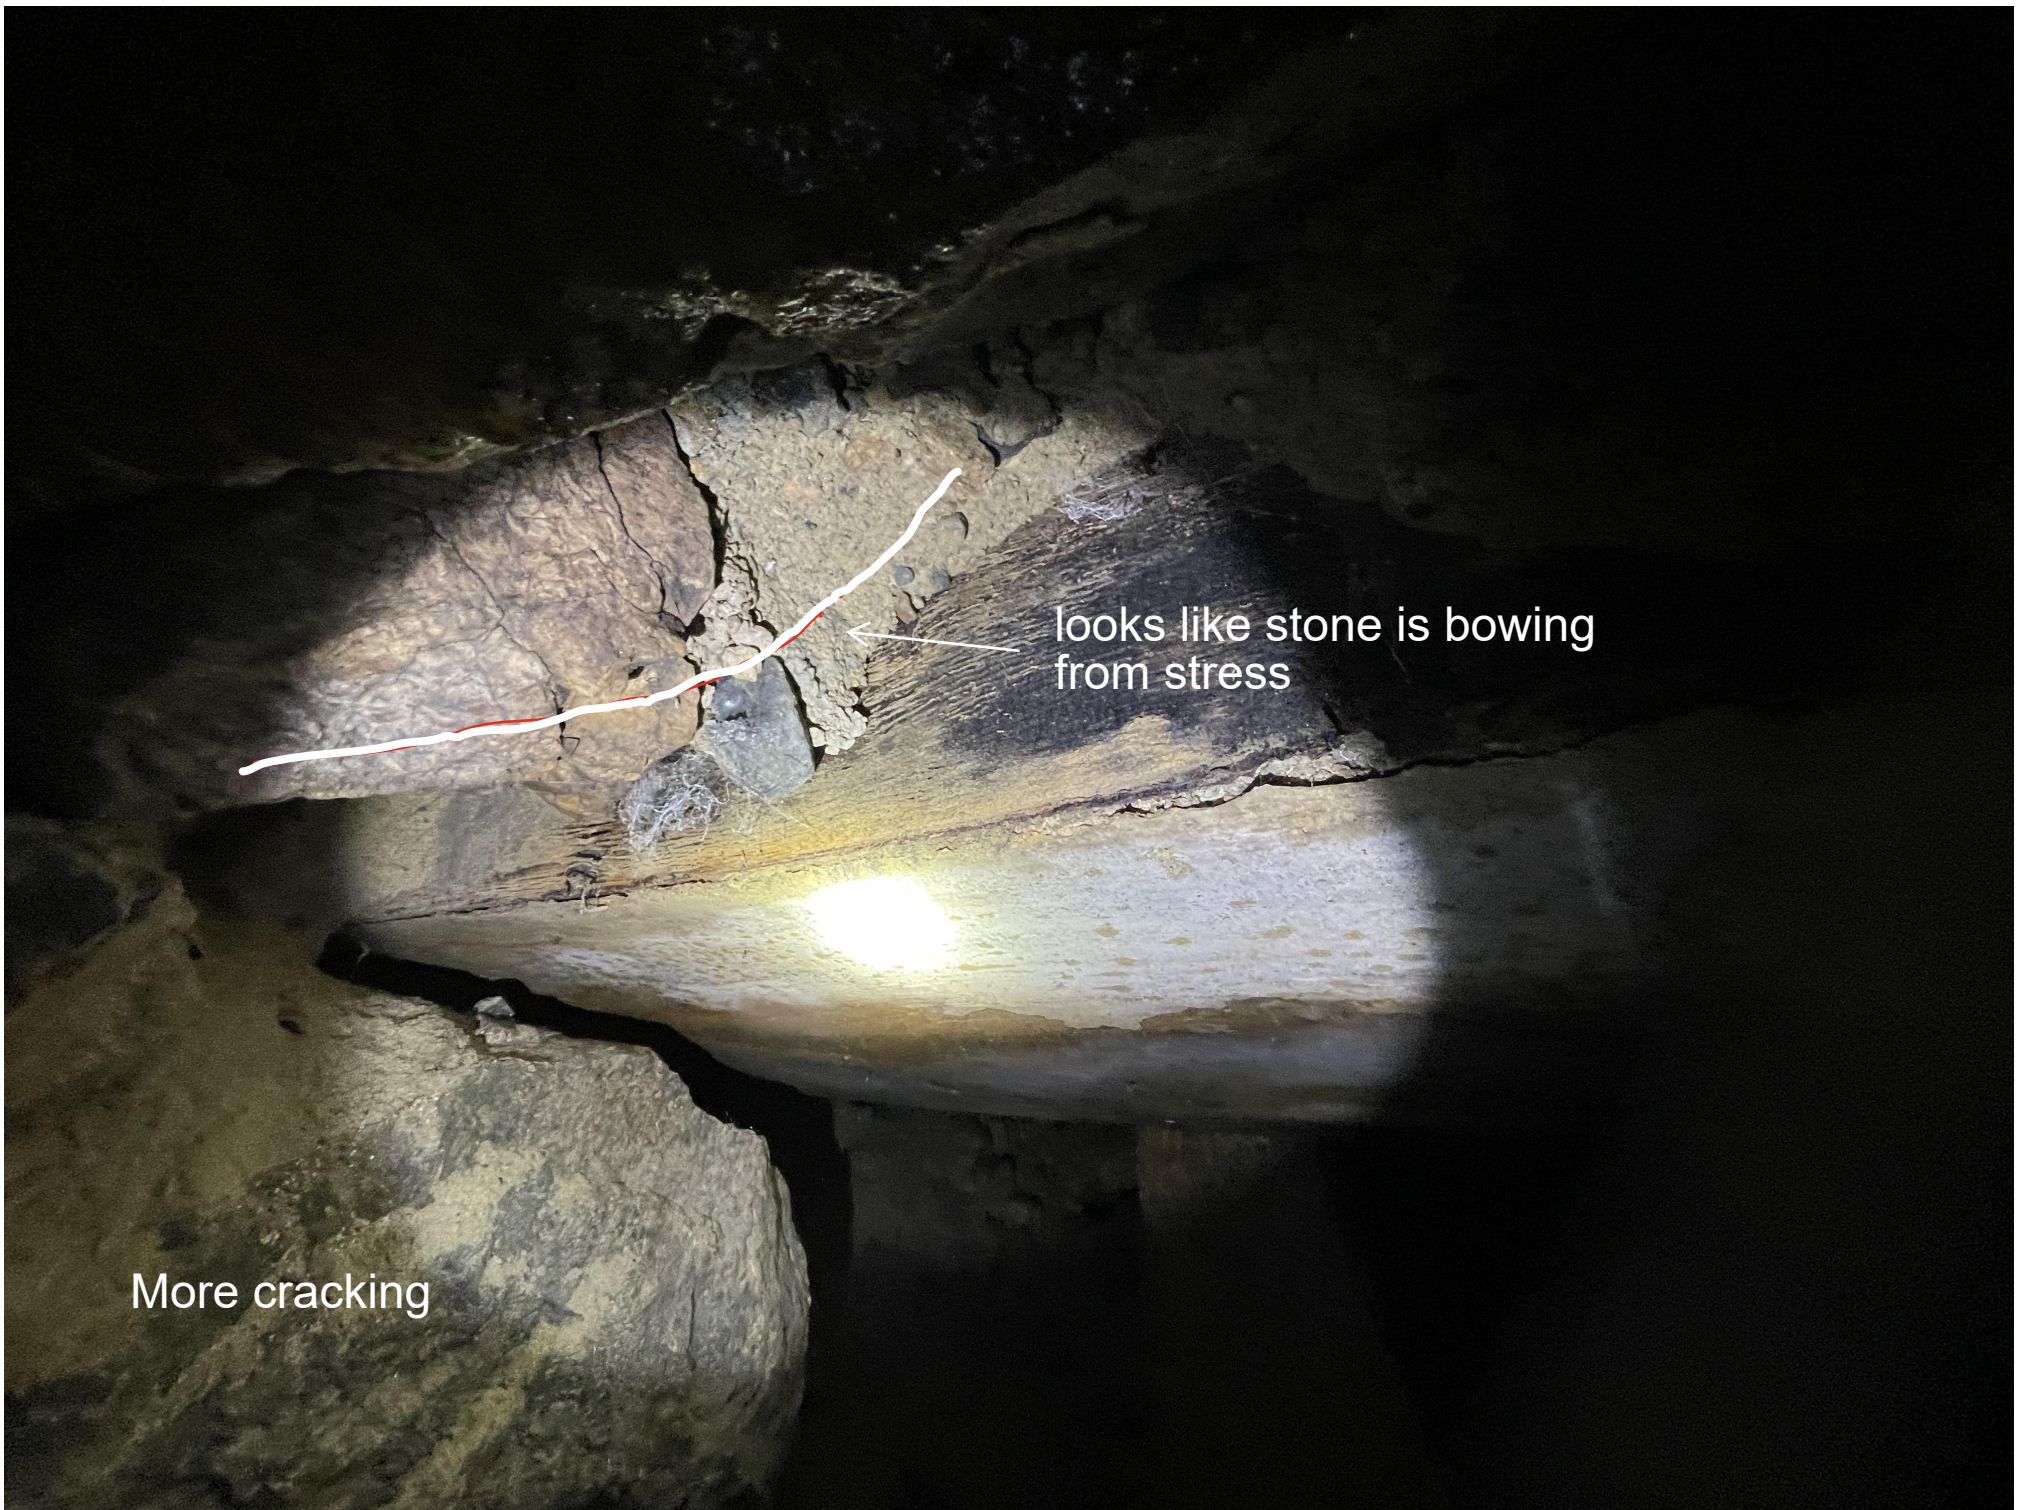
looks like stone is bowing from stress

More cracking

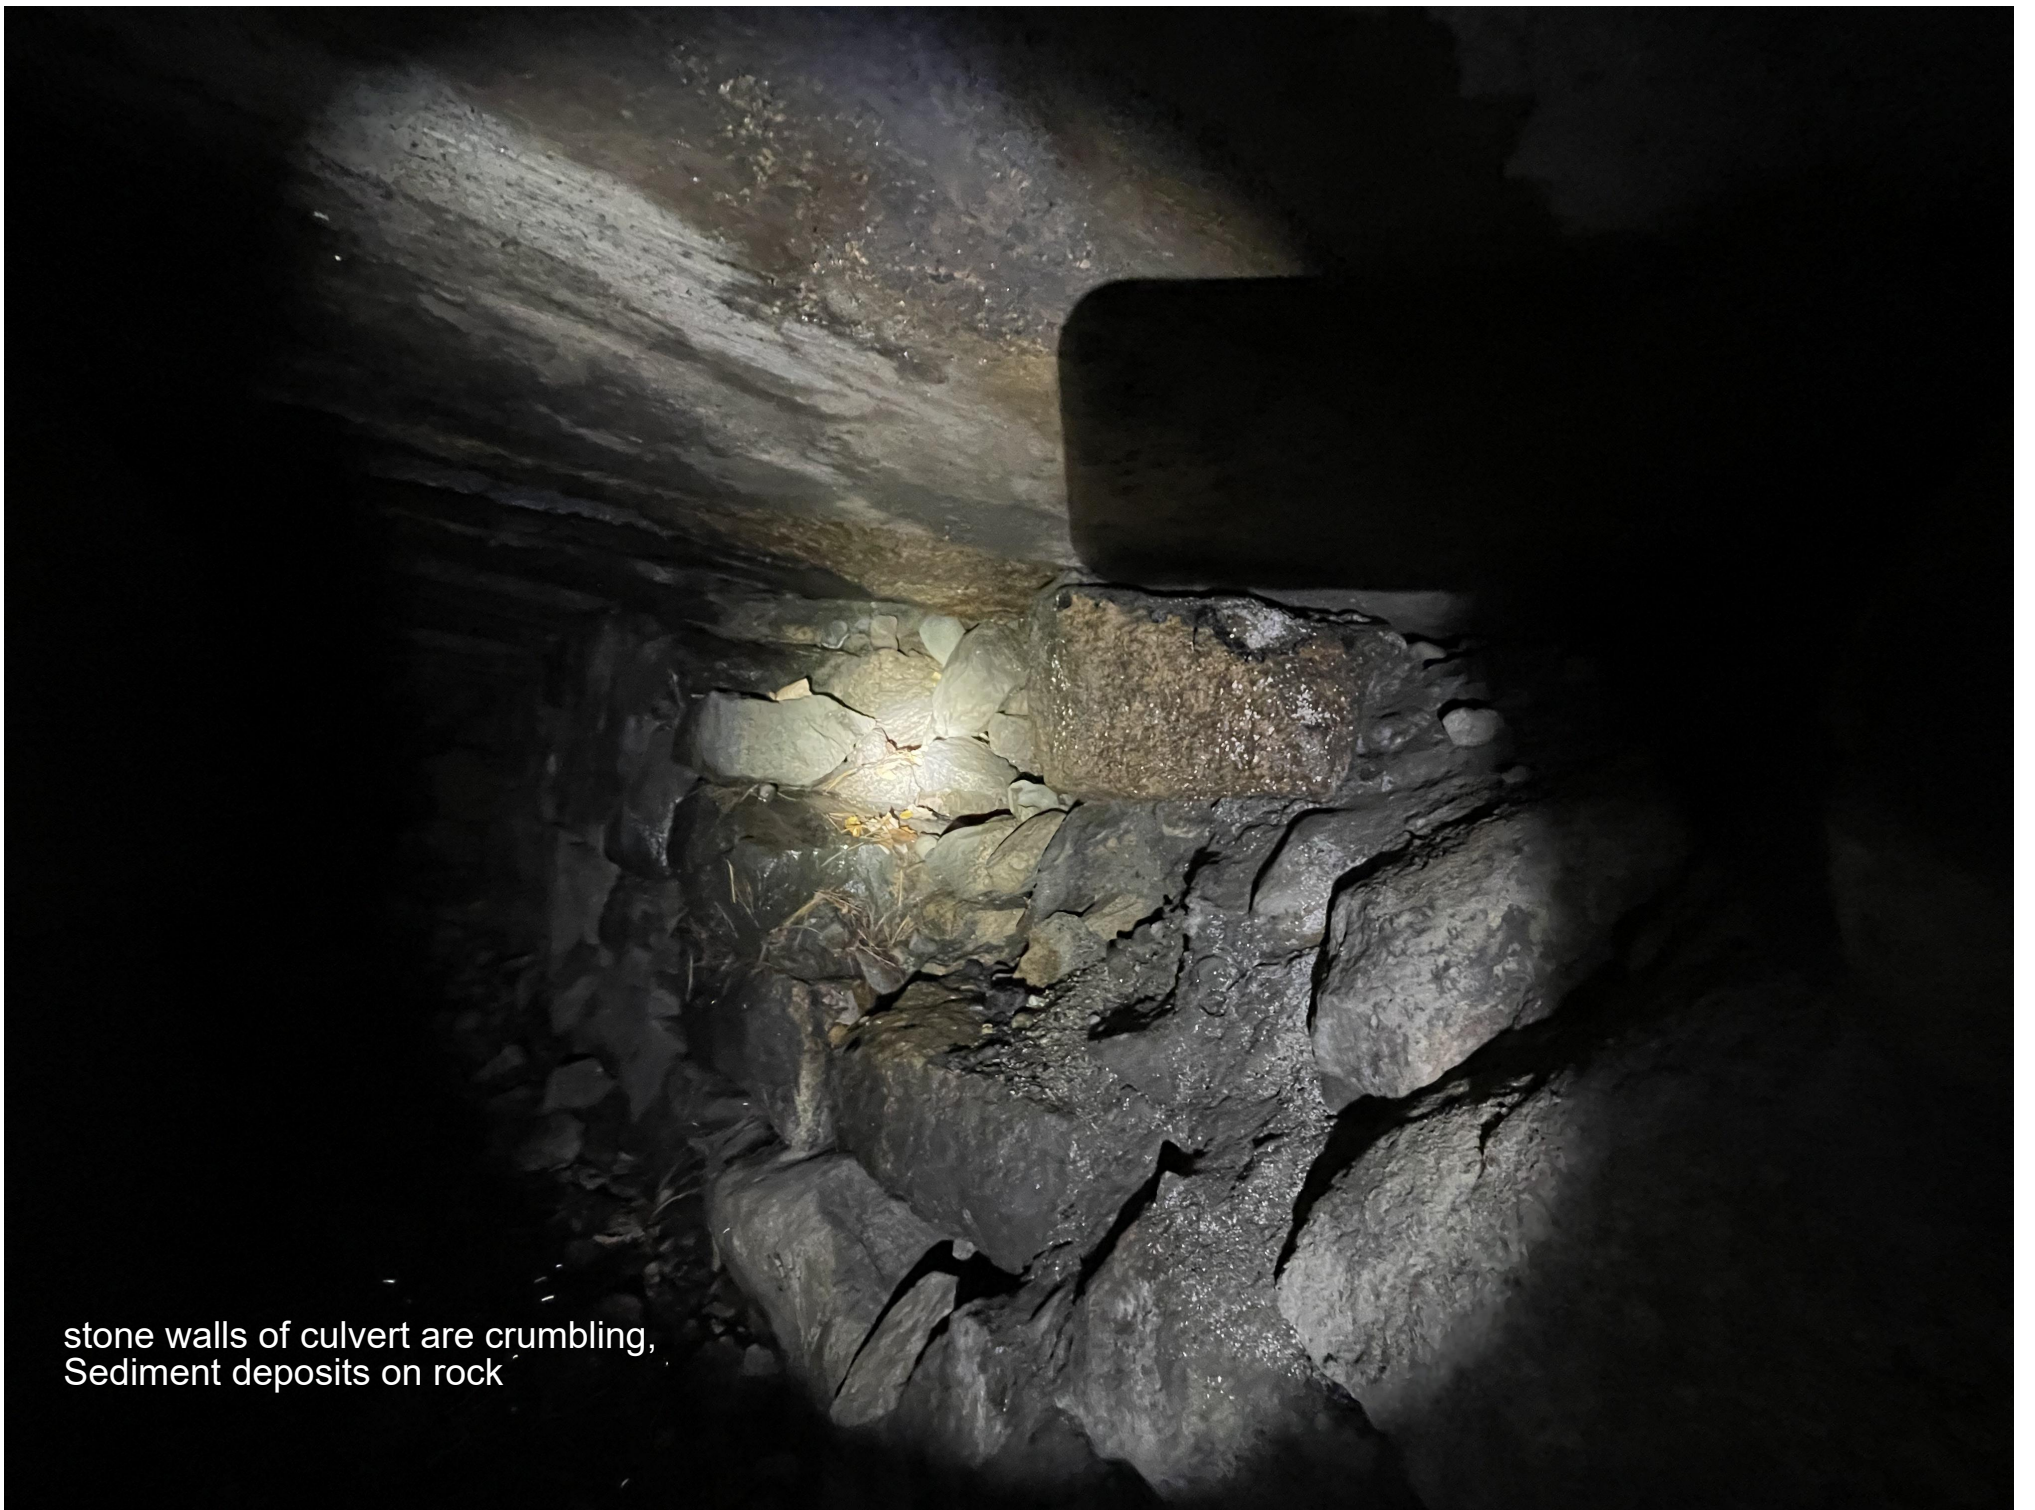
stone walls of culvert are crumbling,
Sediment deposits on rock

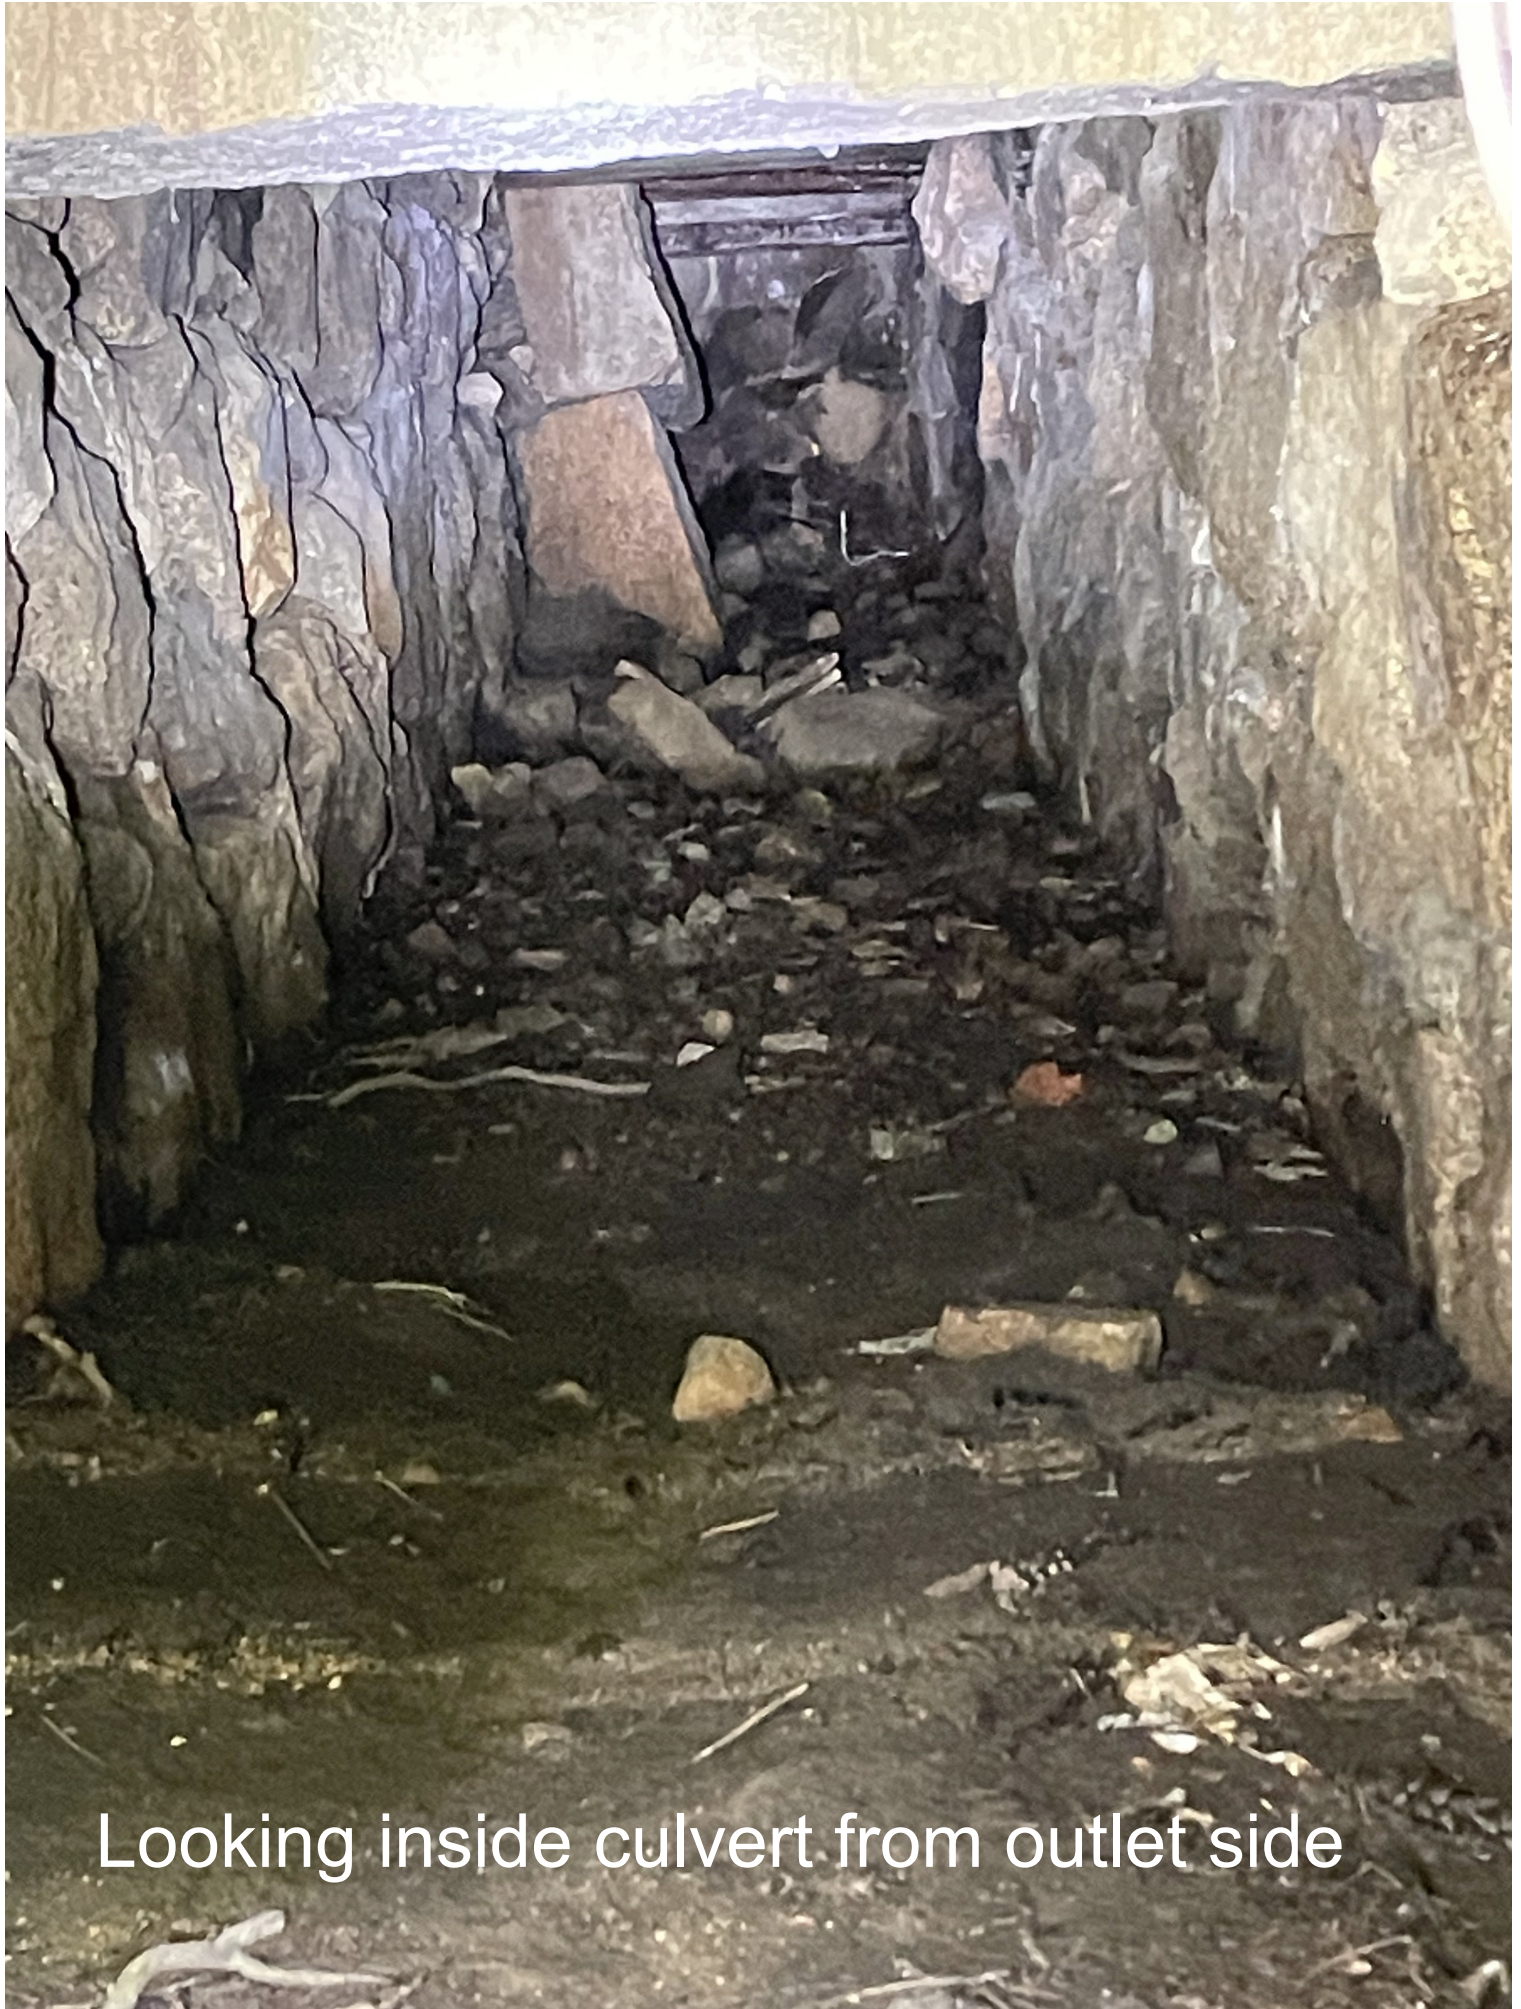
Looking inside culvert from outlet side

DL_3726 outlet from inside the culvert

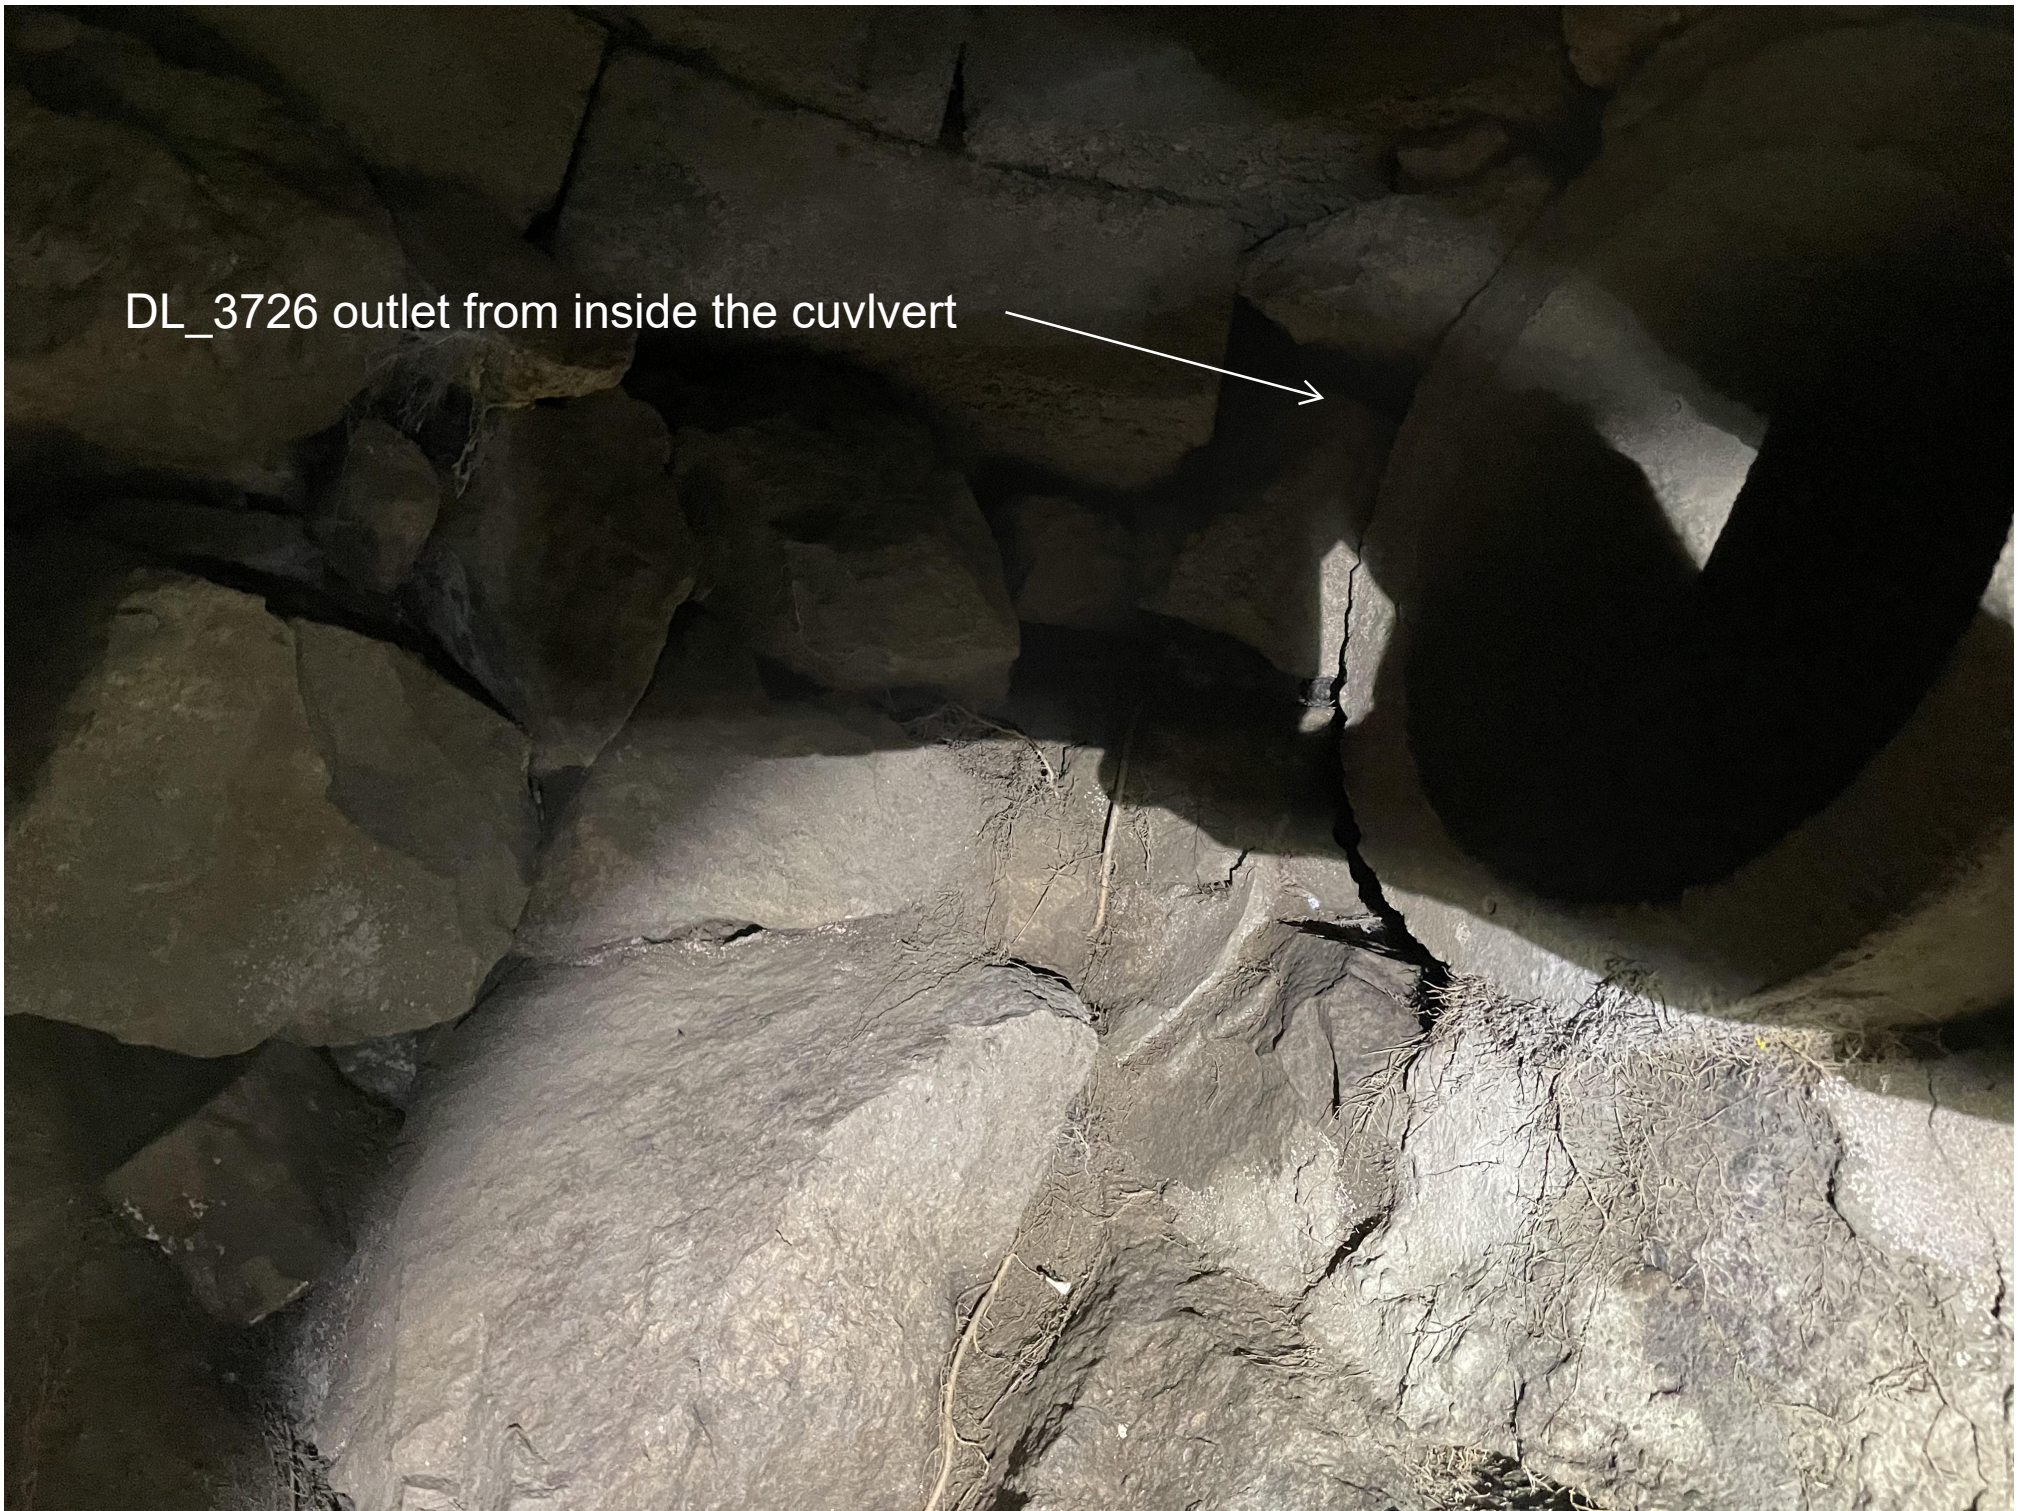
CB_2578

INV(out): 12" RCP
Only about 6-12" below
the CB rim

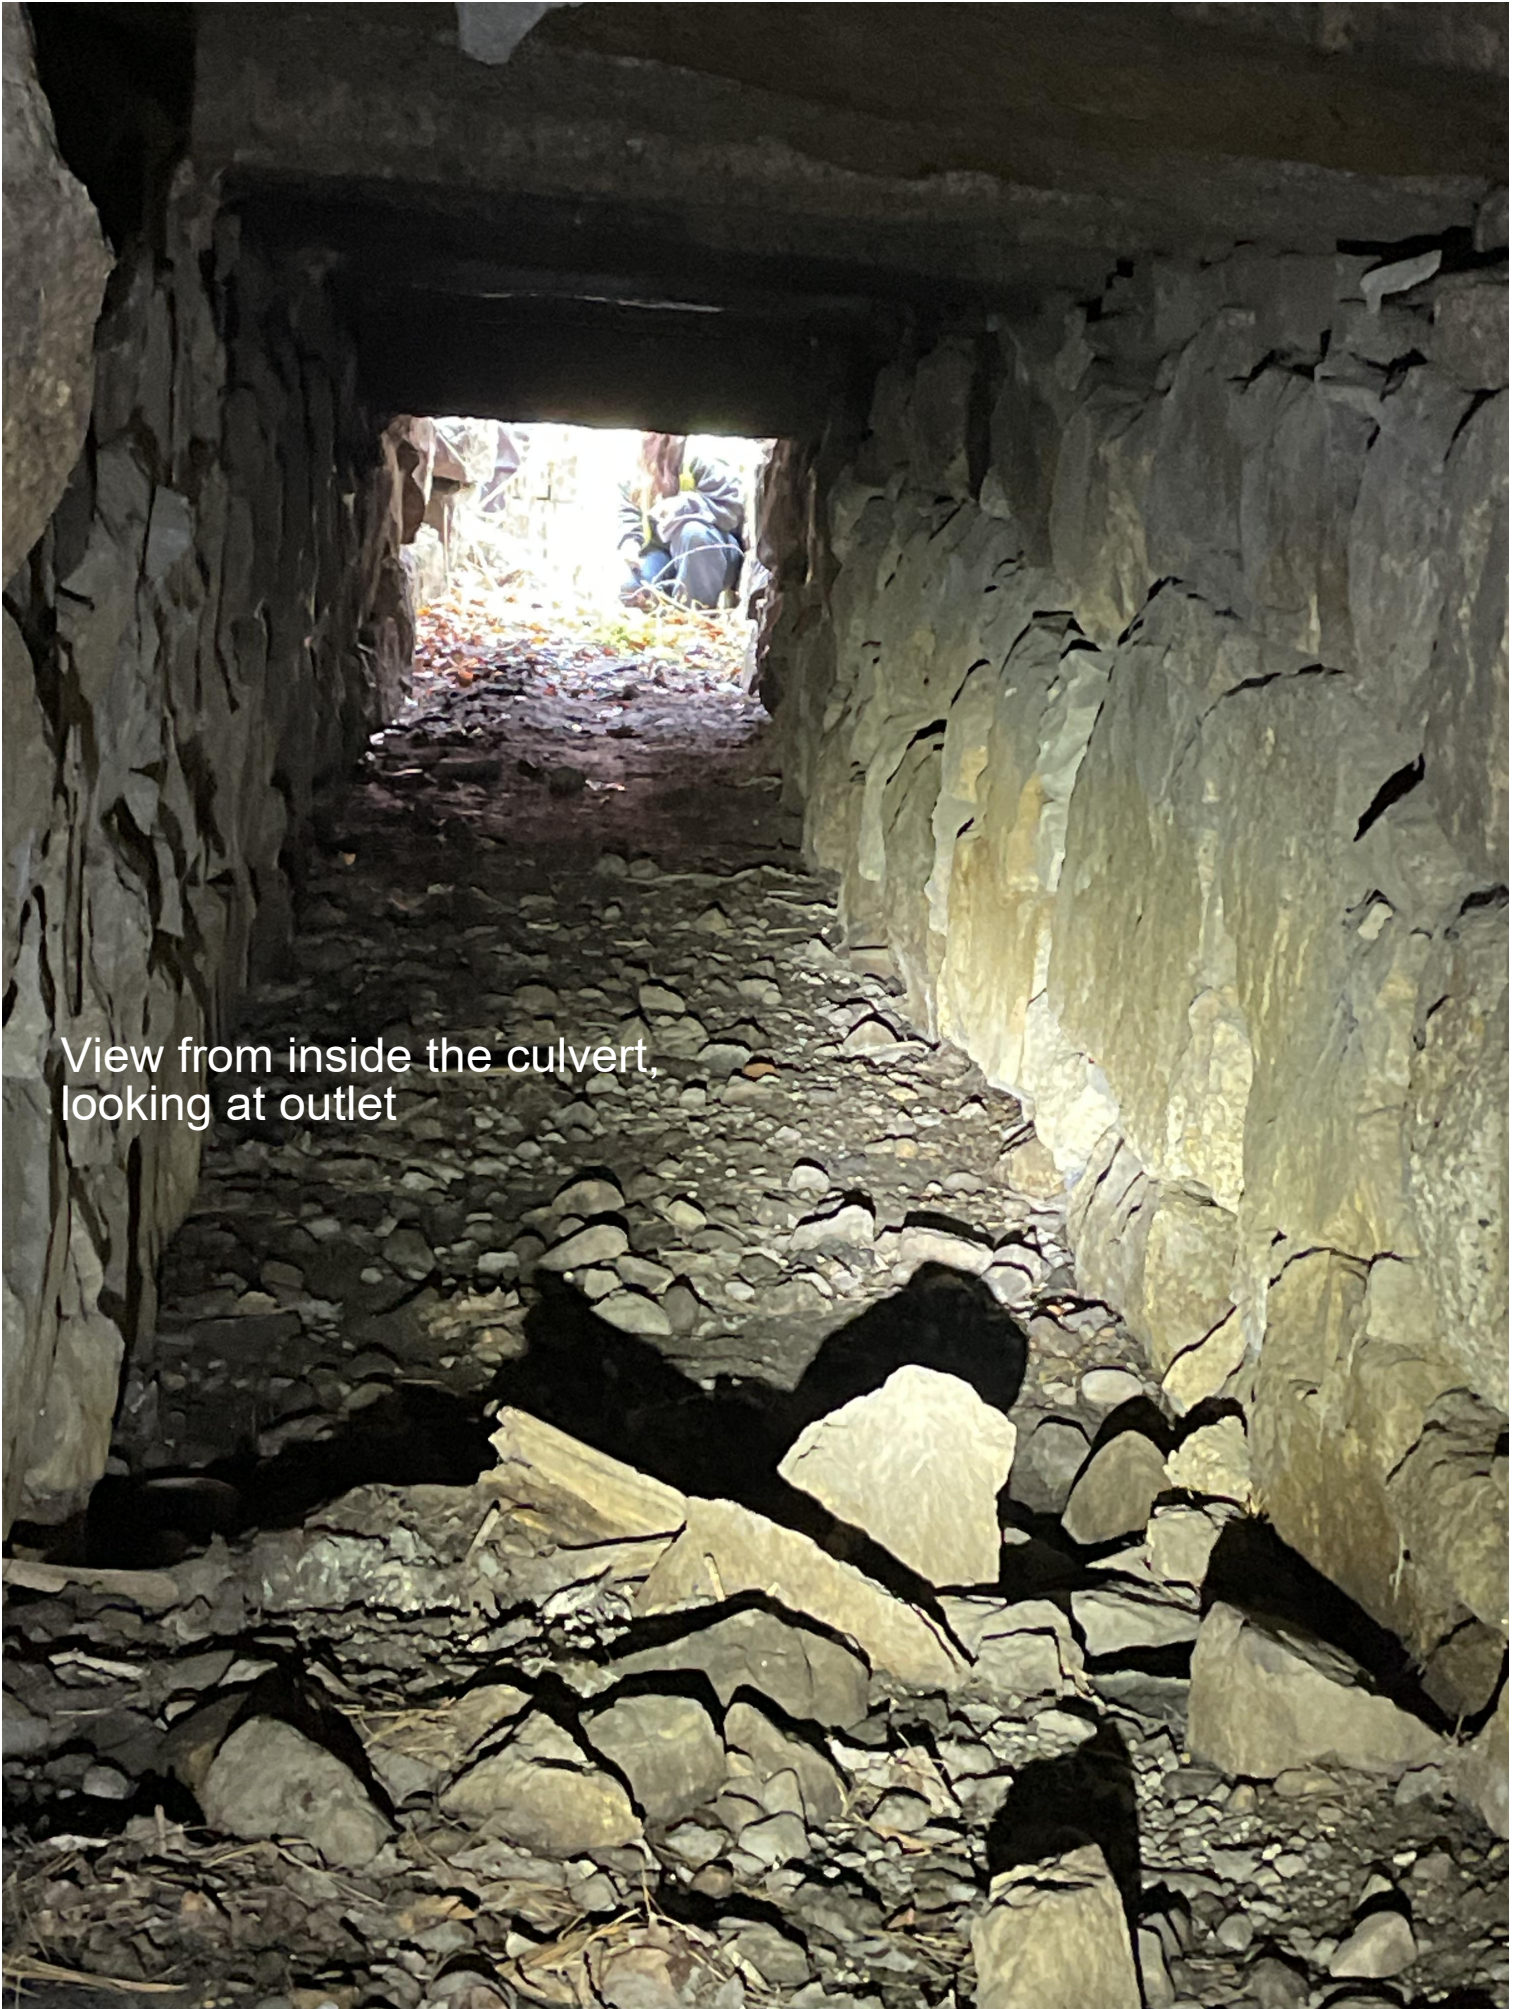
View from inside the culvert,
looking at outlet

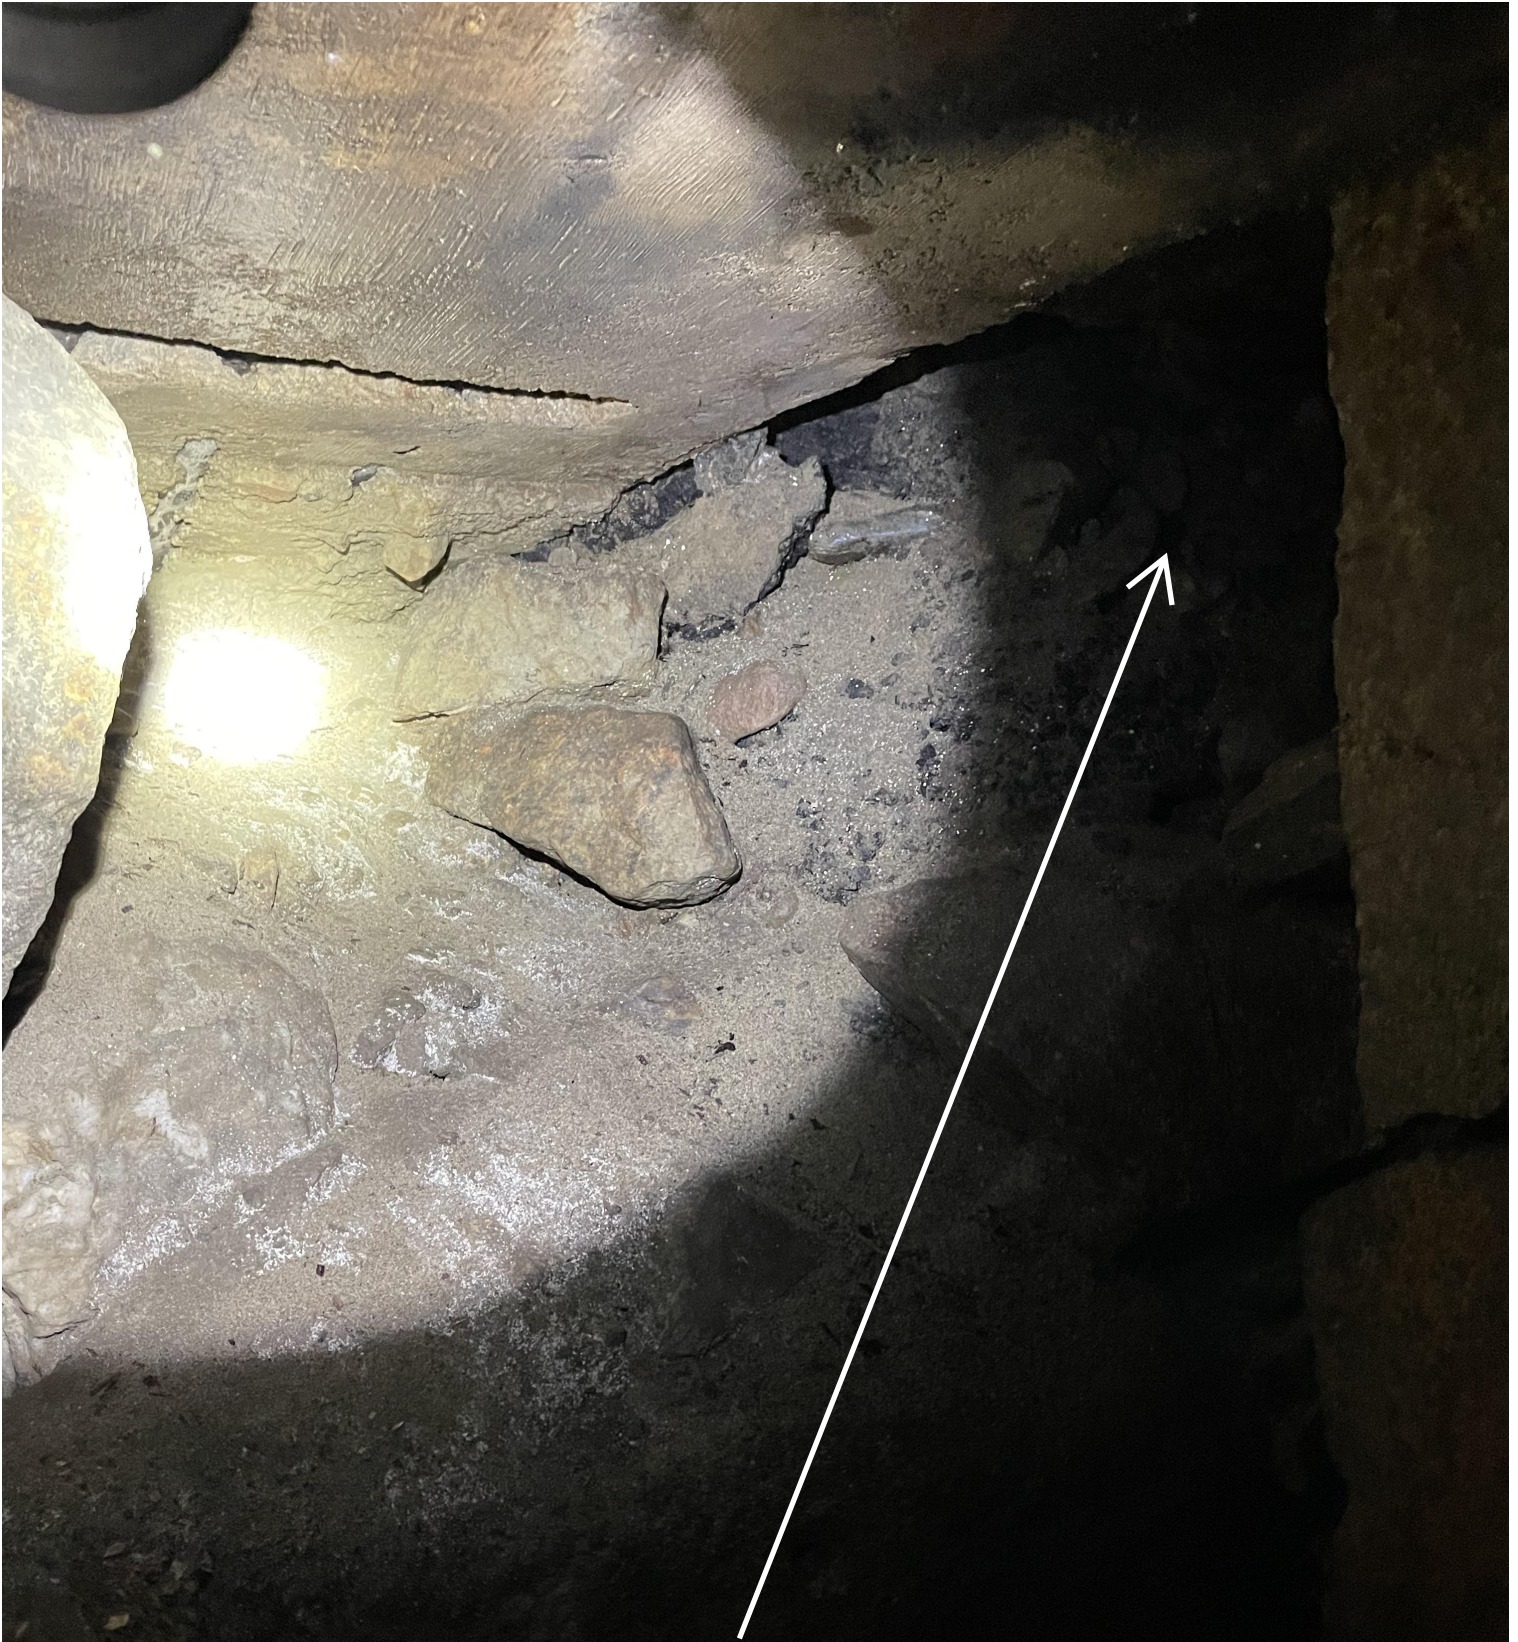
Cavity that has formed in the walls and bypassed the crown of the culvert.

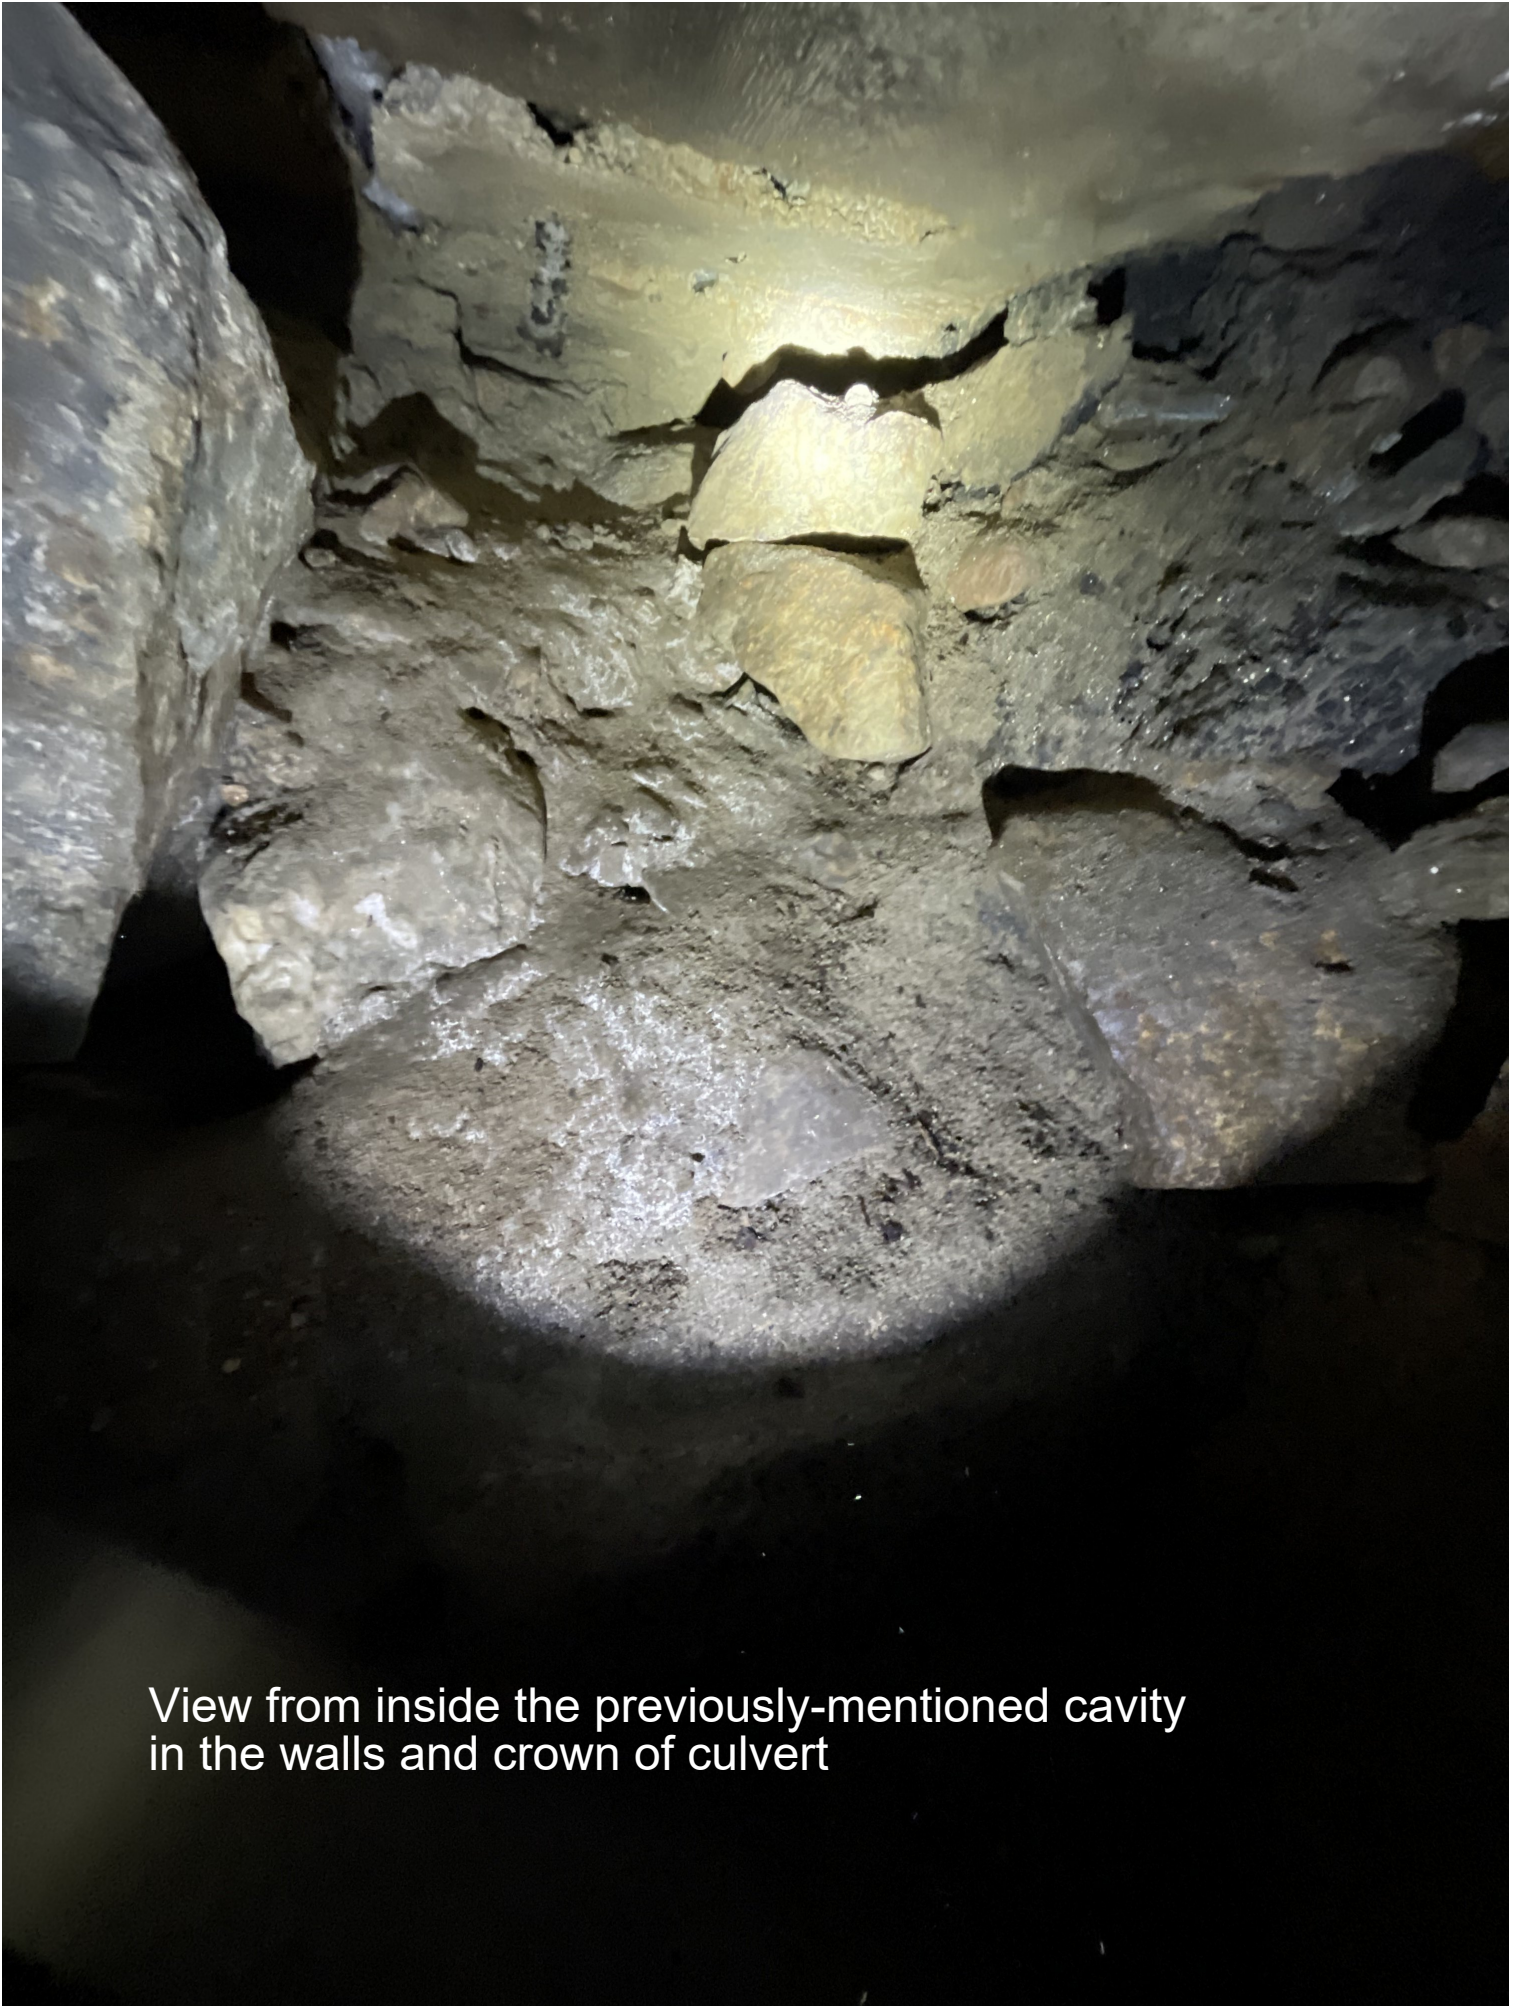
View from inside the previously-mentioned cavity
in the walls and crown of culvert

Sediment deposits on culvert floor
