**STORMWATER EXISTING CONDITIONS
61 TO 68 WAVERLY STREET
TOWN OF ASHLAND**

**STORMWATER PROPOSED CONDITIONS
61 TO 68 WAVERLY STREET
TOWN OF ASHLAND**

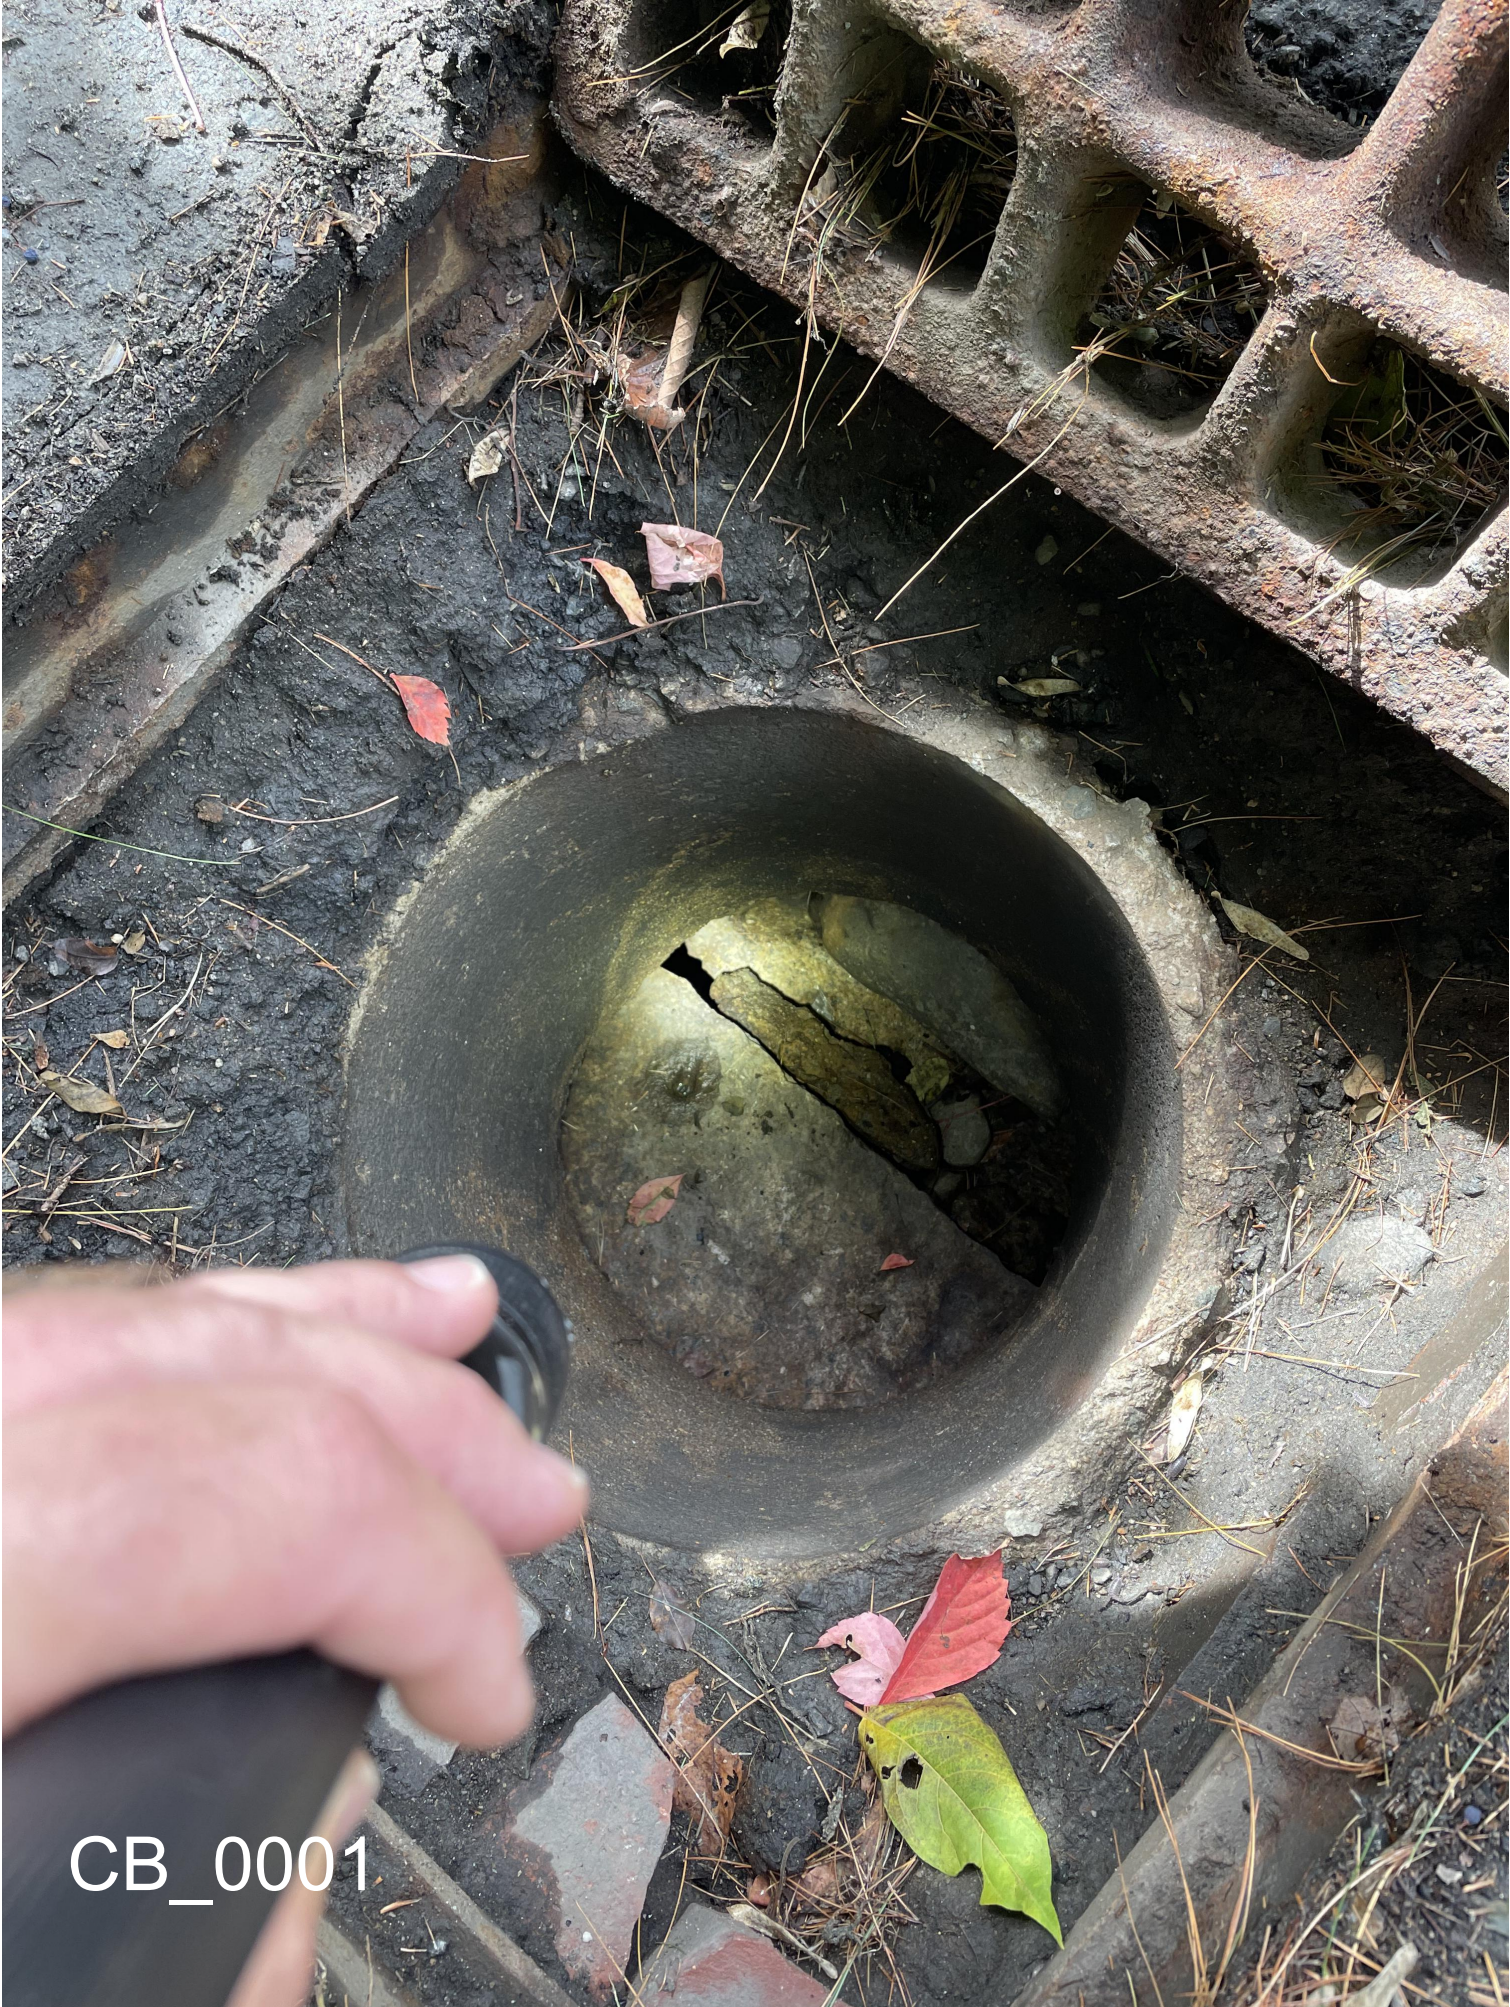
View of CB_0001 from inside the culvert,
"false sump" seen at the top of the chimney structure
