Nyanza Chemical Superfund Site

Update for Ashland Board Of Health

April 12th, 2016

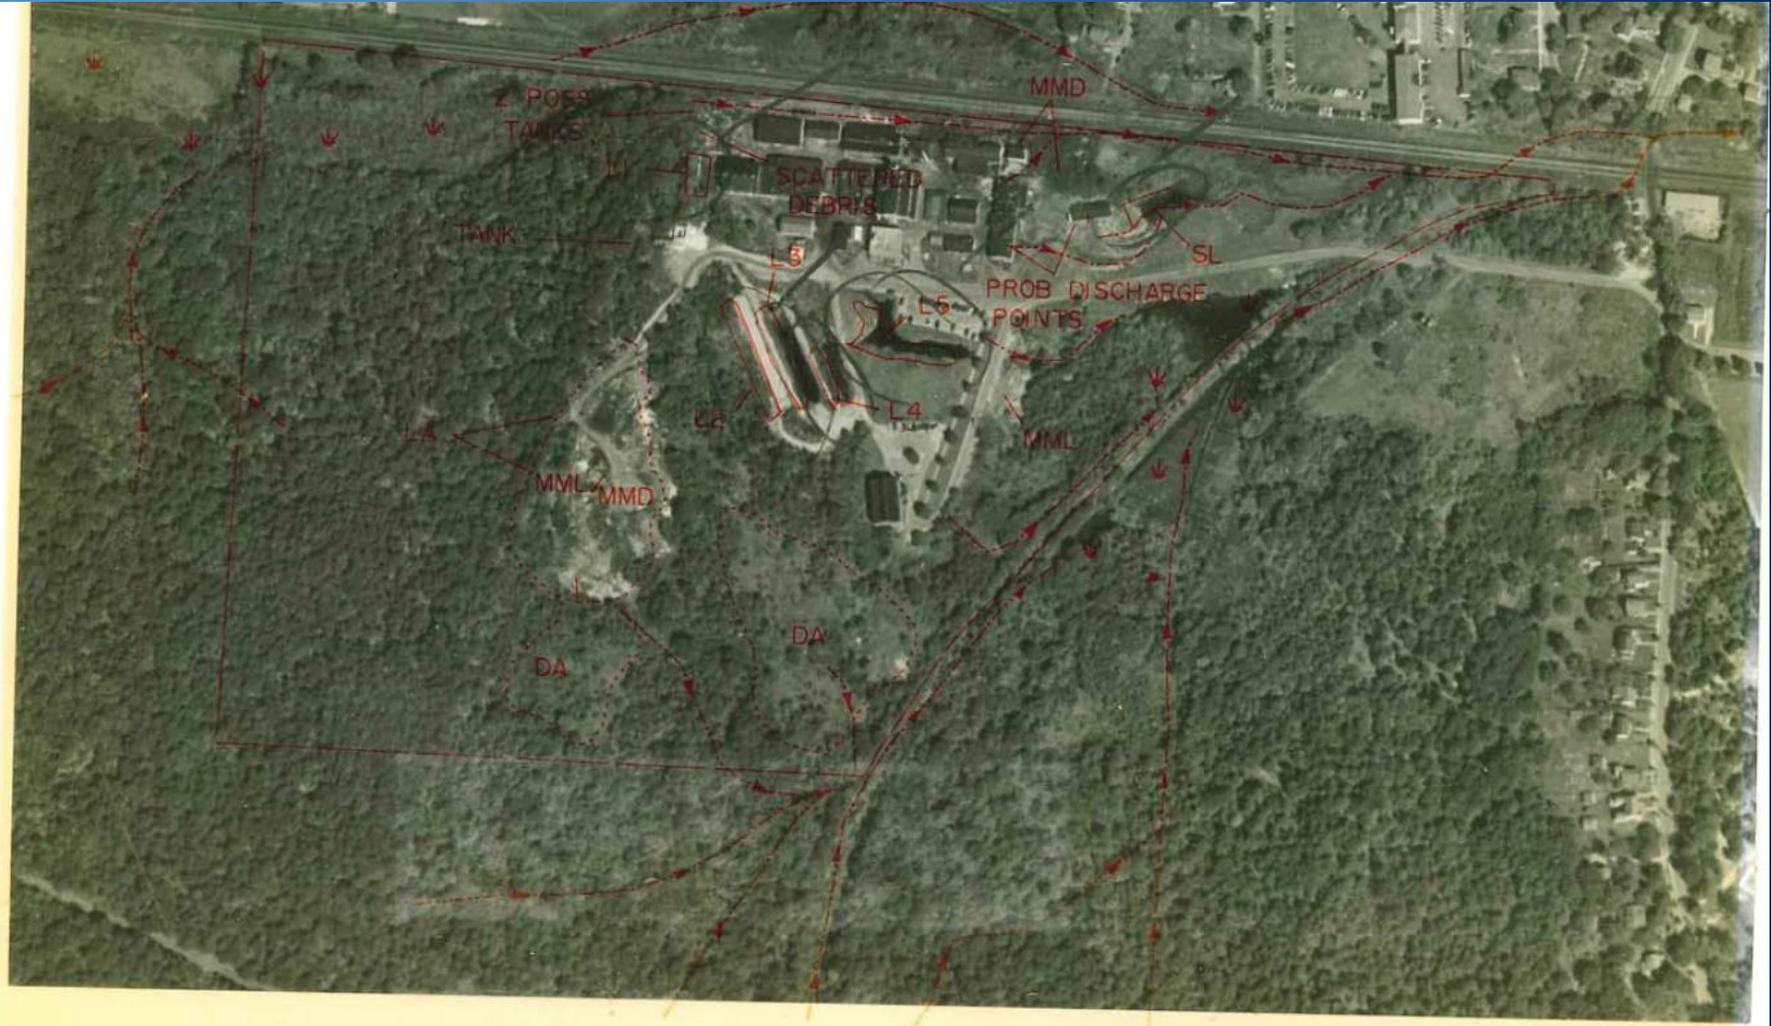
PHOTO 2 NYANZA SEPTEMBER 5, 1952 APPROX SCALE 1:4,200

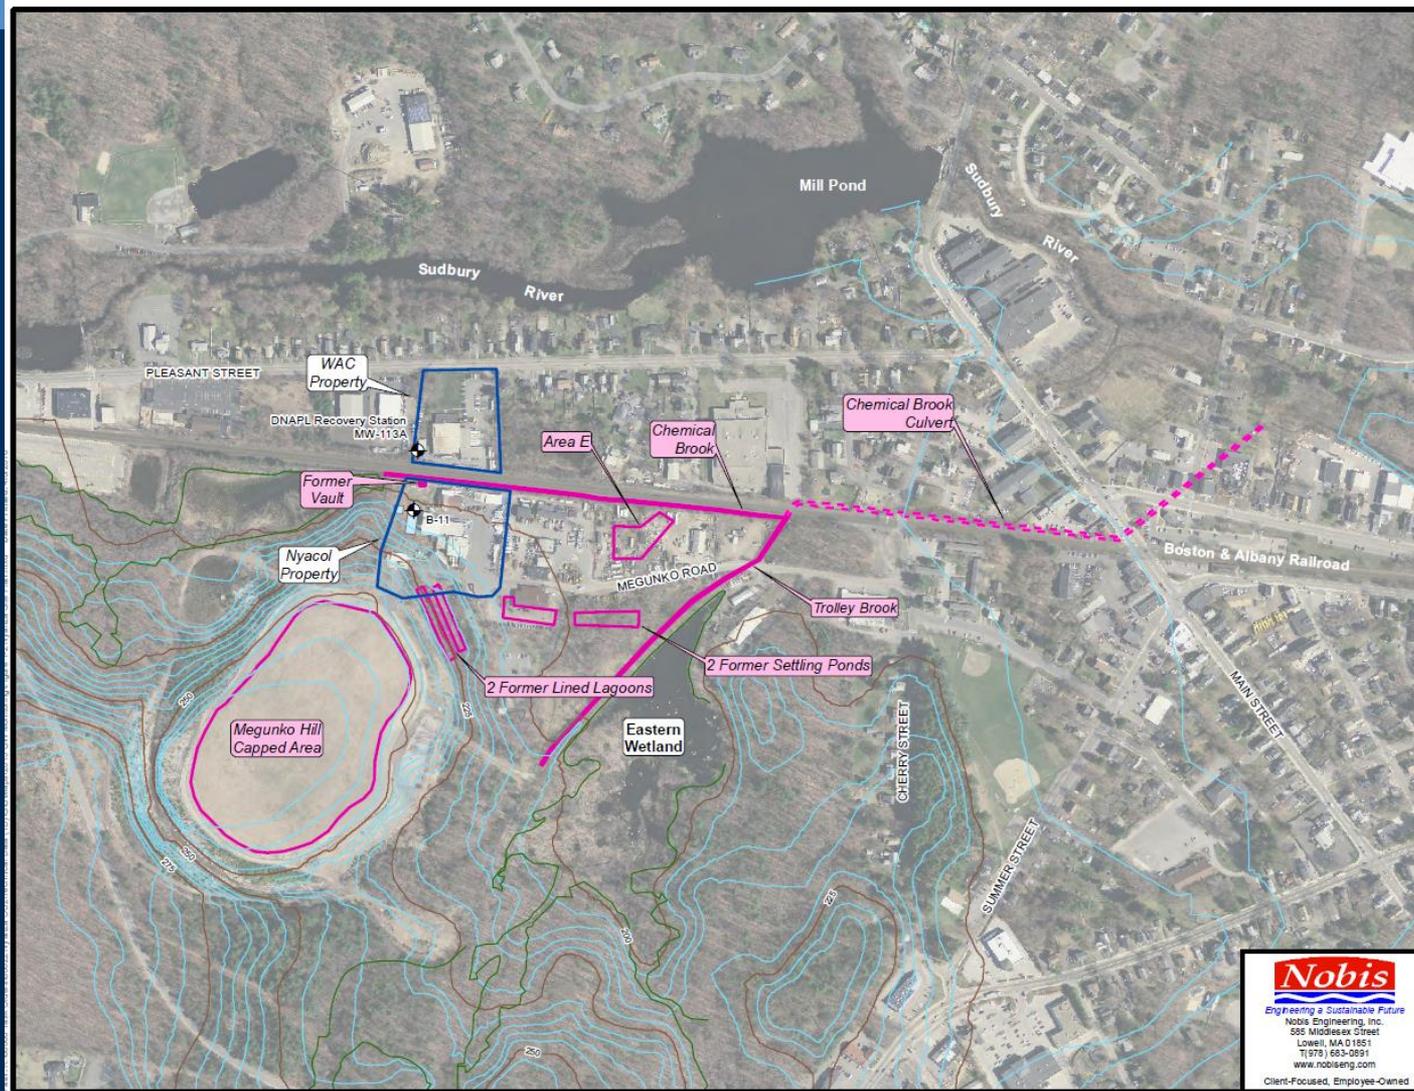
FIGURE 1-2

1. This site plan was created from a site plan titled "Base Mapping and Well Survey" by A-Plus Construction, Dated September 25, 2012.
2. Contours were interpolated from 3 meter contours obtained from the MassGIS website.
3. Horizontal Datum is in reference to the North American Datum of 1983 (NAD83).
4. Vertical Datum is in reference to the North American Vertical Datum of 1988 (NAVD88).
5. Potential DNAPL Sources from Figures 2 and 4 in Shaw (2004).
6. Locations of site features depicted hereon are approximate and given for illustrative purposes only.

SITE PLAN
 NYANZA CHEMICAL WASTE DUMP
 SUPERFUND SITE - OPERABLE UNIT II
 ASHLAND, MASSACHUSETTS

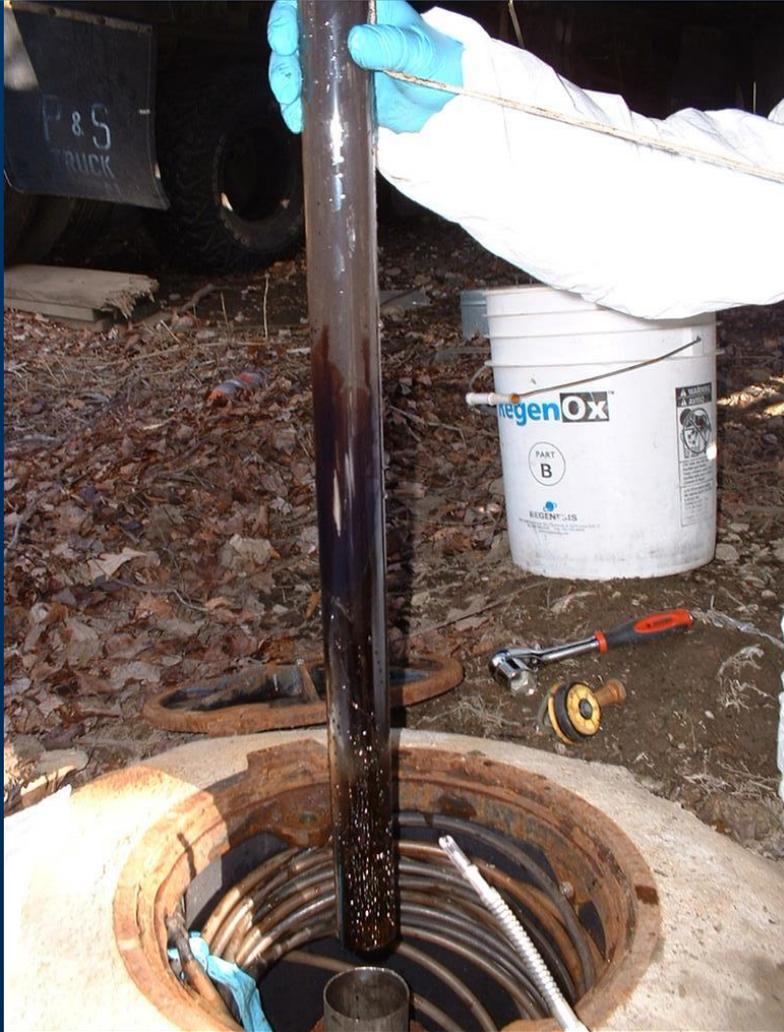
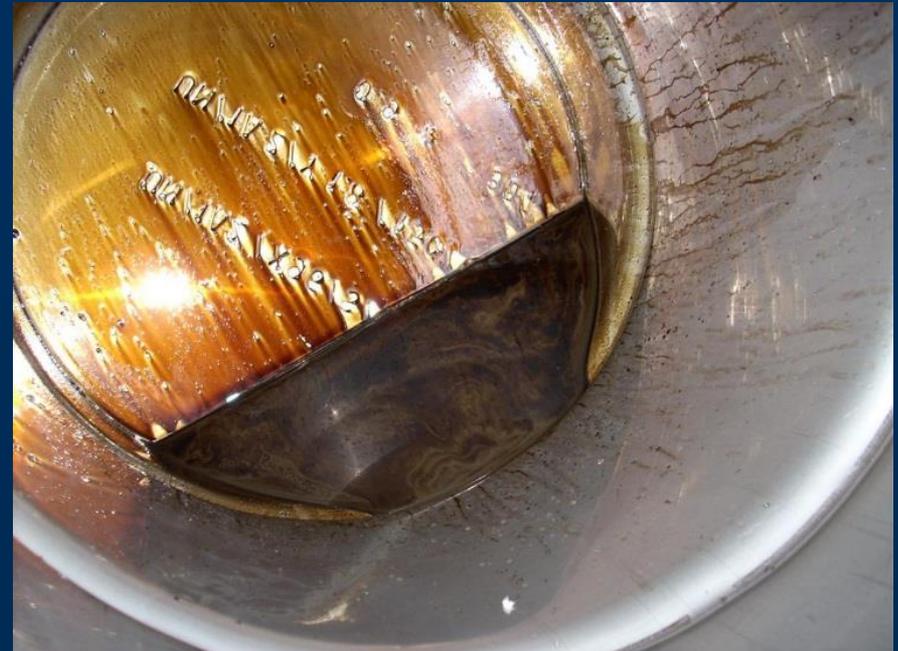
NAPL (= Industrial, Process Waste)

NAPL = Non-Aqueous
Phase Liquid

Chemical	Percent of Total
1,2 Dichlorobenzene	30.9%
Nitrobenzene	28.0%
1,4 Dichlorobenzene	10.6%
Chlorobenzene	10.3%
Trichloroethene (TCE)	3.5% (35,000 ppm)
1,3 Dichlorobenzene	2.8%
1,2,4 Trichlorobenzene	2.4%
Petroleum hydrocarbons	11.5%

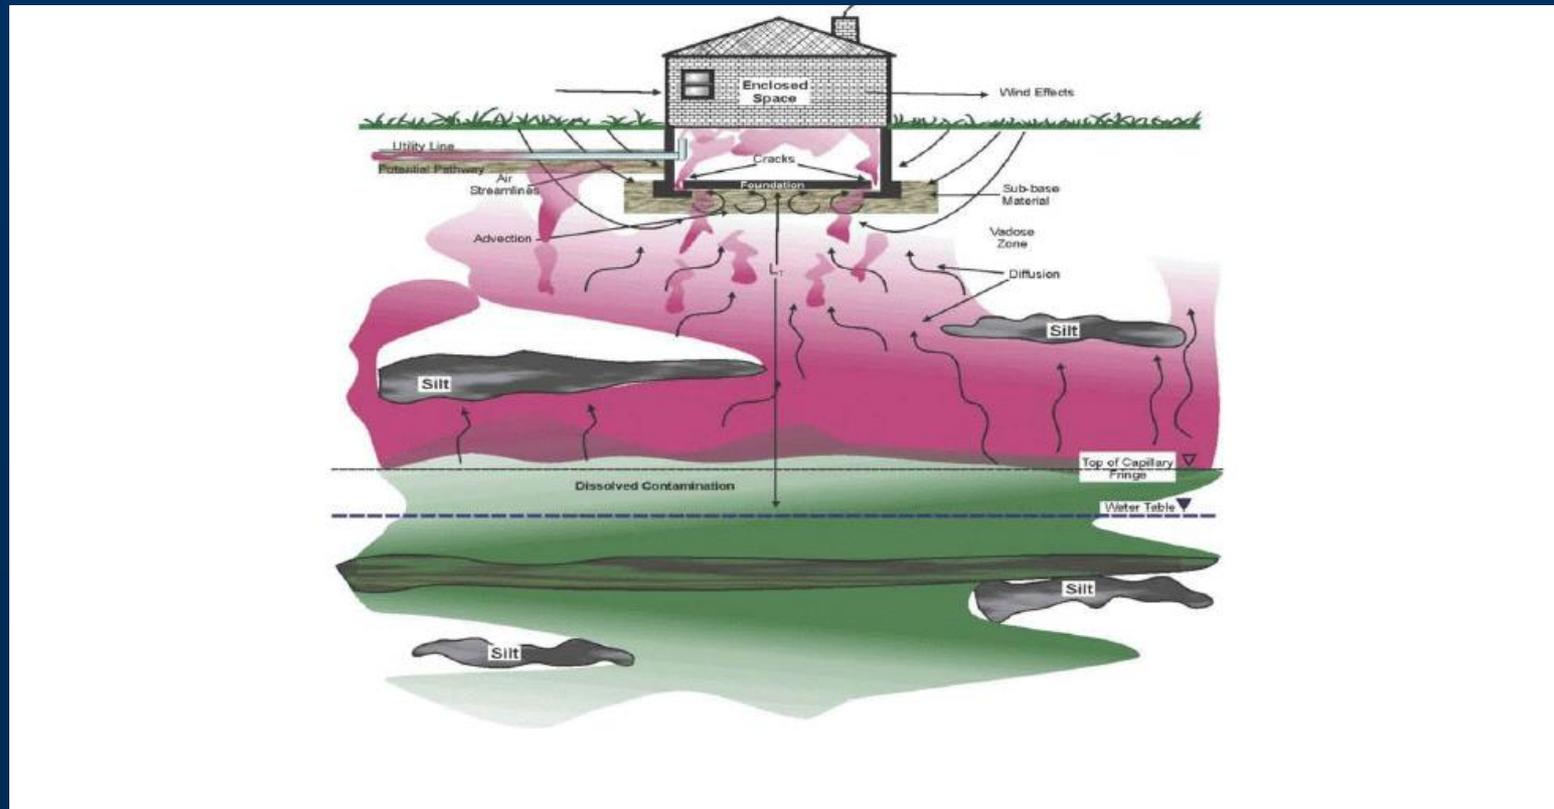
The migration of volatile chemicals (such as **TCE**) from the subsurface into overlying buildings.

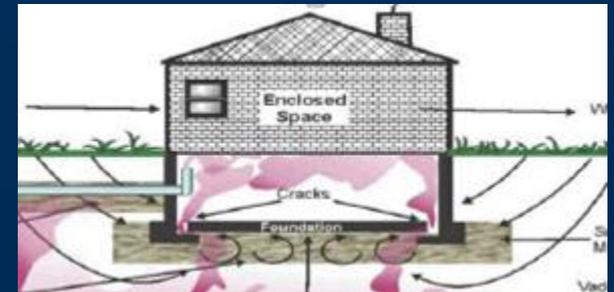
- 41 systems installed in 2007
- Nearly identical to a Radon system
- Prevents vapors from entering indoors by reducing the pressure below structure
- Post-construction, MassDEP:
 - performs annual inspection
 - conduct maintenance
 - make repairs

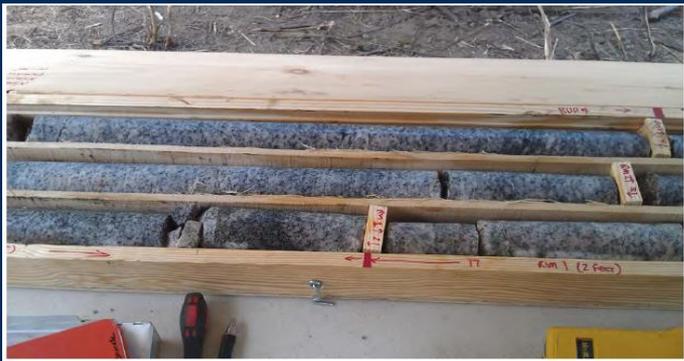
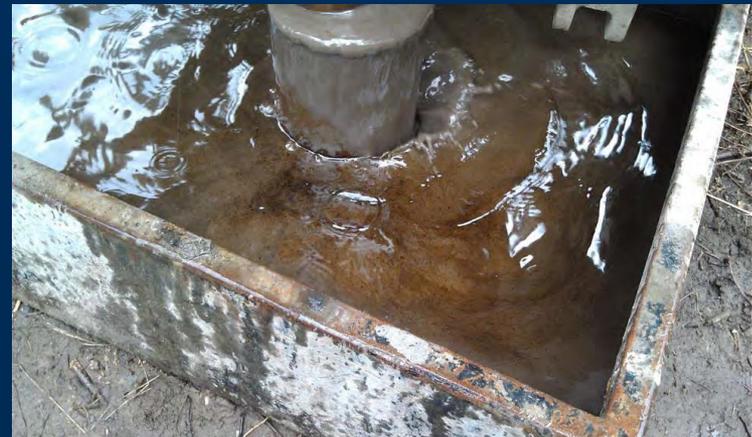
2. NAPL Extraction Systems

- Conduct multiple drilling programs to located NAPL (2009, 2012)
- Borings advanced 15' into bedrock
- NAPL no longer easily identified/located
- Identify two (2) locations with recoverable NAPL

- Two (2) extraction systems constructed
 - Soil boring BW-11 (Nyacol property near vault)
 - MW-113 (Worcester Air Conditioning)
- Operational since September 2013
- NAPL (i.e., “product”) accumulates and a pump runs ~1x per day to transfer material to enclosed storage tank.

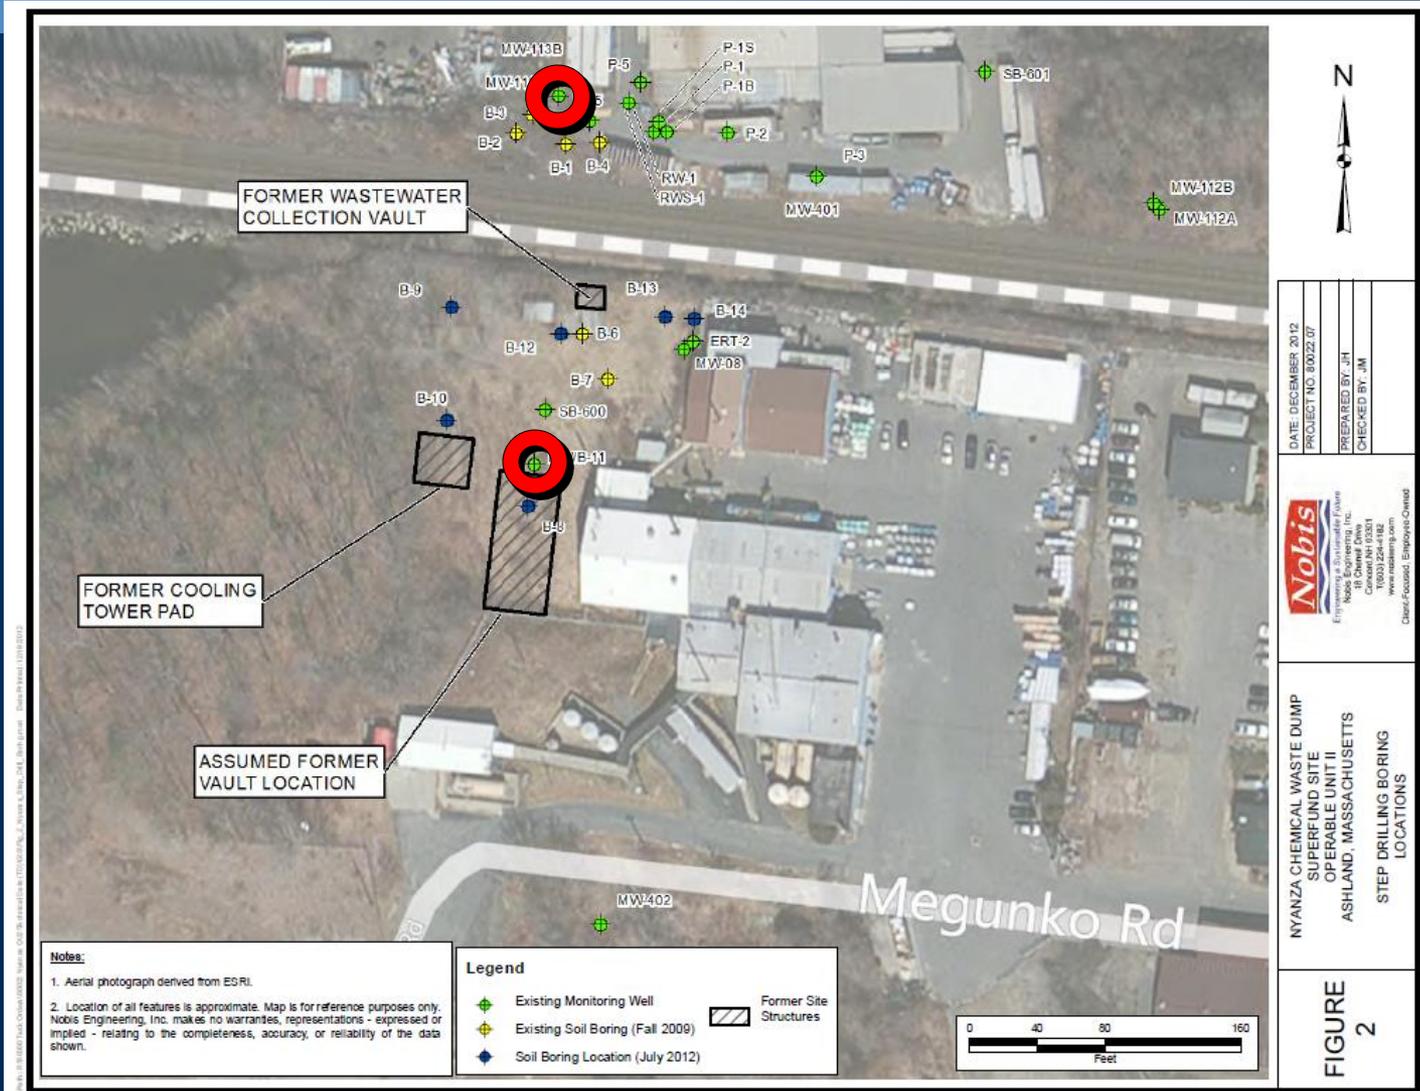
**FIGURE
 2**

**NYANZA CHEMICAL WASTE DUMP
 SUPERFUND SITE
 OPERABLE UNIT II
 ASHLAND, MASSACHUSETTS
 STEP DRILLING BORING
 LOCATIONS**

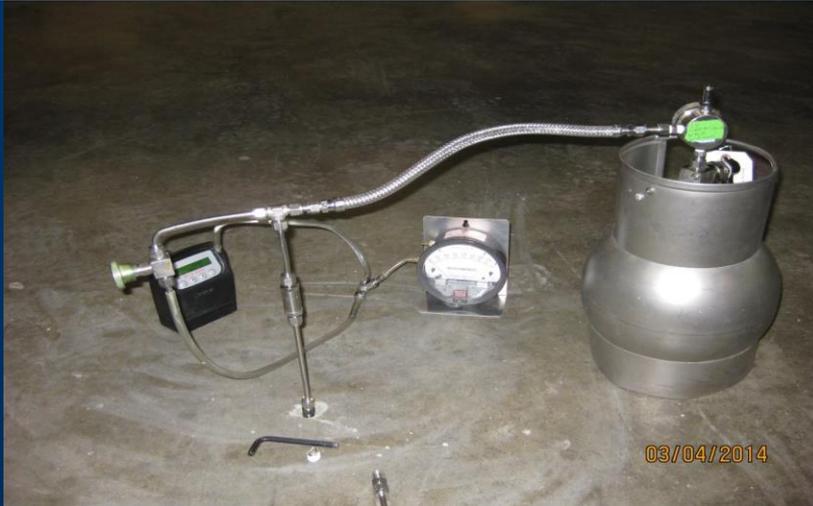
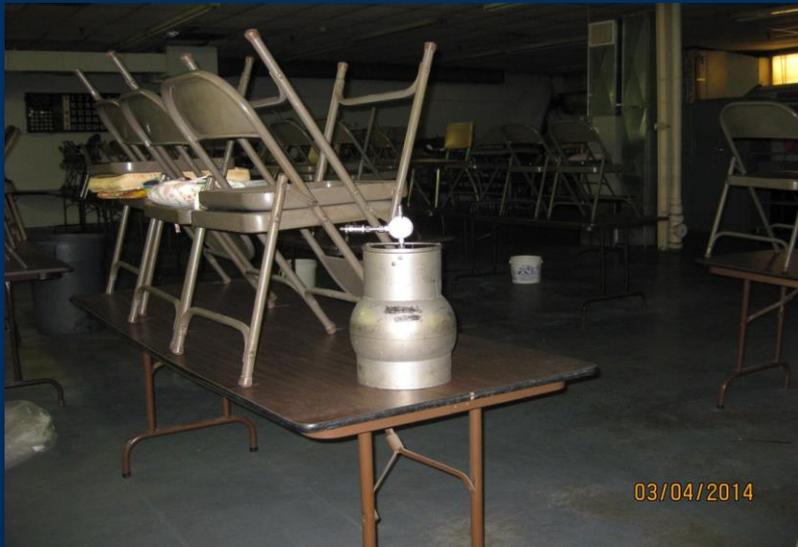
3. Supplemental VI Assessments

No new mitigation systems required.

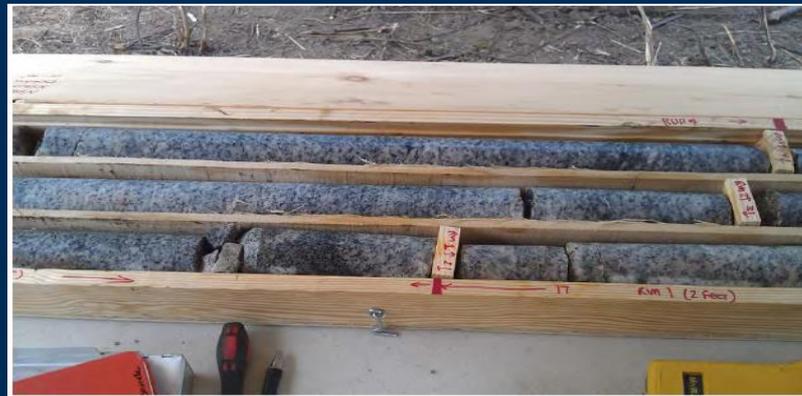
4. Groundwater Monitoring

- Contamination in Bedrock present many unique challenges:
 - Bedrock fractures (degree and orientation)
 - Difficult to characterize
 - Difficult to remediate
 - Different **Level of Risk (typically no VI)**

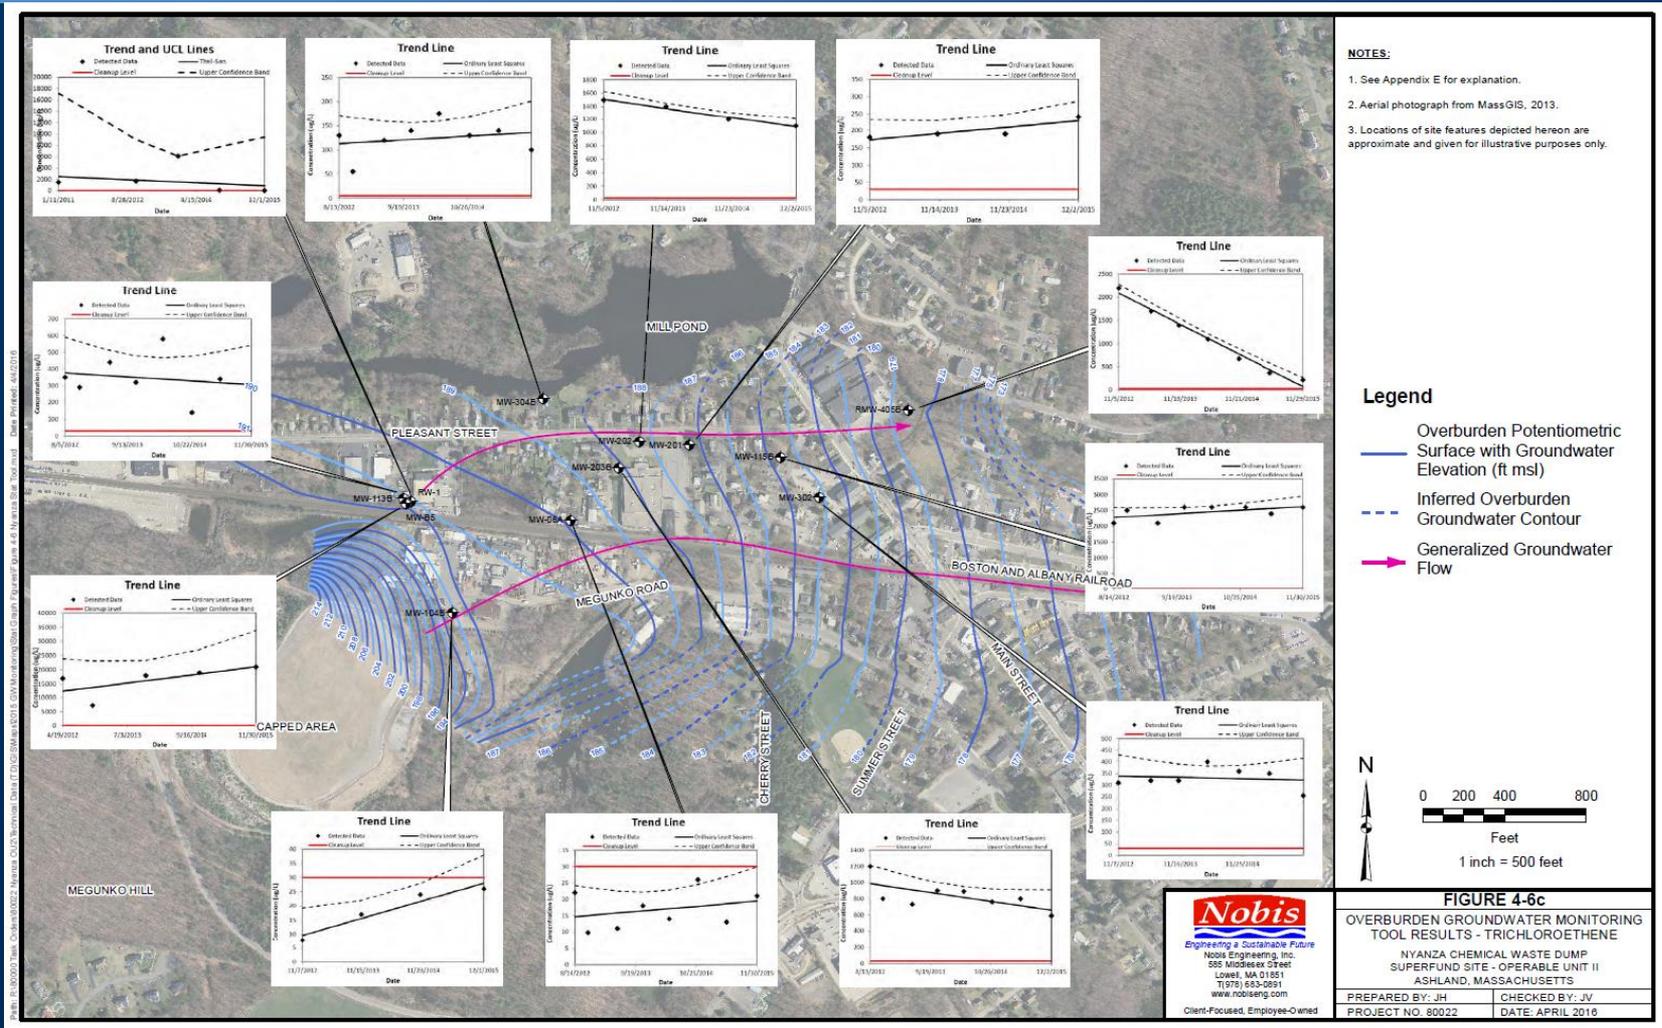
TCE Trends in Shallow Groundwater

FIGURE 4-6c
 OVERBURDEN GROUNDWATER MONITORING TOOL RESULTS - TRICHLOROETHENE
 NYANZA CHEMICAL WASTE DUMP SUPERFUND SITE - OPERABLE UNIT II
 ASHLAND, MASSACHUSETTS

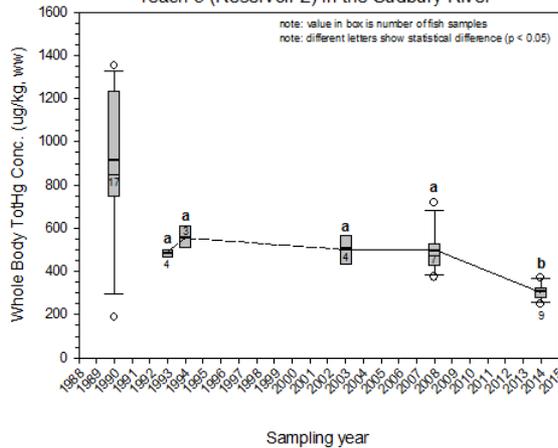
Figure 1.1: Whole body total Hg in 3- and 4-year old (or age-equivalent) largemouth bass collected from reach 3 (Reservoir 2) in the Sudbury River

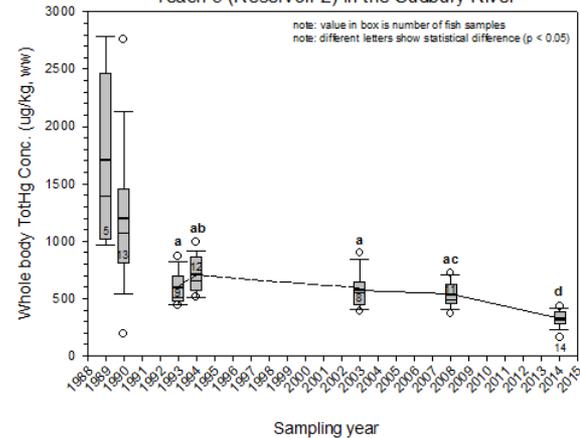
Figure 1.2: Whole body total Hg in 3- to 5-year old (or age-equivalent) largemouth bass collected from reach 3 (Reservoir 2) in the Sudbury River

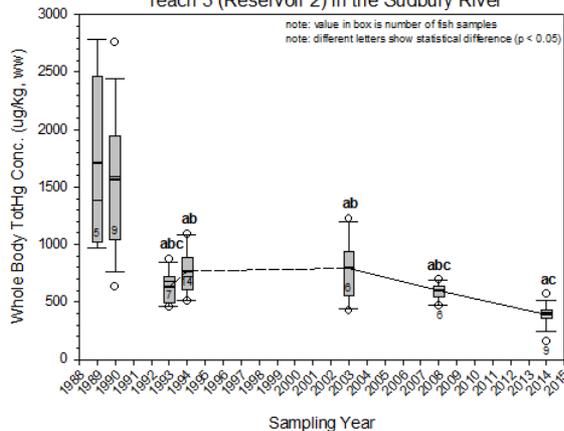
Figure 1.3: Whole body total Hg in 5- to 7-year old (or age-equivalent) largemouth bass collected from reach 3 (Reservoir 2) in the Sudbury River

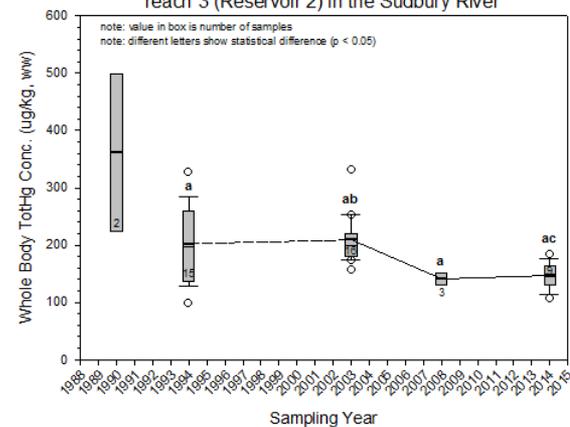
Figure 1.4: Whole body total Hg in 1- to 3-year old (or age-equivalent) yellow perch collected from reach 3 (Reservoir 2) in the Sudbury River

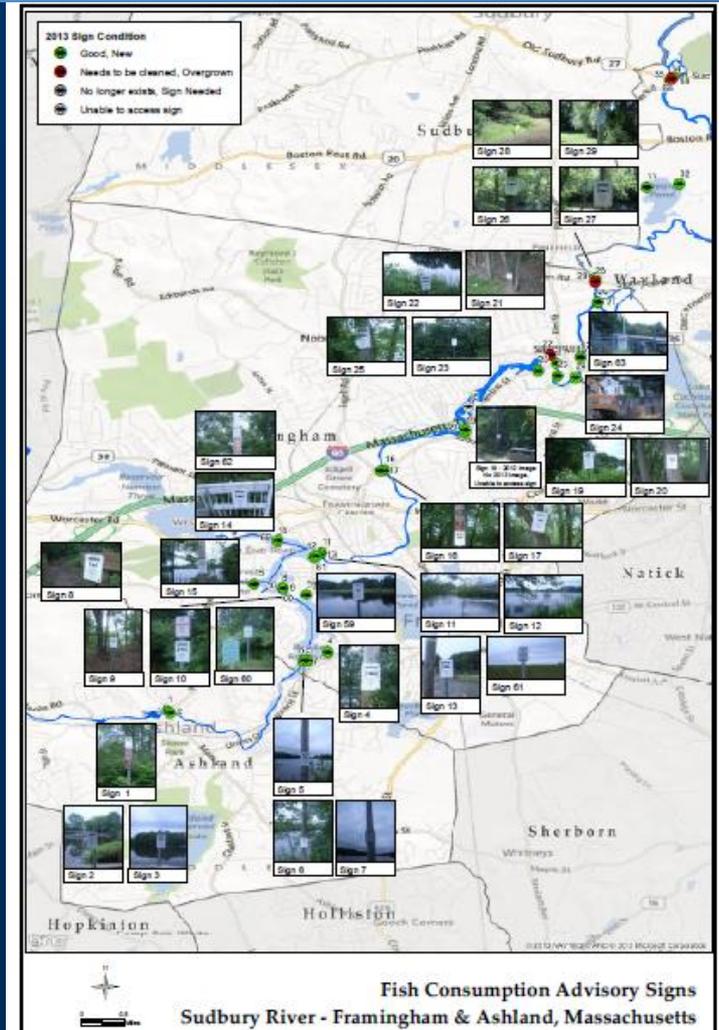
OU4 – Education/Outreach

Warning sign inspection annually since 2009.

Contact each town prior to inspection to solicit new locations (if any).
