Memorandum

To:	Mr. Greg Wands Chair, Ashland Conservation Commission	Project Number:	24142
From:	Will Park, PE	Date:	12/23/2025
Project Name:	61 Waverly Street – Notice of Intent		
RE:	Response to Comments - Hearing 1/5		
Distribution:	Israel Lopez - The Gutierrez Company, Mark Arnold - Goddard Consulting, Luke Norton & Corinne Disenhof - Sanborn Head & Associates

EXHIBIT: BEDROCK ELEVATION PLAN/PROFILE (APPROX.)

THE RESIDENCES AT ASHLAND
61 WAVERLY STREET
ASHLAND, MA

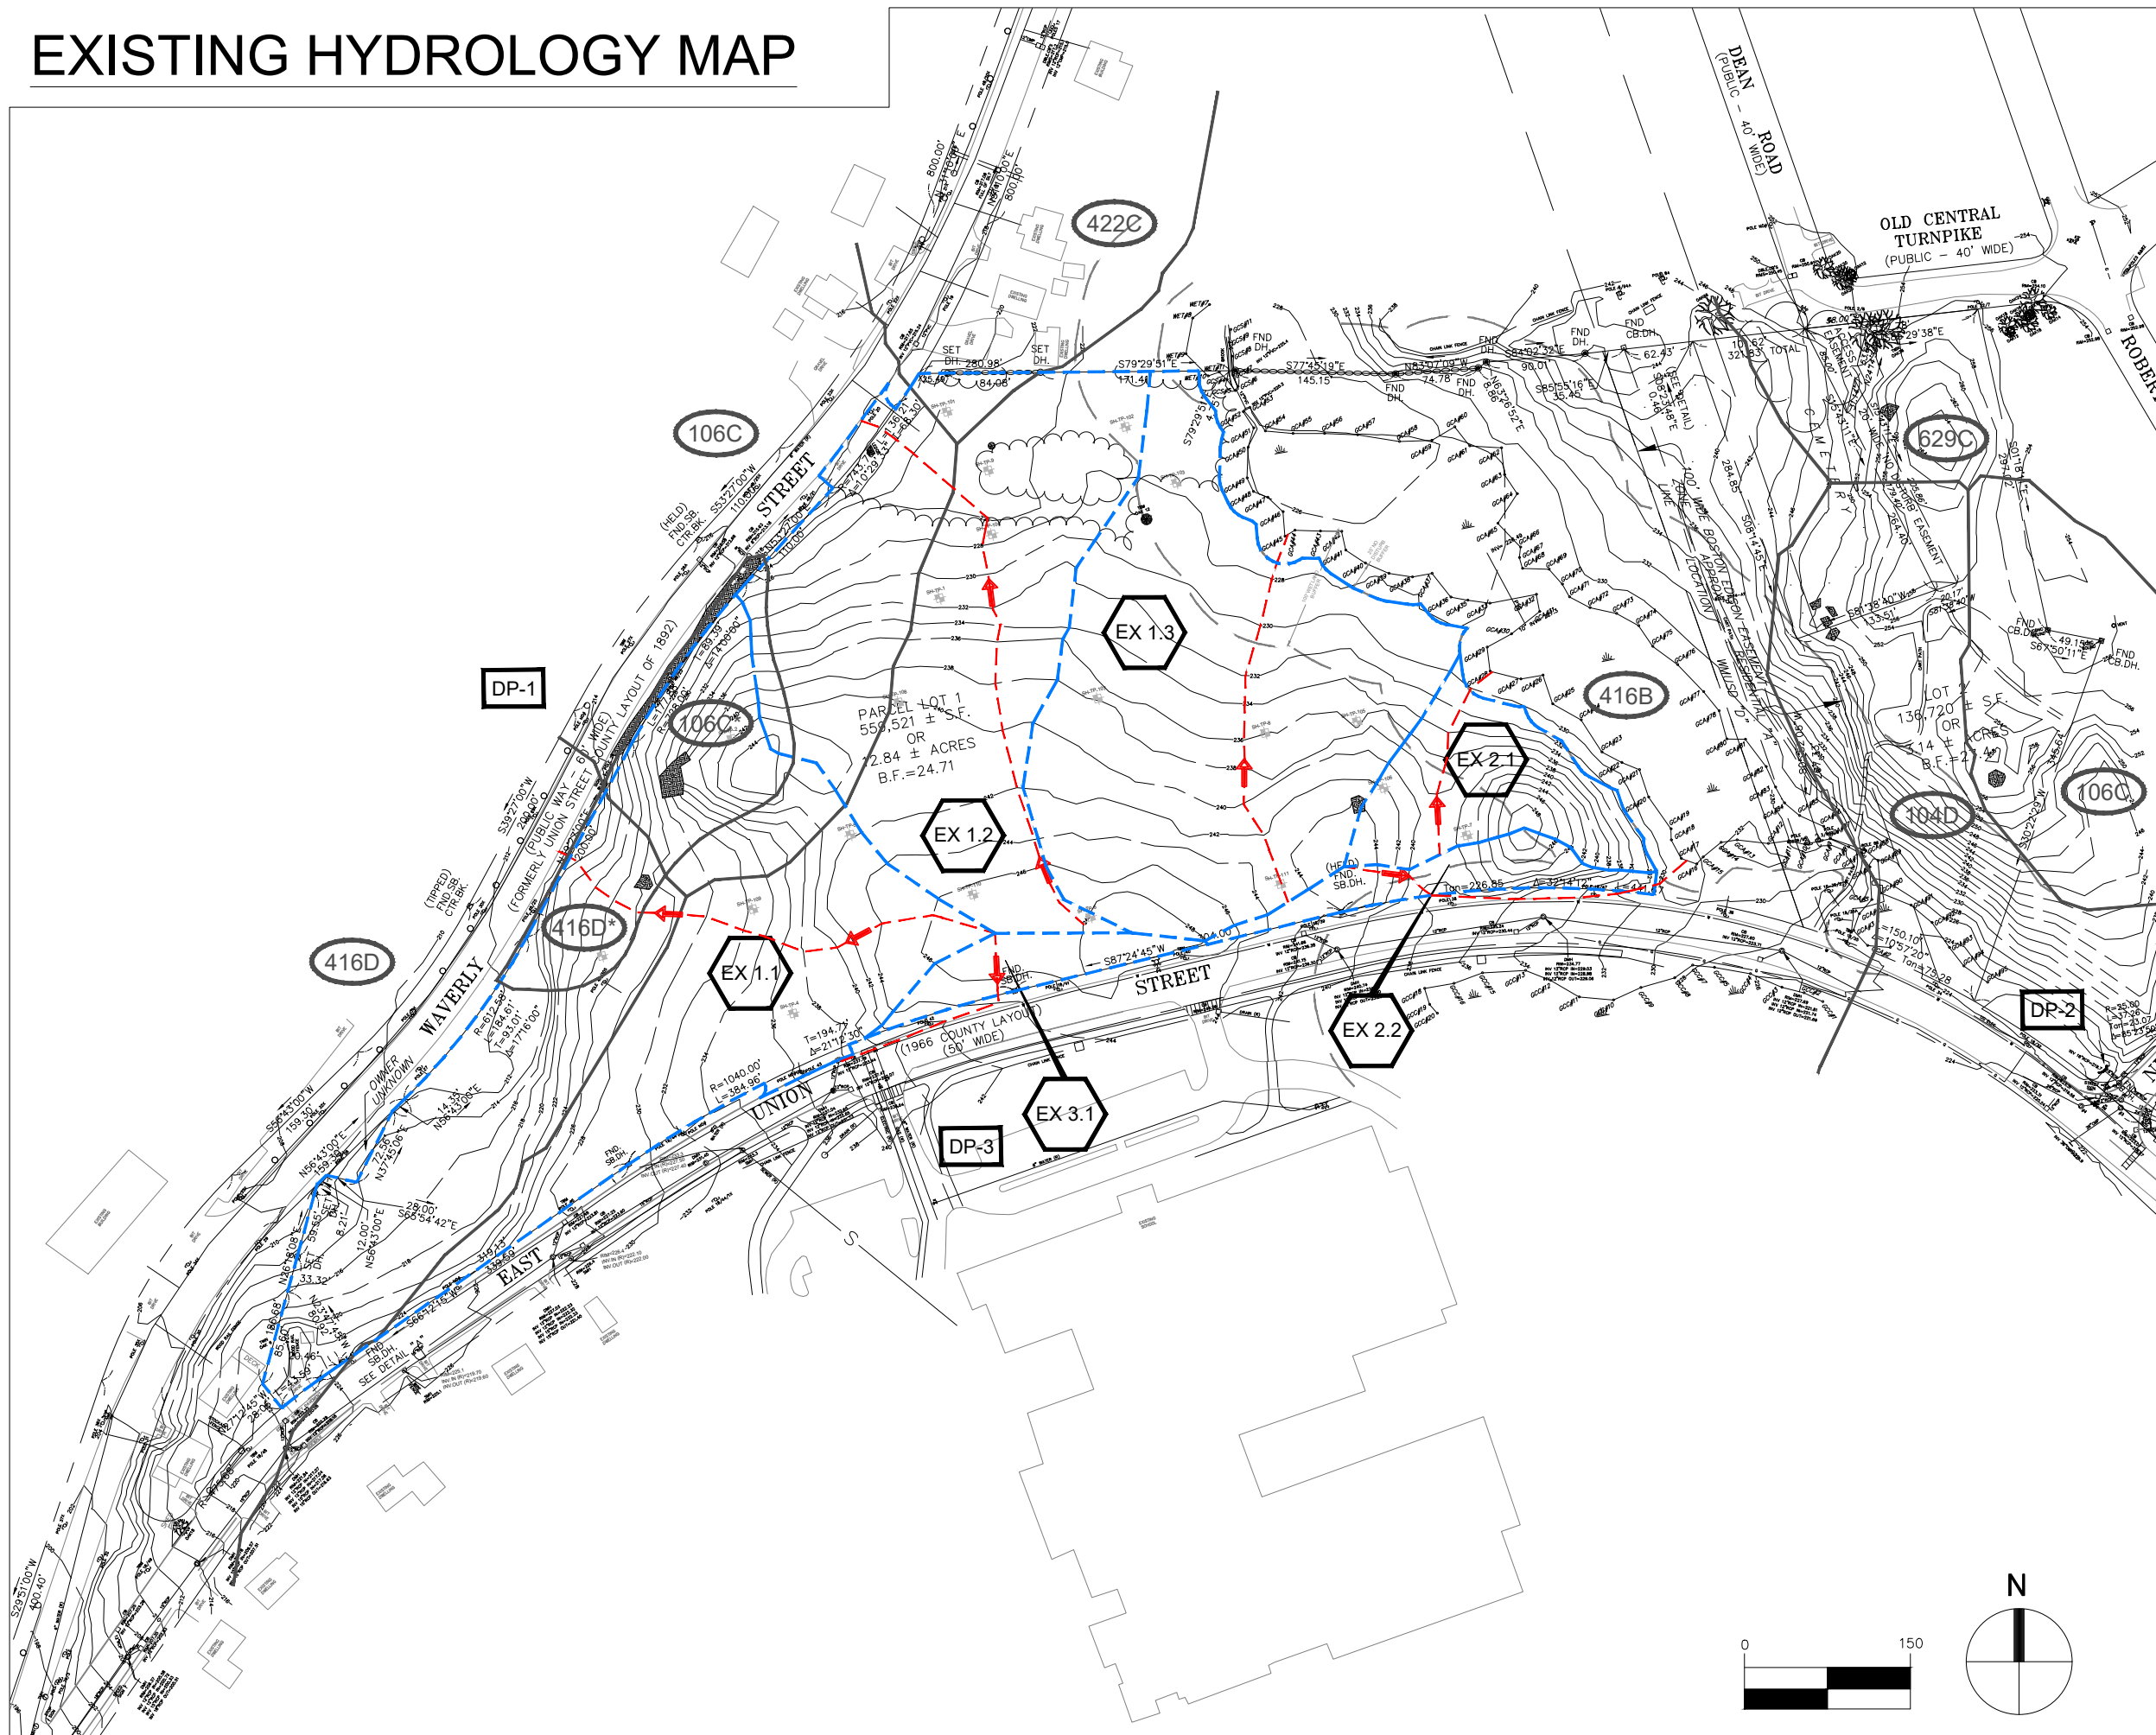
EXISTING HYDROLOGY MAP

The Conservation Commission has expressed concern regarding the presence of bedrock on the project site and specifically, whether stormwater runoff is discharging from the site over the bedrock slope along Waverly Street. Additionally, we received written comments from the Conservation Agent regarding the hydrological soil group classification used in the stormwater model. The project team has taken these concerns into consideration and re-examined the Hydrologic Soil Group (HSG) of the onsite soils. Refer to the enclosed letter from SHA regarding an area of the site where the previously submitted USDA Web Soil Survey soil series of "Narragansett Silt Loam" with a HSG A is now more accurately classified as HSG A/D. Enclosed are updated Existing and Proposed Hydrology Maps that identify these areas noted with an asterisk on the plan and legend.

The existing hydrology model has been updated with a conservative HSG B designation as HydroCAD does not have a HSG A/D option. As a result, the existing peak discharge rates have increased slightly. No other changes to the stormwater model have been made

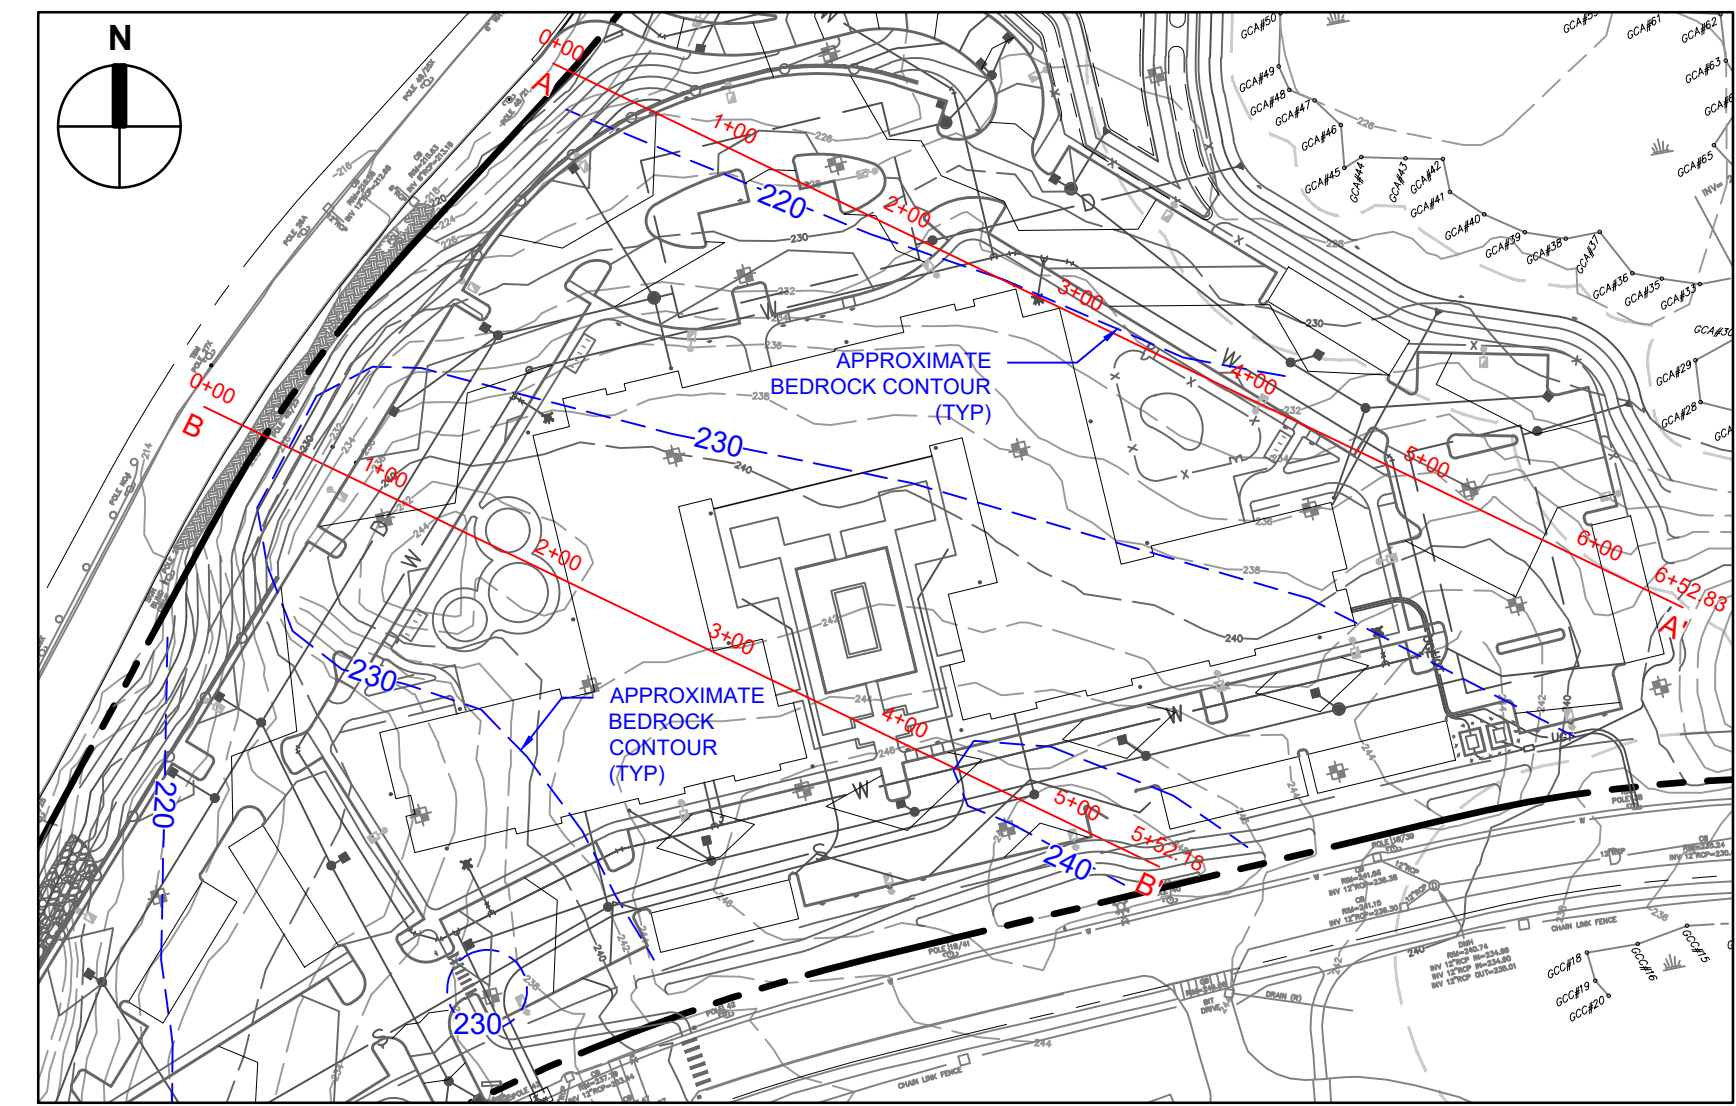
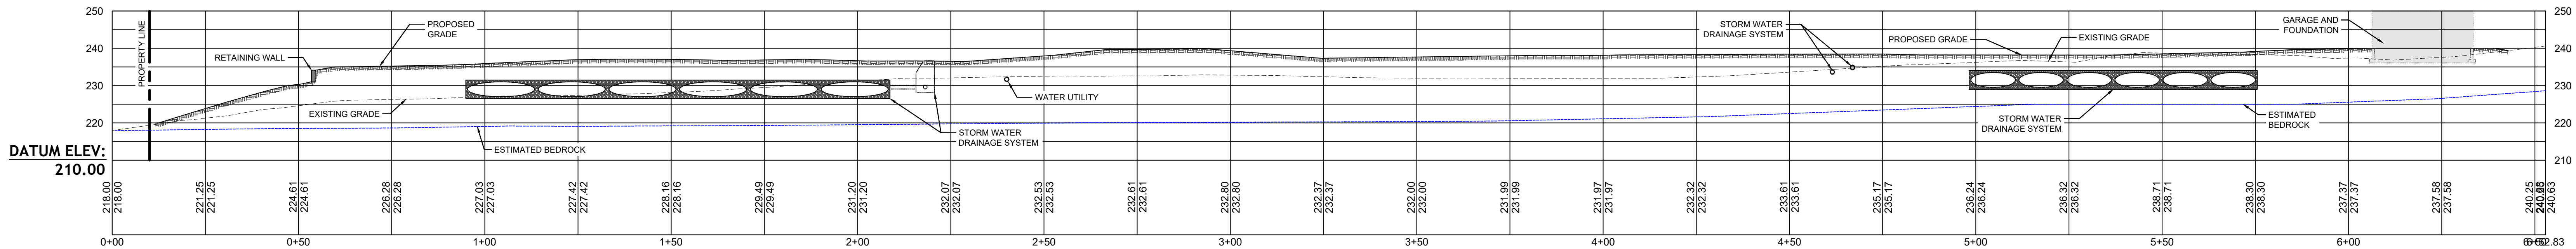
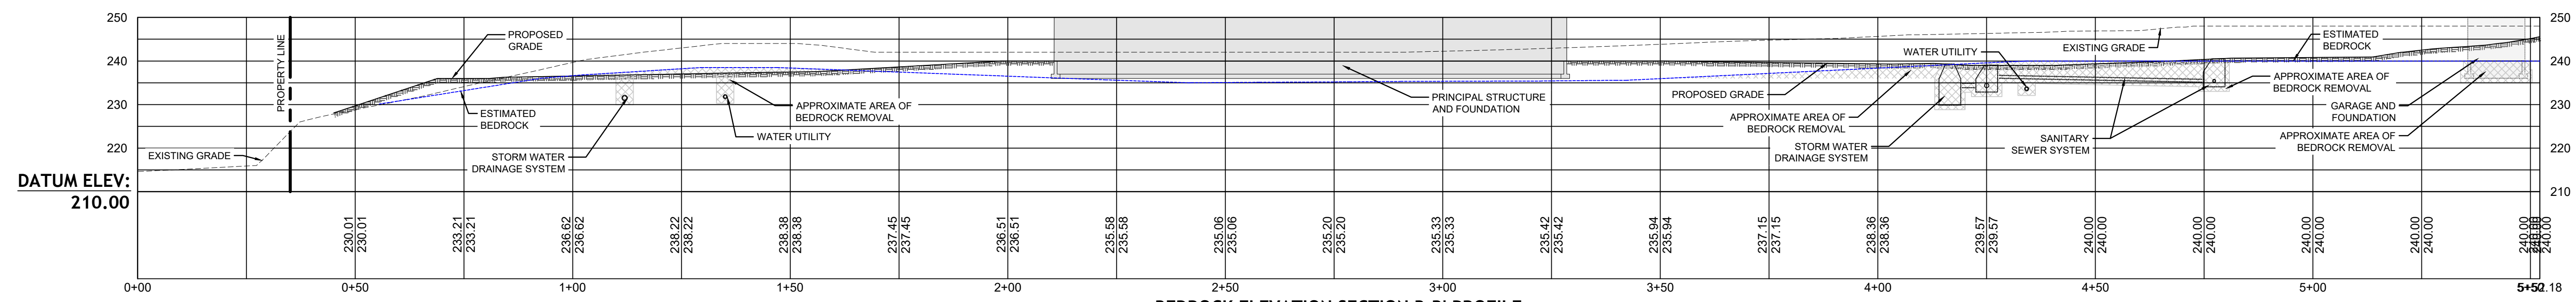
Enclosed is Exhibit: Bedrock Elevation Plan/Profile (Approx.) that shows the limited bedrock removal. Profile "A" demonstrates the more typical project earthwork scenario where bedrock removal is not anticipated. Profile "B" demonstrates the "worst case" through the bedrock ridge as described by SHA.

Based on the depth to bedrock in Sanborn Head's explorations of the Site, it is our observation that the bedrock on the Site is shaped as an east-to-west ridge, and the bedrock approximately follows the Site topography. Bedrock elevations encountered in test pits varied along the ridge line from approximately elevation (El.) 240 feet at the highest observation in the southeast to El. 238.5 feet at the highest observation in the west, and sloping down to both the northeast and southwest to approximately El. 225 to 236 feet, below the proposed building, and deeper than El. 215 feet to the north. Based on a proposed finished floor elevation of 240 feet and assumed bottom of foundation elevation of 236 feet, we do not anticipate that blasting will be required below the building.

Bedrock at the crest of the ridge line between approximate El. 232 and 240 feet in the western and southeastern parking areas is anticipated to require removal to install the pavement sections, utilities, and garage foundations at the proposed or anticipated elevations based on the Grading and Drainage Plan prepared by SMMA and dated January 27, 2025. We have identified approximate areas where we anticipate blasting could be used for this purpose, as described in the memo dated December 23, 2025 by SMMA. However, depending on the actual conditions encountered in the field, bedrock removal by hammering or other mechanical means may be possible in portions of these areas where the depth of removal is limited.

Bedrock removal on this Site is expected to reduce high points of the bedrock ridge or cut a trench to allow the installation of the proposed structures. Based on the proposed Site plan, we do not anticipate a new bedrock face ("rock cut") will be exposed on the Site, nor do we

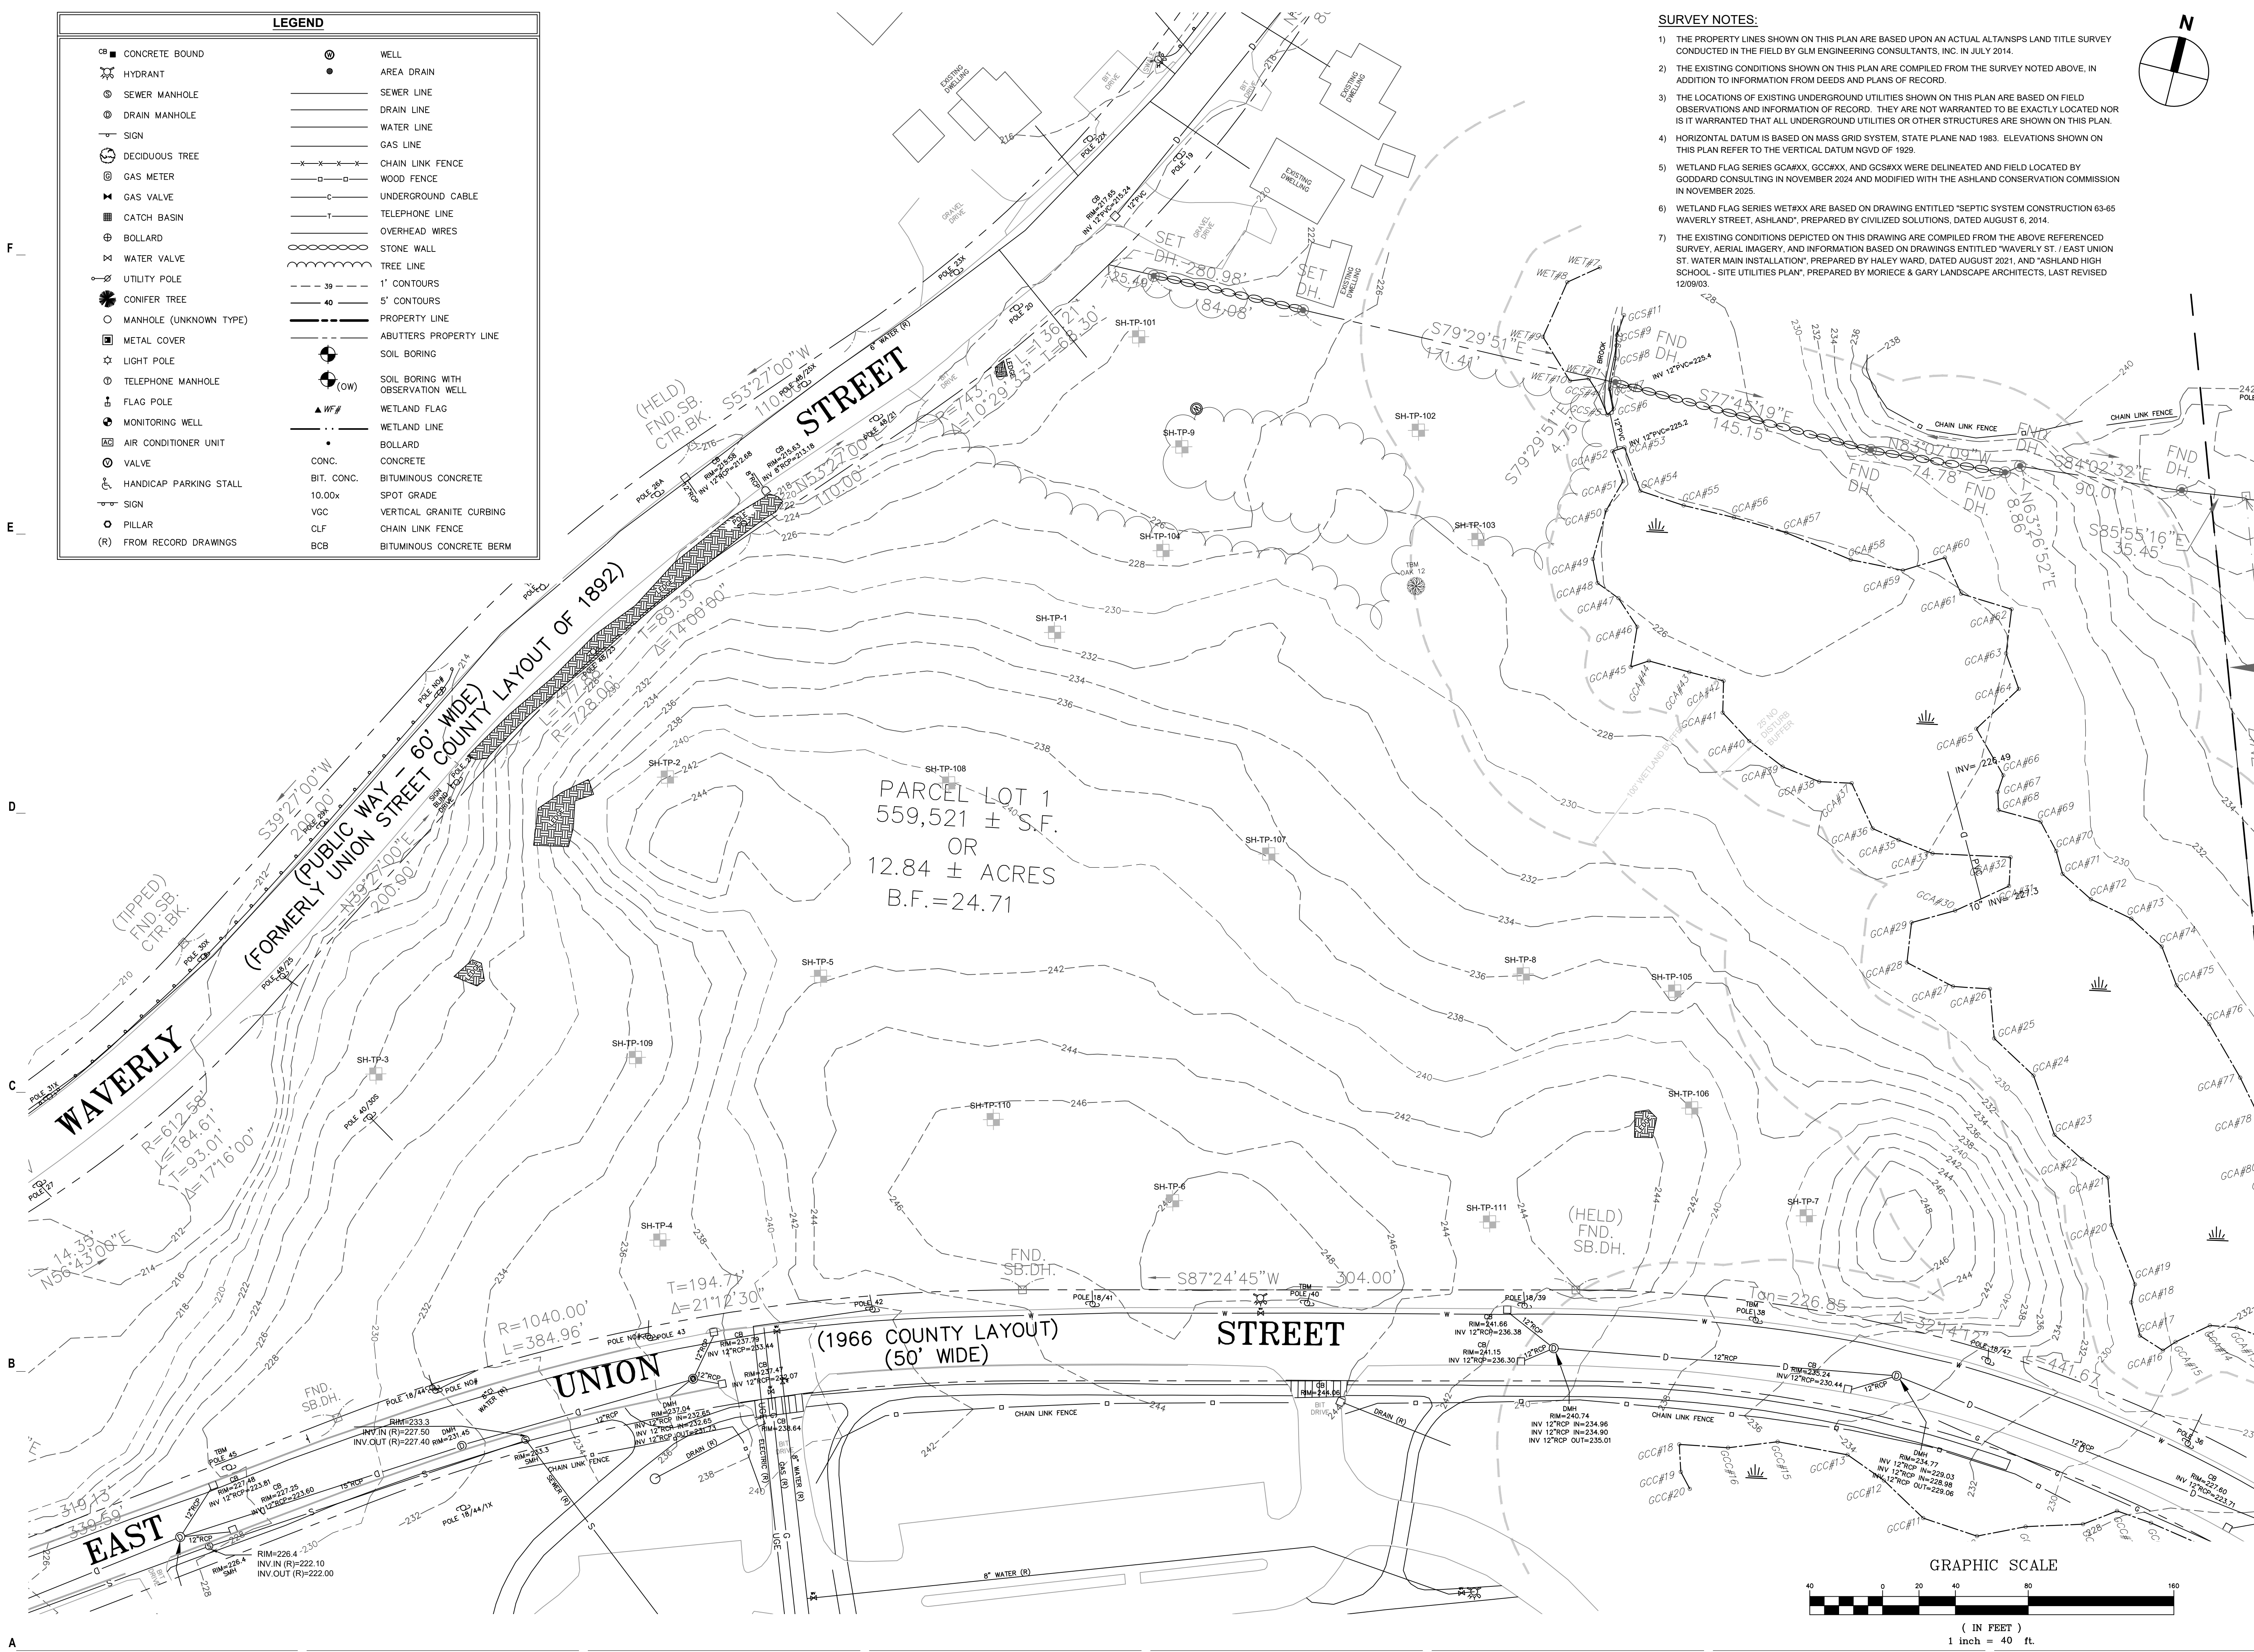
EXISTING CONDITIONS PLAN

- Wetland flag GCA#34 was eliminated and wetland flag GCA#33 was connected to GCA#35, thereby shifting the wetland line further upland. This area was questionable in whether it was upland or wetland but it was considered best to just eliminate GCA#33 to protect the area and delineate it as part of the wetland. Attached as **Exhibit 2** is the updated Existing Conditions Plan C-101 reflecting this change
- Attached as **Exhibit 2** is the Existing Conditions Plan C-101 with the updated delineation.

- Goddard reviewed a 2014 wetland delineation for the 63-65 Waverly Street property as it pertains to the bank of the ditch where it abuts 61 Waverly Street. That delineation differs slightly from the delineation Goddard conducted on November 20, 2024. However, Goddard will respect that delineation and will tie into it where the line crosses onto the subject site. As such, Goddard has adjusted its November 2024 wetland line delineation on the project-side. Specifically, wetland flags WET #10 and 11 from the 2014 delineation will be retained. WET #11 will connect to GCA#4. This will require minor grading adjustments to the site to respect the 25-foot No Disturbance Buffer Zone. **Exhibit 2** is the updated

Existing Conditions Plan C-101 reflecting this change
