# PUBLIC SAFETY BUILDING FEASIBILITY AND SITE LOCATION STUDY

ASHLAND, MASSACHUSETTS  
JUNE 19, 2018

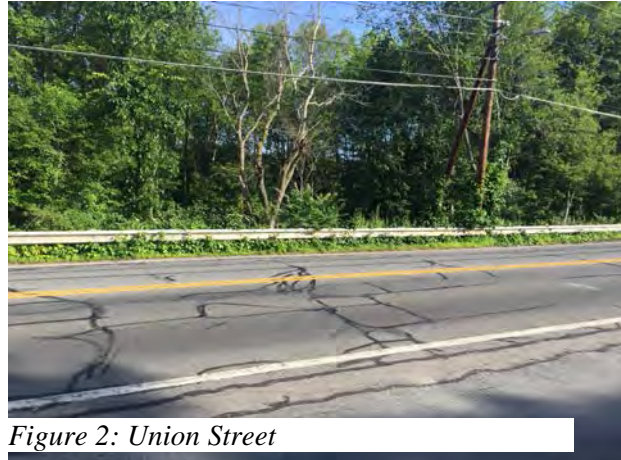
Figure 2: Union Street

Union Street is in fair condition with visible surface cracks which have been repaired with asphalt patching. Union Street has a 6" vertical granite curb on the south side of the street and no curb on the north side of the street. There is a bituminous sidewalk directly abutting the back of the granite curb on the south side of the street.

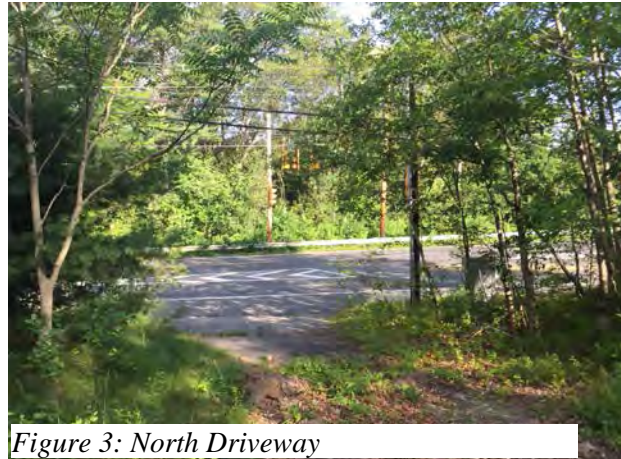
Figure 3: North Driveway

The Site has frontage along the south side of Union Street. At the intersection of East Union Street and Waverly Street, there is a paved driveway extending approximately 10 feet into the site. The driveway is in poor condition with deep cracks and potholes. The driveway is located south of the intersection of Waverly Street and East Union Street. There are existing traffic controls at this intersection including traffic lights and striping.

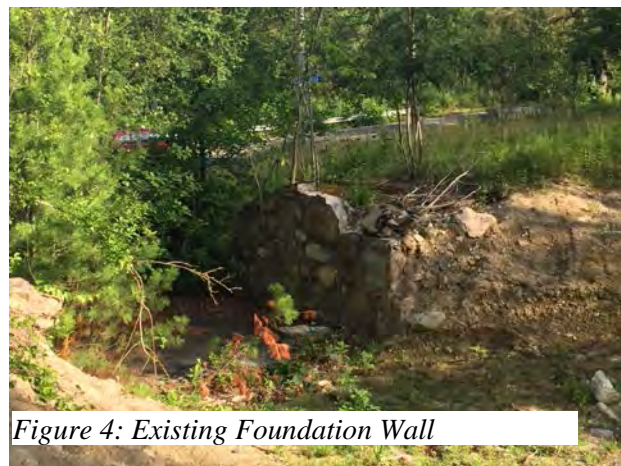
Figure 4: Existing Foundation Wall

The driveway leads to a small tree clearing. There is a stone foundation wall on the north side of the driveway in extremely poor to critical condition. The foundation wall is constructed of large boulders and a concrete material. Some stones have dislodged from the wall. Erosion is evident on the south side of the wall. At the south side of the tree clearing, stone steps were observed. The steps are in poor condition and are overgrown. A 4' chain link fence was also observed at the south side of the clearing. The chain link fence is in poor condition and is rusted and overgrown.

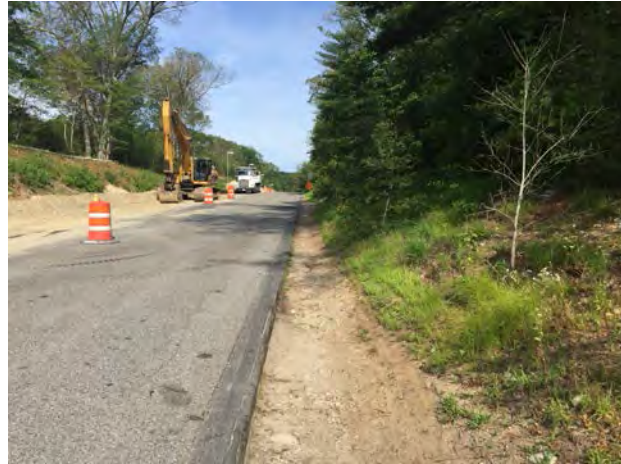
Figure 2: MBTA Access Road

The Station Site parcel is 123.22 acres and is currently undeveloped. The portion of the Parcel included in the study area is 11.10 acres (the Site). The Site is located north of MBTA Access Road, on the southwest corner of the property. There is a Superfund site on the northwest corner of the property (north of the Site) which has been capped. West of the property, on the south side of the MBTA access road, there is a residential development under construction. It is understood from conversations with Amy Dunlap that the community strongly opposed the development due to its close proximity to the Superfund site and the potential to disturb the cap.

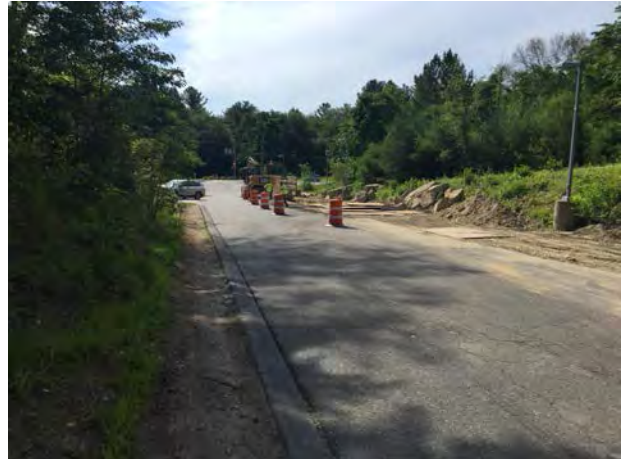
Figure 3: MBTA Access Road

MBTA Access Road is currently under construction for road widening and utility improvements in anticipation of the residential development. Upon final pavement, the road may be subject to a road moratorium.

MBTA Access Road had a bituminous berm curb along the north side. There is no curb on the south side of the street. The road does not have a sidewalk or other pedestrian access.

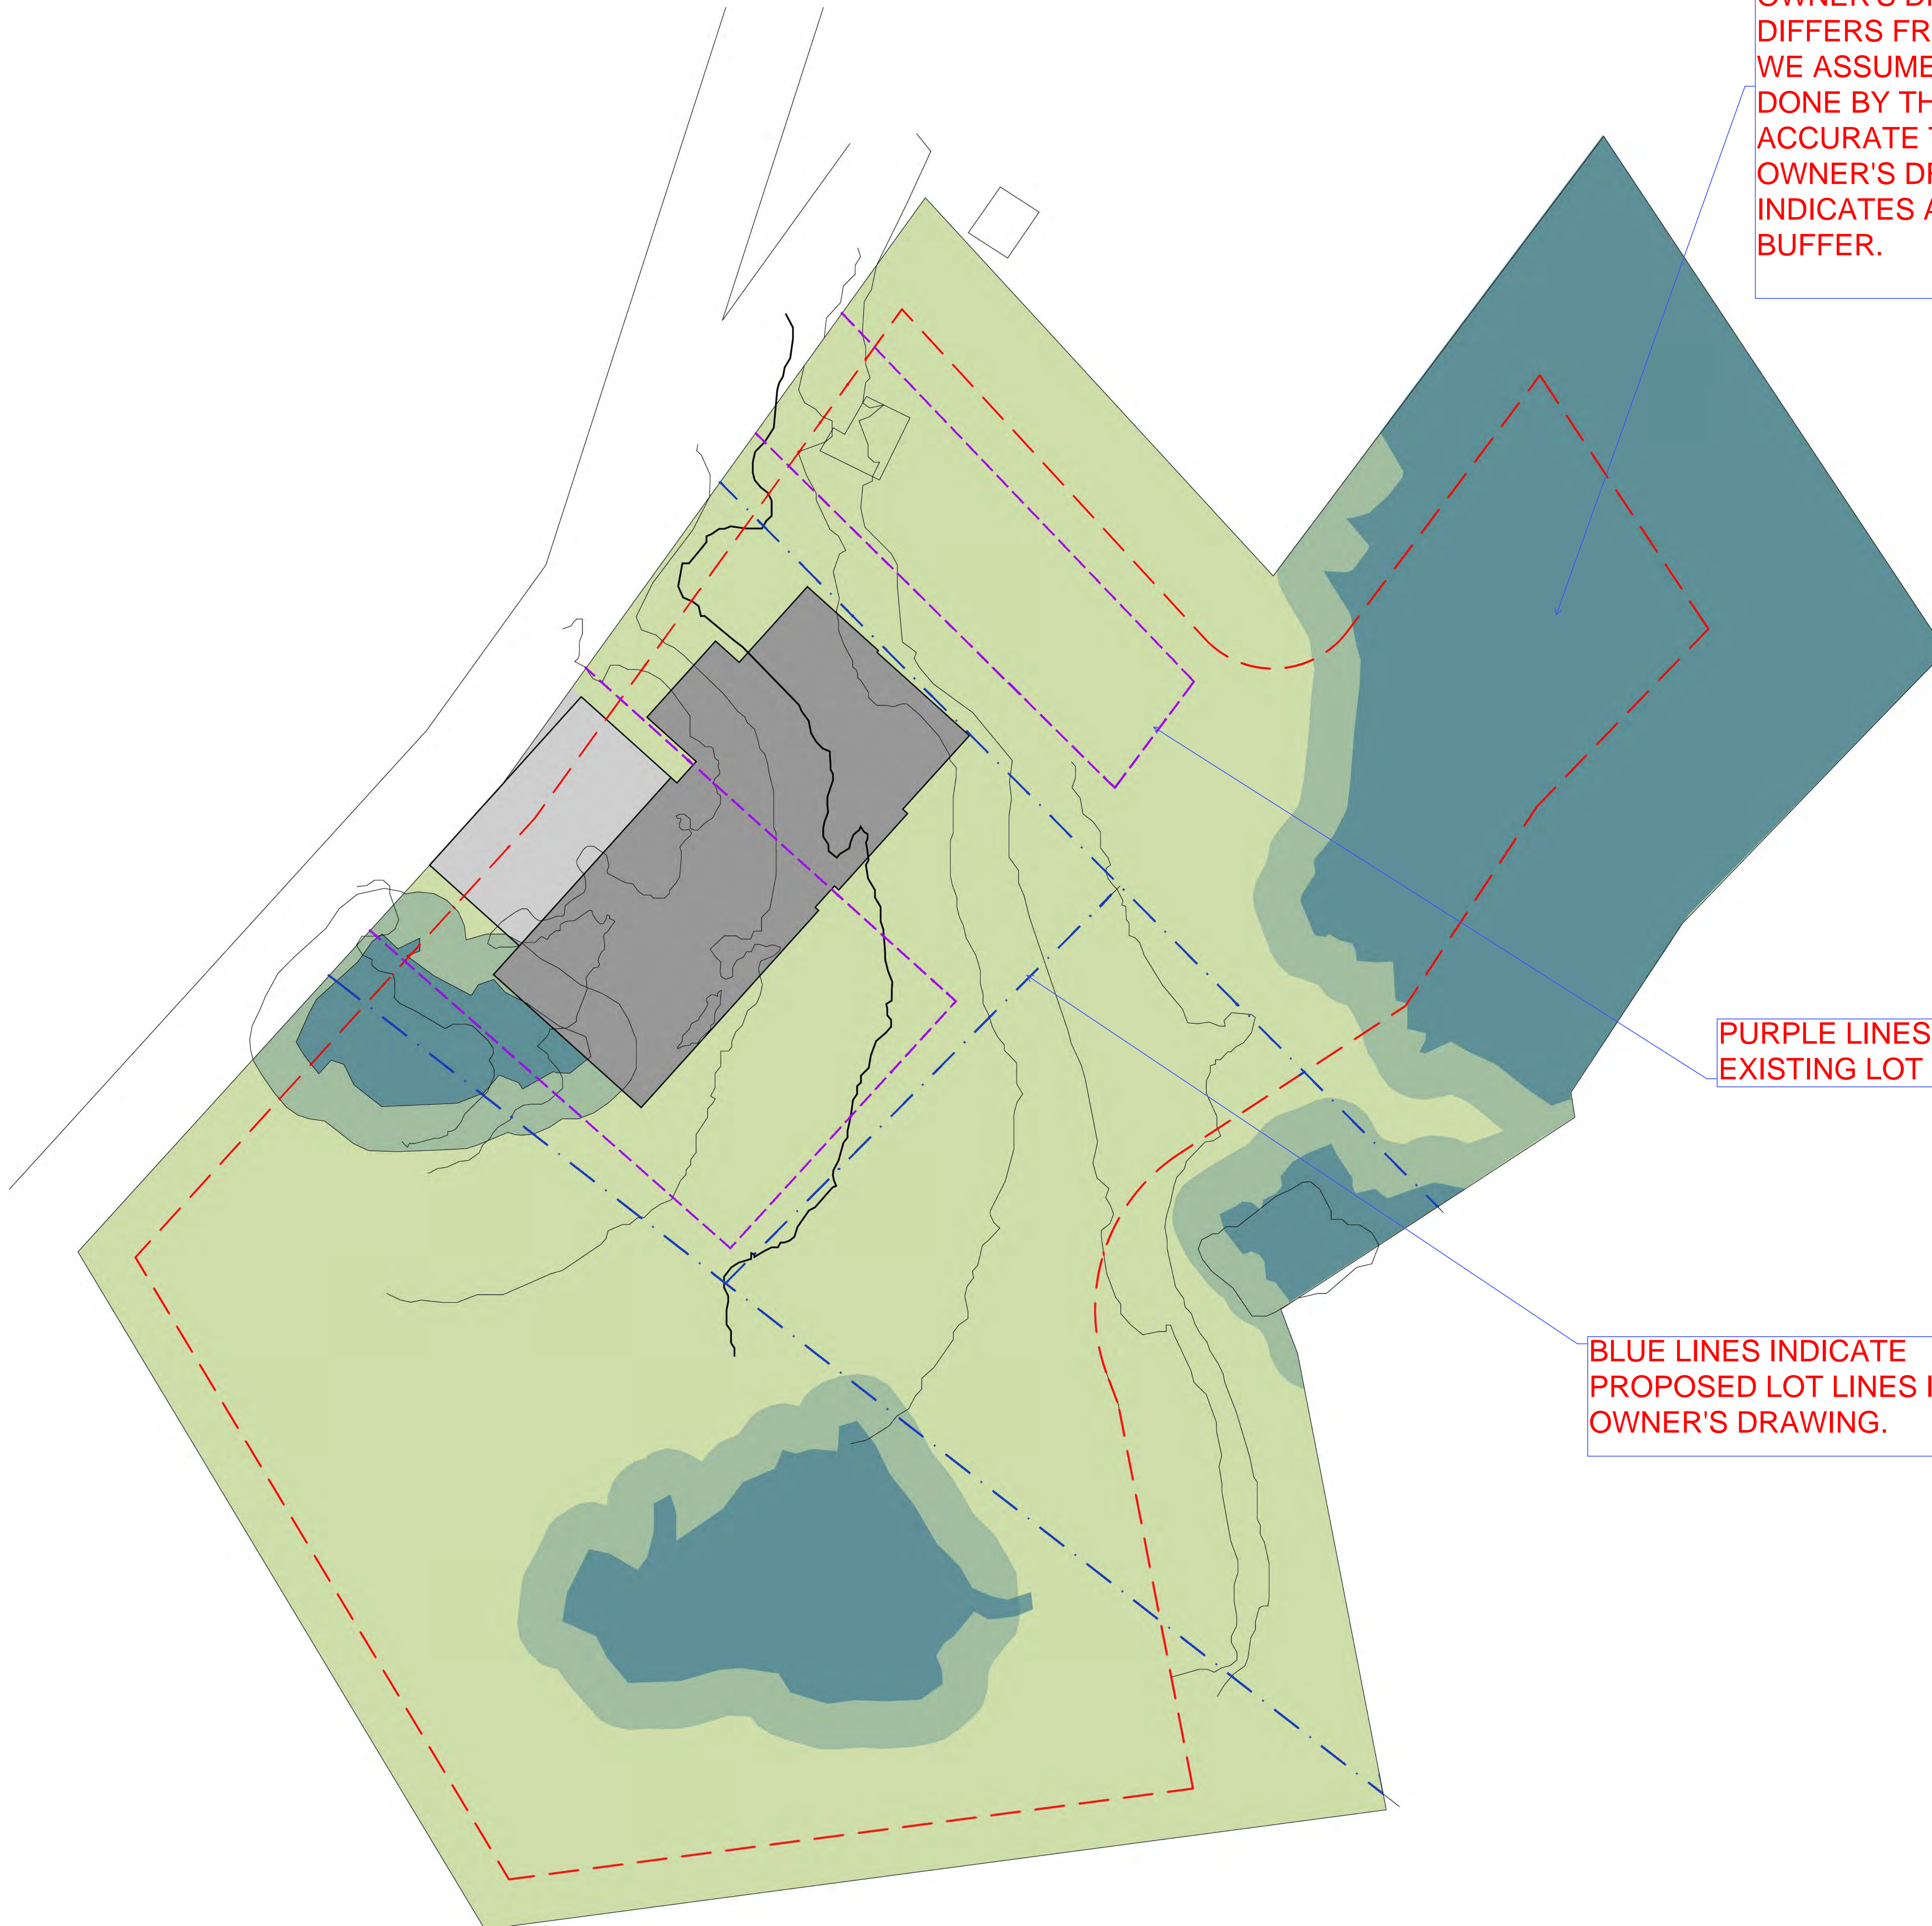
As a starting point, we took the block diagram from the MBTA Test Fit #1 and tried putting it on the Union Street site. You can see the width of the building almost completely fills the width of the parcel being offered to the Town, and there is development in the wetlands. We abandoned this option immediately and moved on to another.

FOR ALL UNION STREET TEST FITS, WE USED WETLANDS DELINEATION PROVIDED BY OWNER'S DRAWING, WHICH DIFFERS FROM GIS INFORMATION. WE ASSUME WETLAND FLAGGING DONE BY THE OWNER IS MORE ACCURATE THAN GIS DATA. OWNER'S DRAWING ONLY INDICATES A 25' WETLANDS BUFFER.
