Ballard and Highland Ashland, MA

Depietri Group LLC
Sander Depietri

MP Design Consultants
Marc Alencar
Carlos Ferreira
John Grenier

Introduction

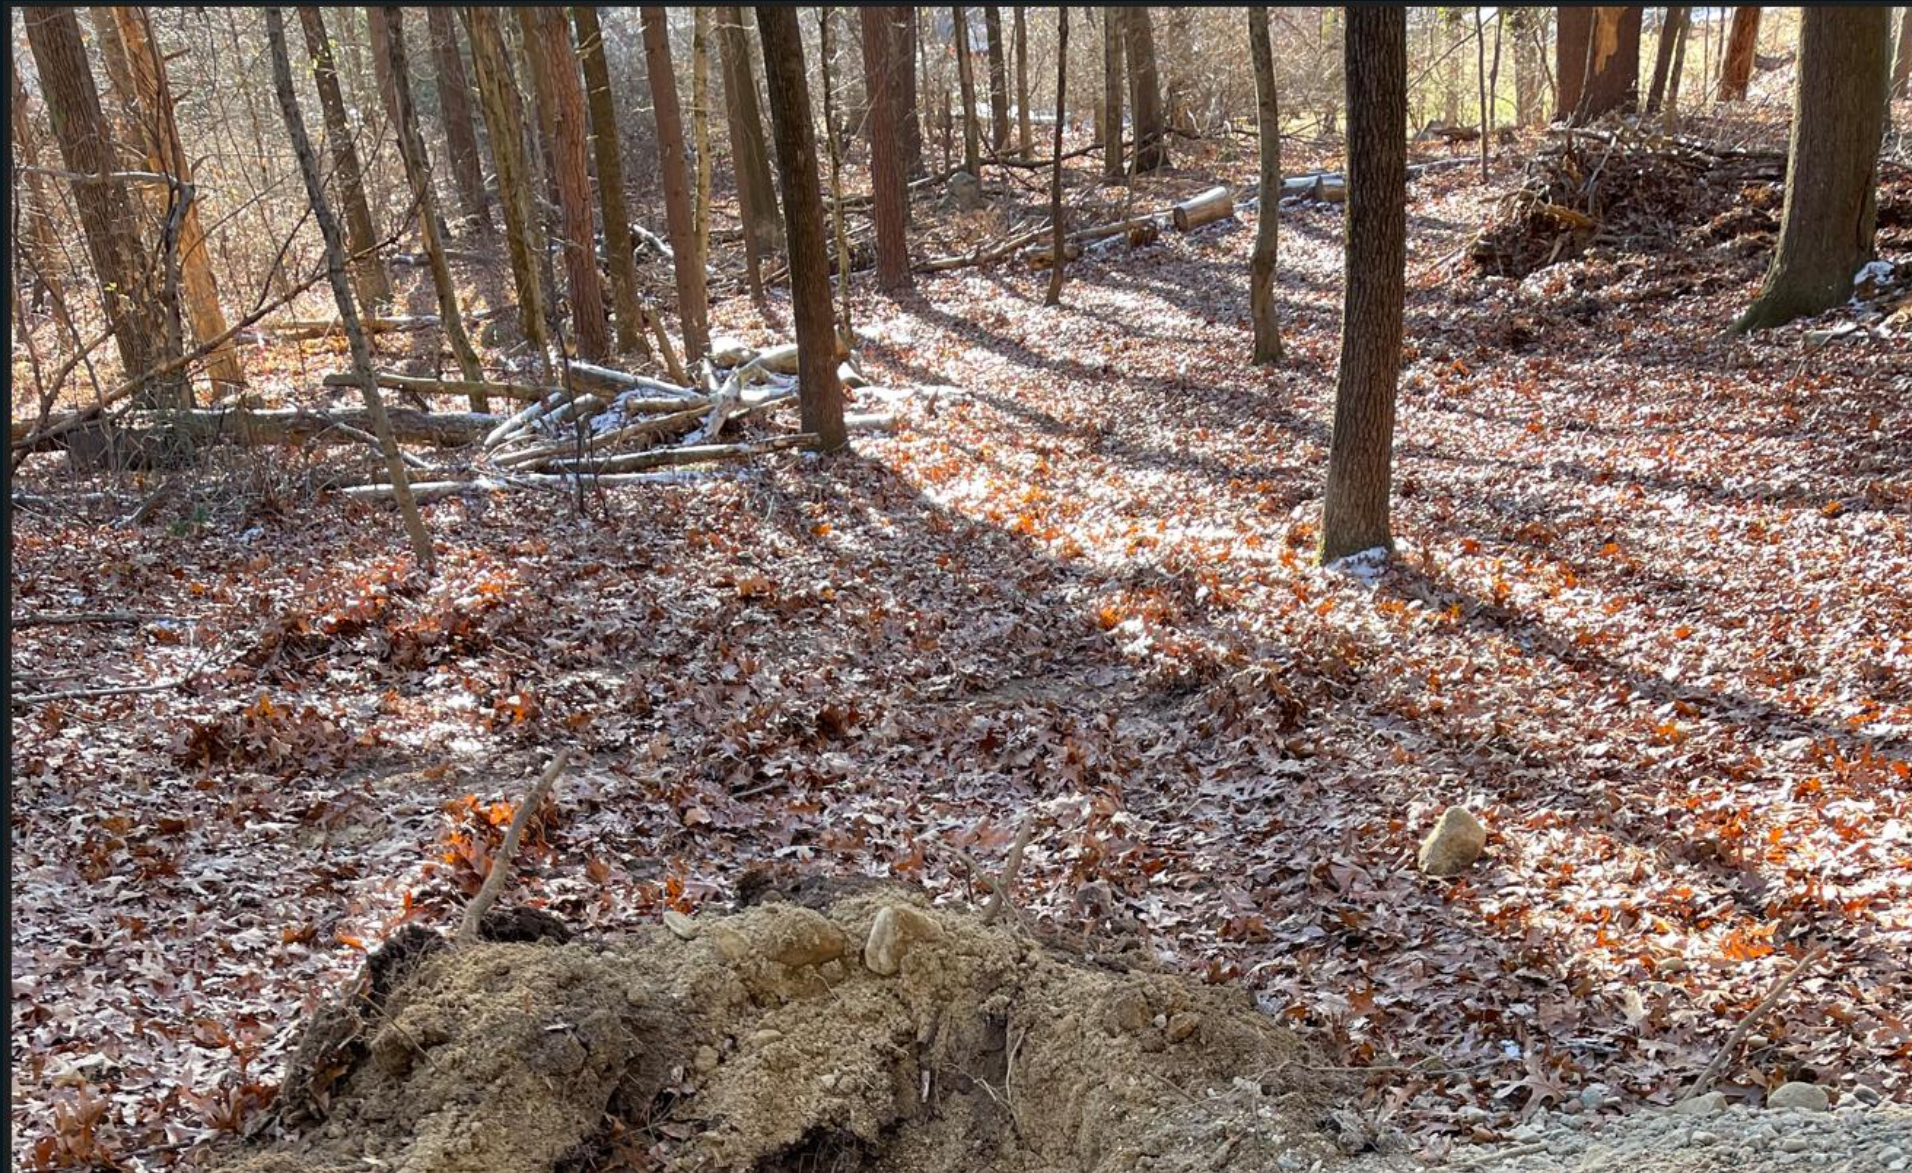
Proposed Development

Erosion and Sedimentation Control

During Construction :

Implementation of silt sacks on downstream CB, double layer linear sedimentation control on downgradient areas, Construction entrance and soil stockpile area

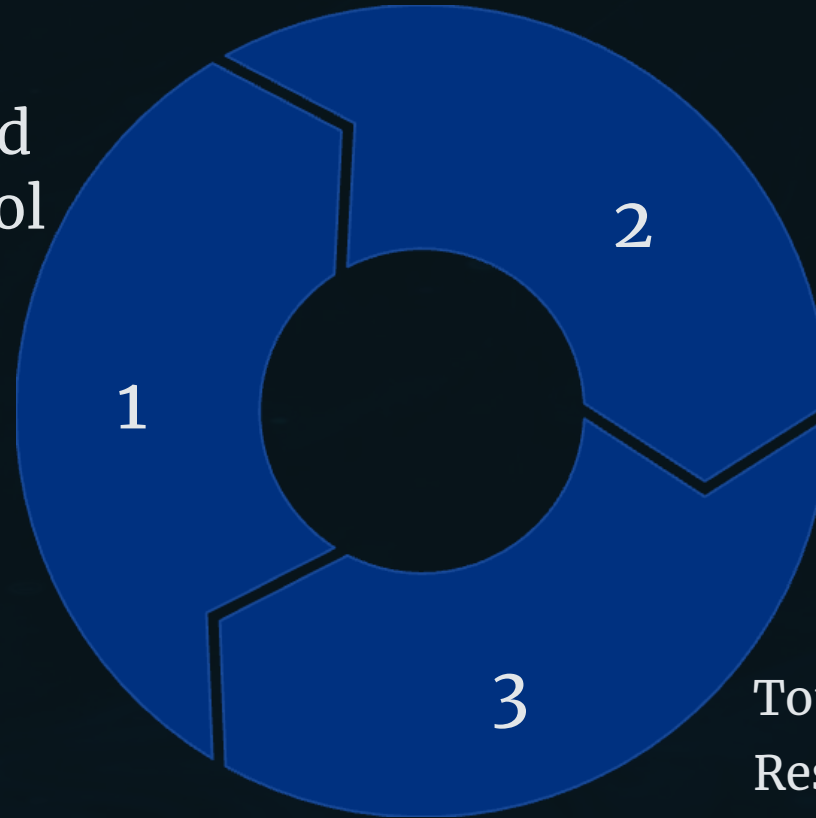
Stormwater Design

Highland Road:
Stormwater runoff treated by an infiltration basin (BMP #11) designed with an outlet control structure and mitigating steep slopes stormwater through a closed drainage system

Ballard Road:
Stormwater runoff treated by subsurface infiltration galleys

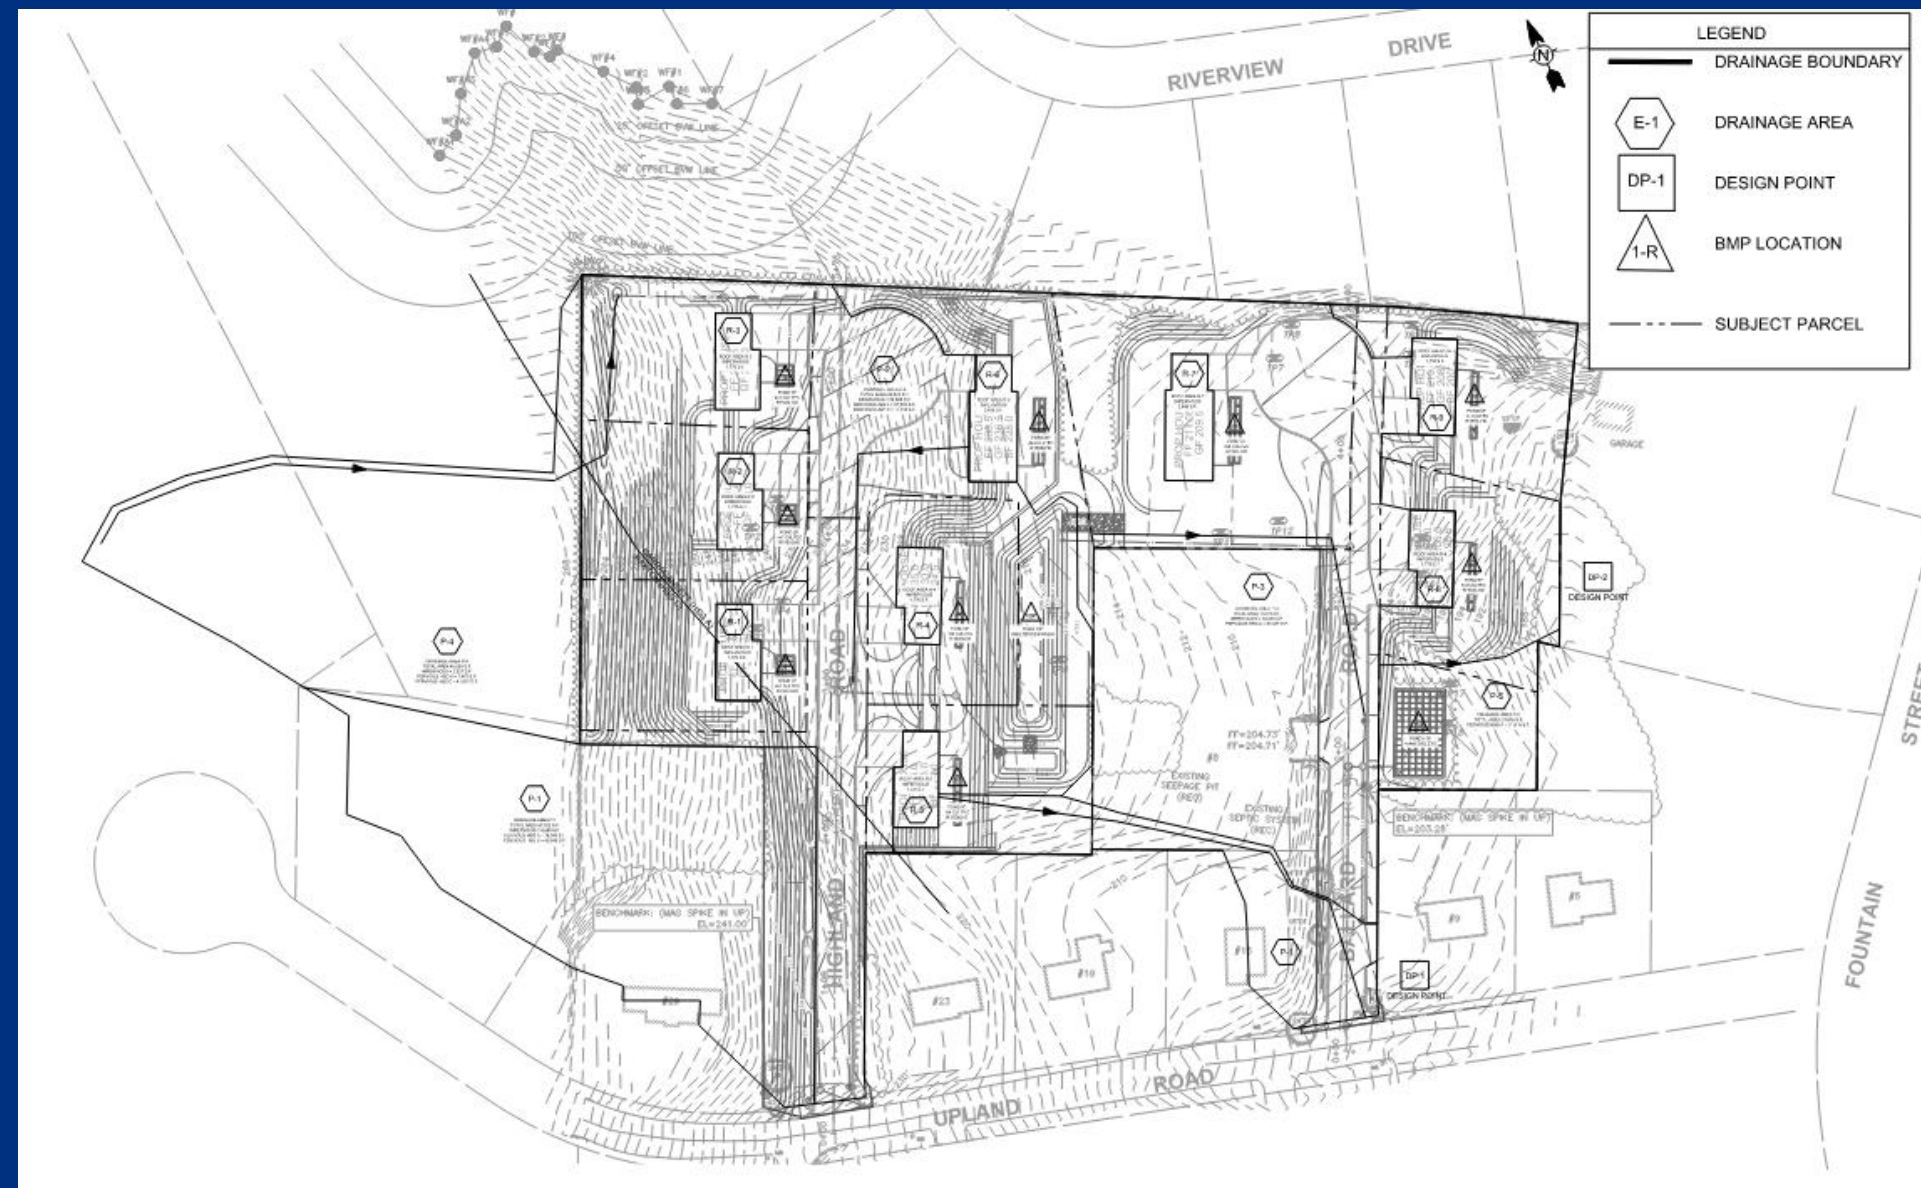
Figure 3 – Post-Development Drainage Plan

Maintain to the extent practicable existing runoff characteristics while significantly improving stormwater runoff volume to abutters and containment within project development area in compliance with applicable regulations.

Overflow continues flowing to closed drainage system without affecting abutters.

Answer: The proposed drainage design improves existing conditions and does not increase runoff to abutting properties, directing flows into the municipal closed drainage system in a controlled manner.

Answer: The site is graded to maintain positive drainage and prevent ponding, and any overflow during extreme events is directed to the municipal closed drainage system consistent with existing conditions.
